## **Milestone Inspection – Phase 1**

## **Ola Grande Condominium**

5350 Ocean Beach Blvd, Cocoa Beach, Florida 32931 (Bldg 2)

October 7, 2024

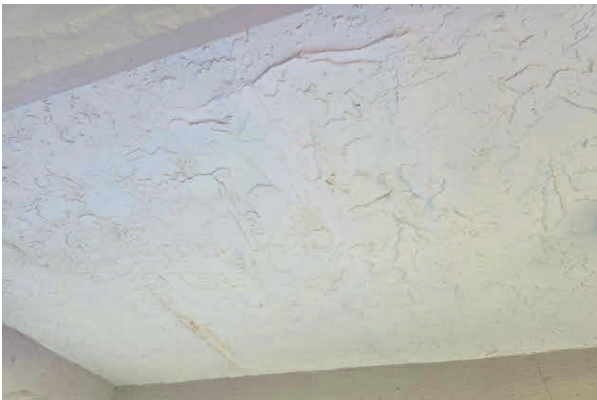
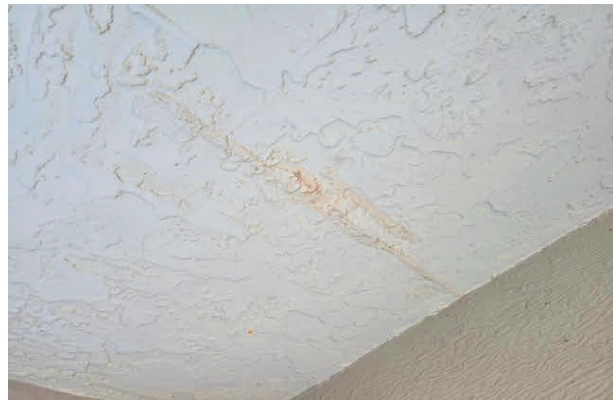
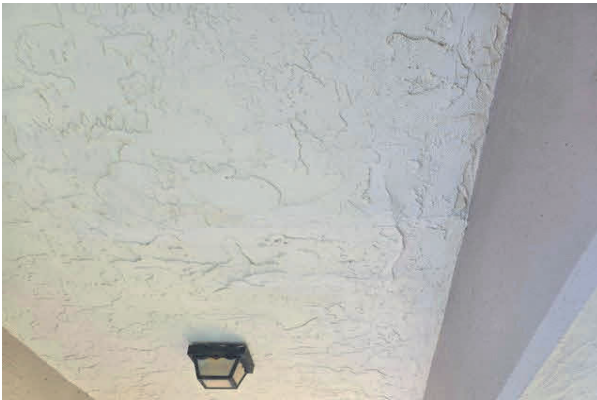
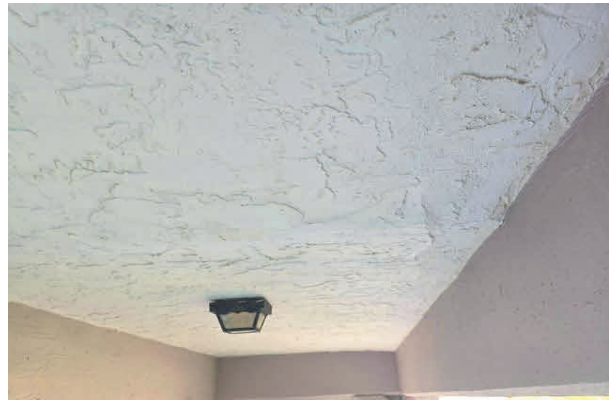
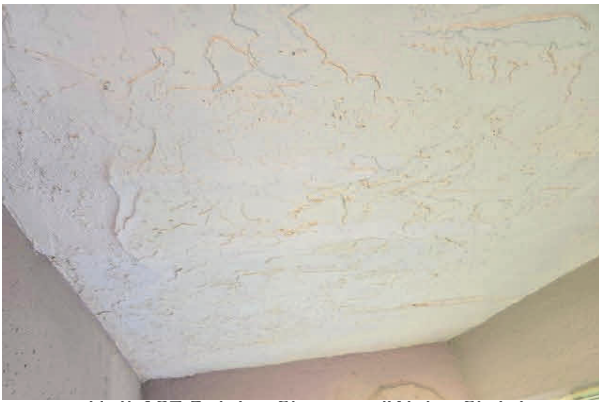
Bulging Stucco with Water Staining Unit 107 Patio Ceiling See Photos 5-13. Stucco was opened to verify that structural framing wood members did not have wood rot.

5 Unit 107 Bulging Stucco w/Water Staining on Patio Roof

6 Unit 107 Bulging Stucco w/Water Staining on Patio Roof

7 Unit 107 Bulging Stucco w/Water Staining on Patio Roof

8 Unit 107 Bulging Stucco w/Water Staining on Patio Roof

9 Unit 107 Bulging Stucco w/Water Staining on  
Patio Roof

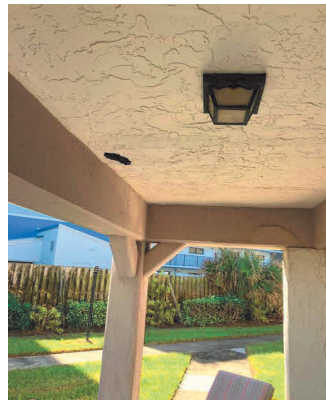
10 Unit 107 stucco removed

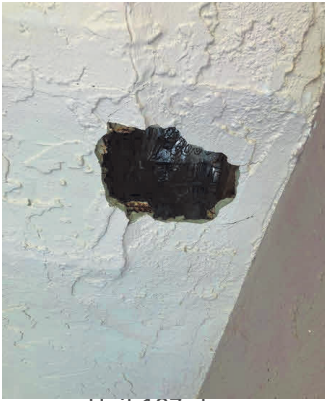
11 Unit 107 stucco removed to verify traming  
memebers

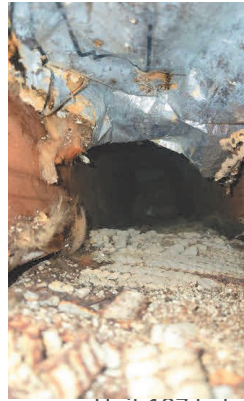
12 Unit 107 balcony with wood traming  
memebers

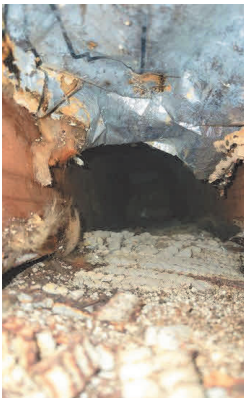
13 Unit 107 balcony with wood traming  
memebers
