# Florida Association of Building Inspectors

## 4-Point Insurance Inspection Report

Client: Casali Inc.	Date: 6/19/2026	Policy #	Type of Home: Single Family
Client Email:	Client Phone:	Number of Stories: 1	Type of Construction: Wood Frame
Address: 2010 Algeria St. NE	City: Palm Bay	Zip Code: 32905	Year Built: 1978

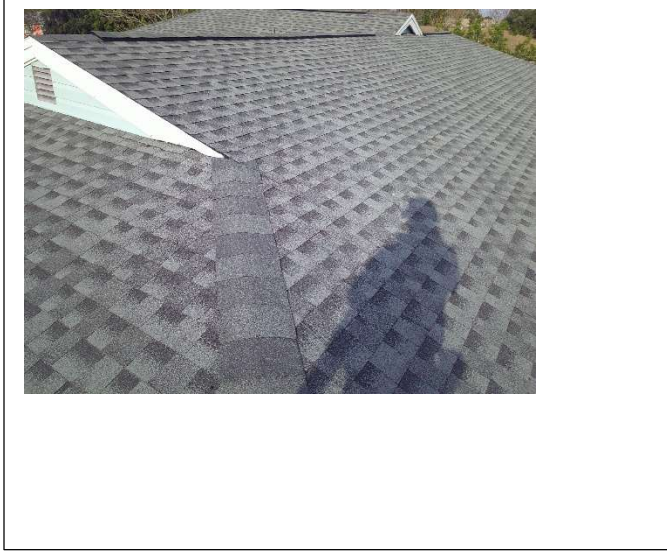
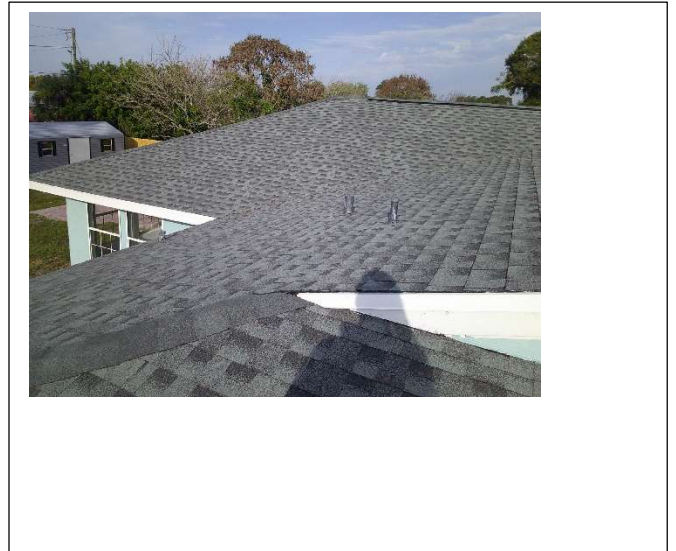
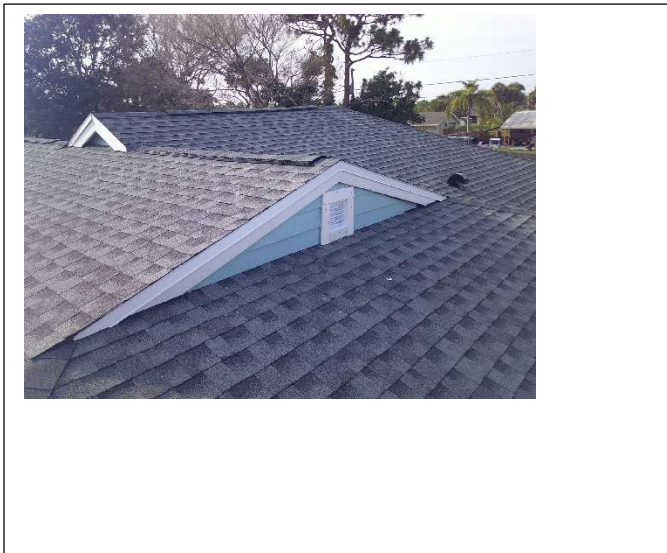
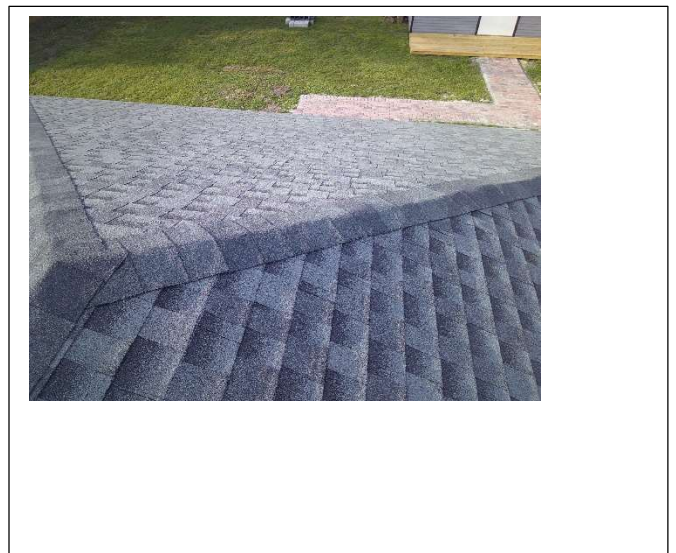
Comments: Although the manufacturer may give this roof 30 plus years, the Insurance Industry typically only gives 20 – 25 years. With that, based on the roofs overall condition and date of installation; it is this Inspectors professional opinion that this roof has approximately 20 plus years depending on future environmental conditions.

Roof Covering

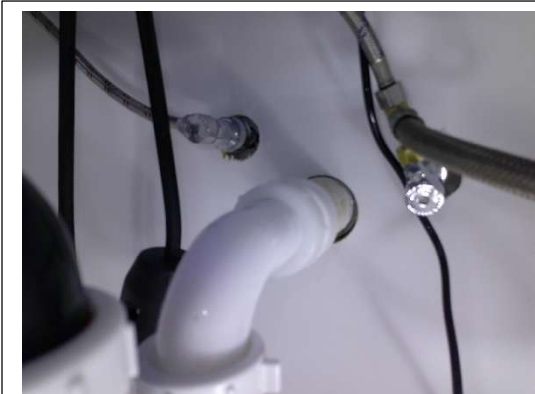
Plumbing Supply/Waste (Kitchen)

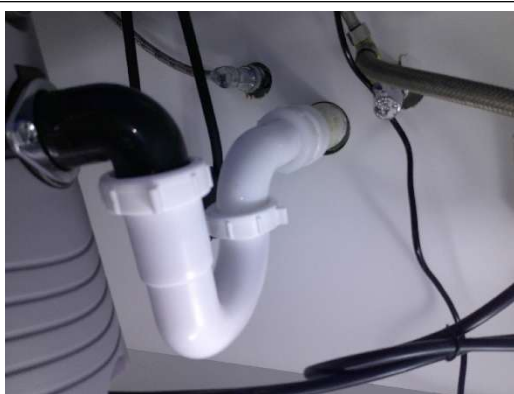
Plumbing Supply/Waste

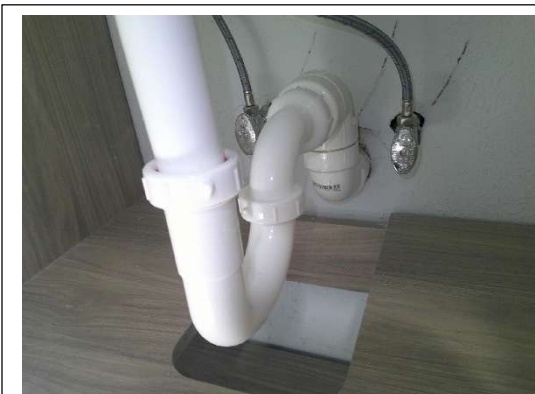
Plumbing Supply/Waste (Hall Bath)

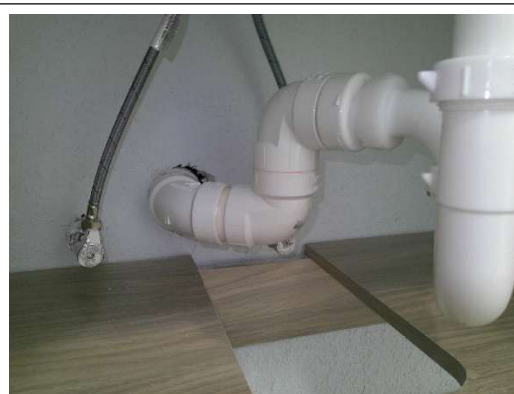
Plumbing Supply/Waste (Master)

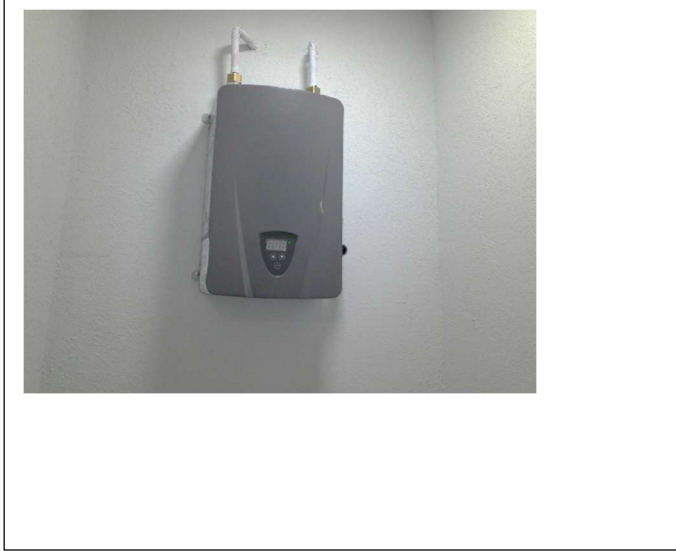
Comments: Although most of the supply and waste lines appear to be the original, this residence has just completed a total renovation/update (6-17-26), and with that, PEX was noted under some sink locations and at the tankless water heater, along with all new stainless supply lines, fixtures, toilets and shutoffs.

Water Heater

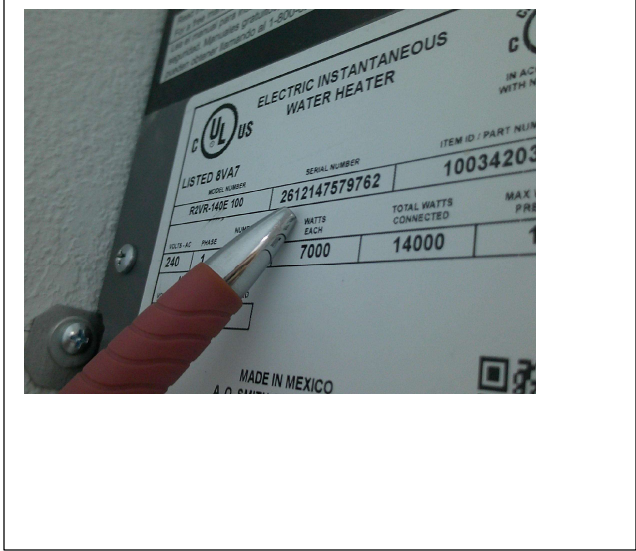
Water Heater Data Plate (2026)

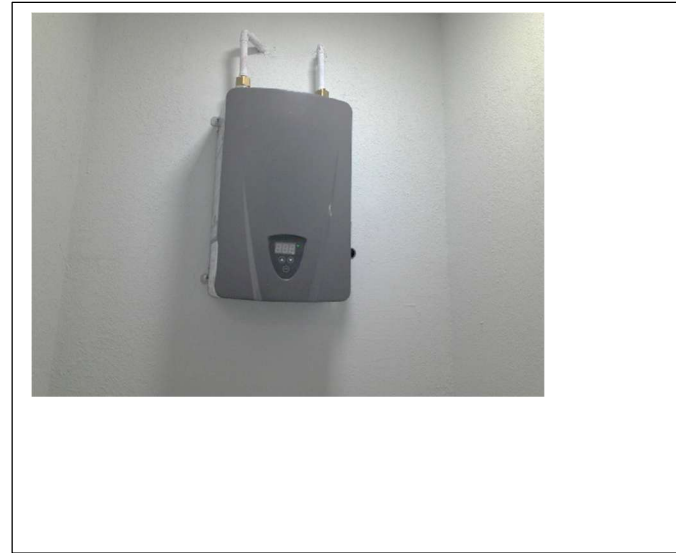
TPR Valve

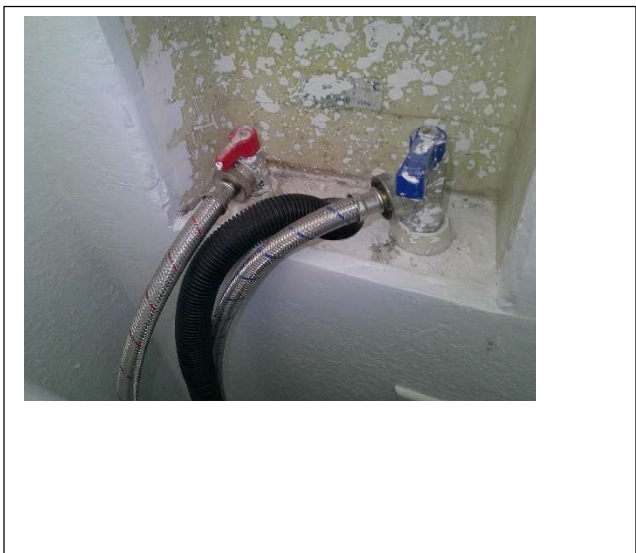
Washer Connections

Note: No TP Valve required for this unit, reason for TP Valve statement on page 2 left blank.

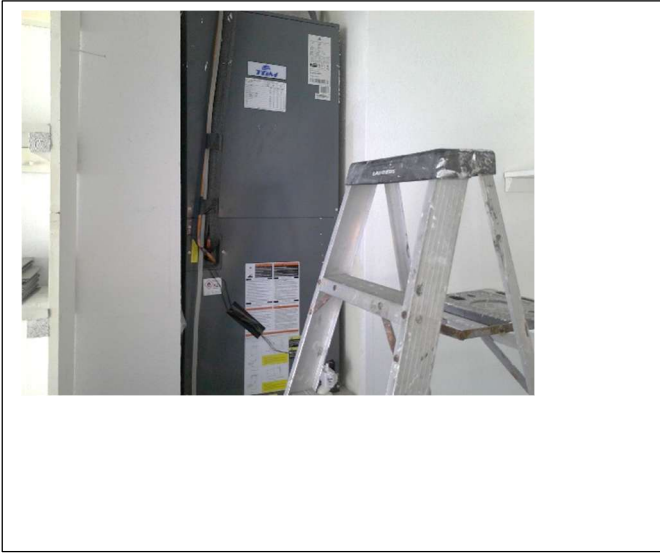
Comments: Although the unit has a manufacture date of 2025 (see photo section), system was just installed this month (June). No problems noted with this system

HVAC - Air Handler

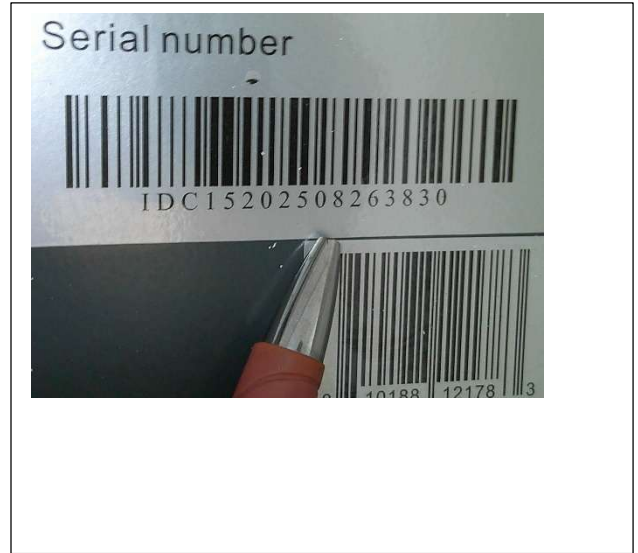
Data Plate (2025)

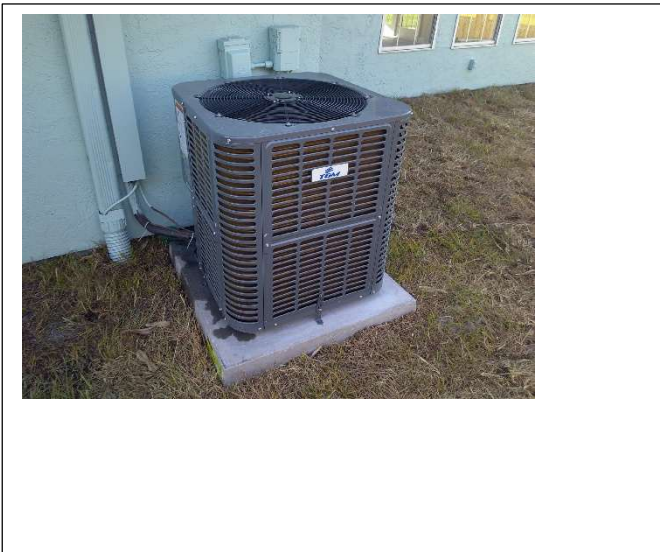
HVAC - Condenser

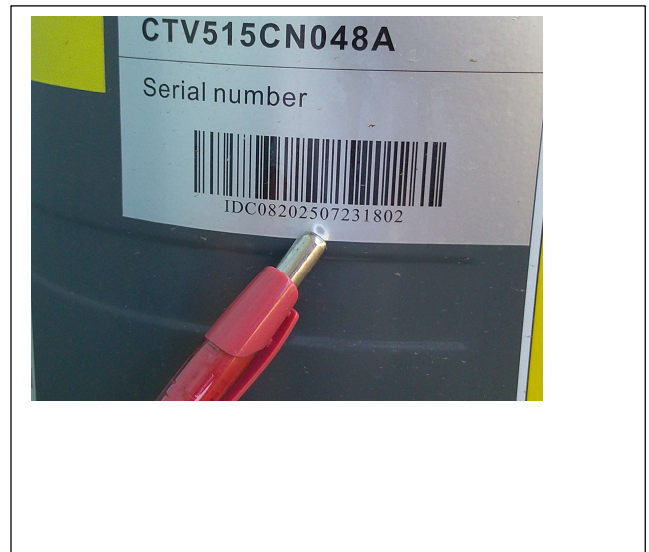
Data Plate (2025)

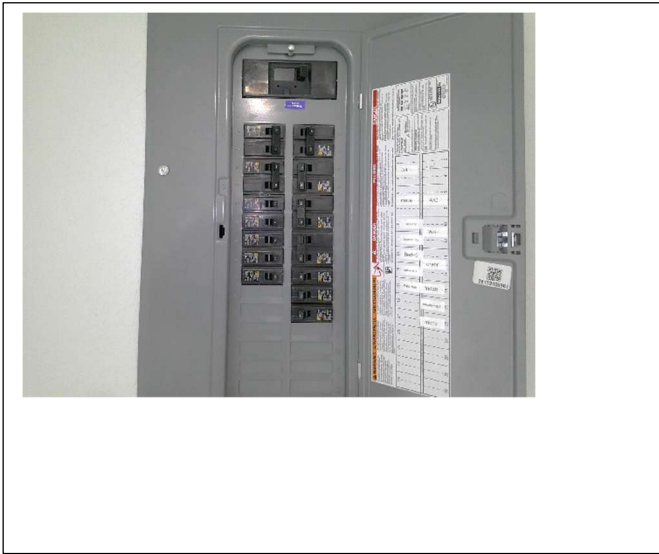
Comments: Although some of the wiring may be the original, the electrical panel, all outlets, switches and fixtures were recently replaced/upgraded (this month, June). See photo in the "Observation" section of this report regarding new panel.

Main/Distribution Electrical panel with dead front and door

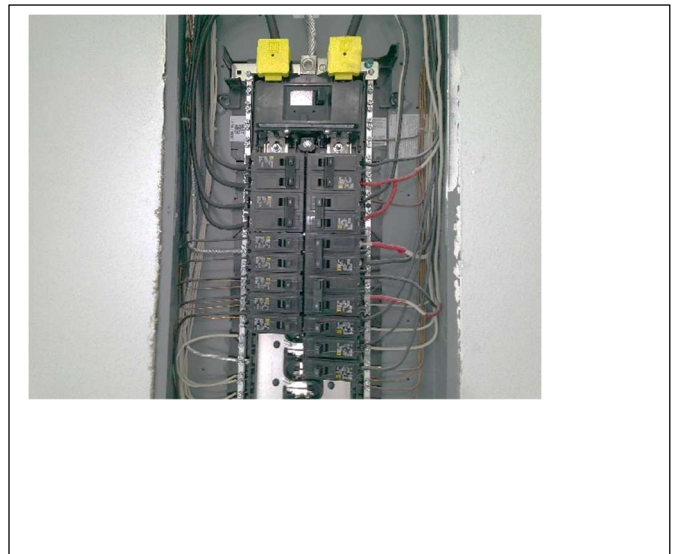
Note: The only aluminum wire seen was that of stranded service wire (still used today)

Electrical panel w/o Cover

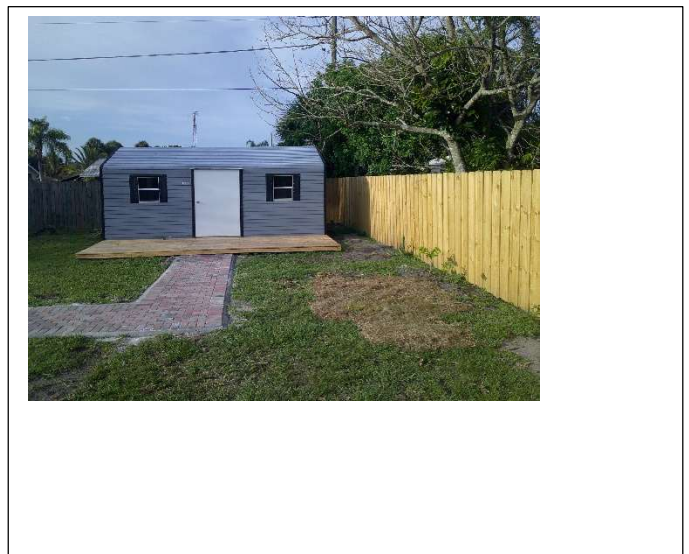
Detached Shed (no access)

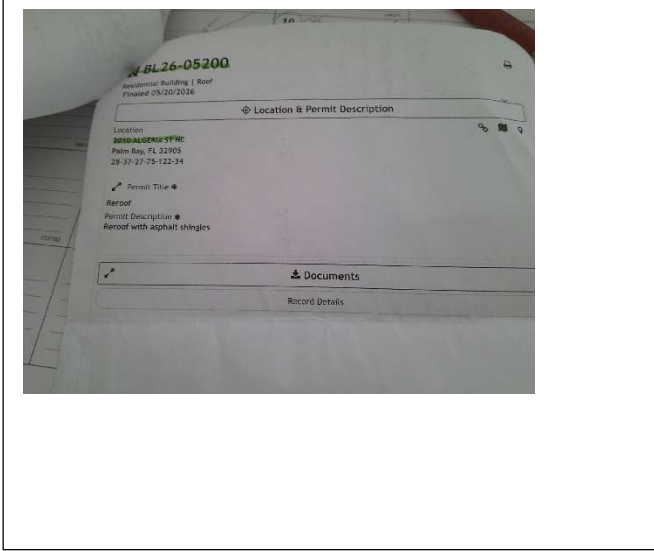
Roof Permit (BL26-05200)

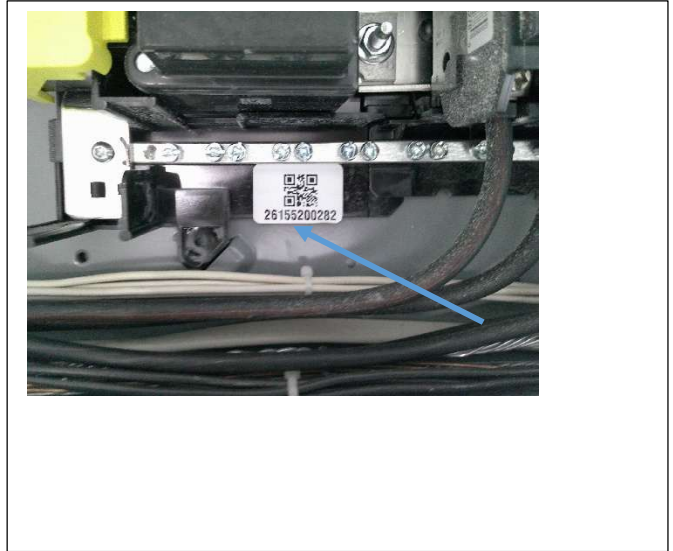
Manufacture Date for the electrical panel (2026)

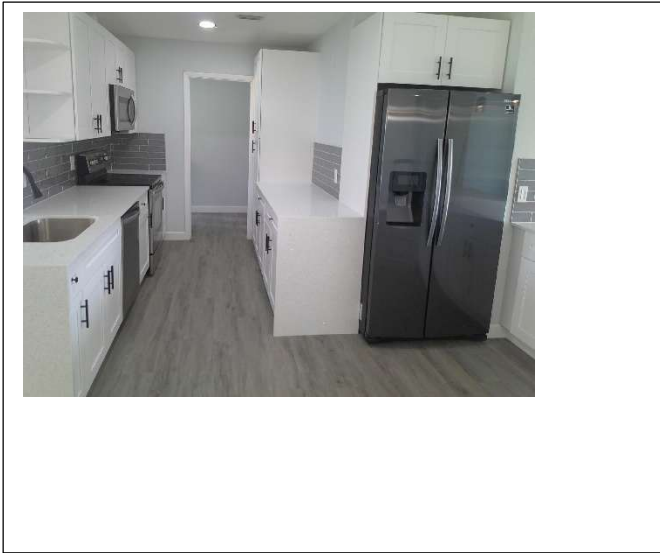
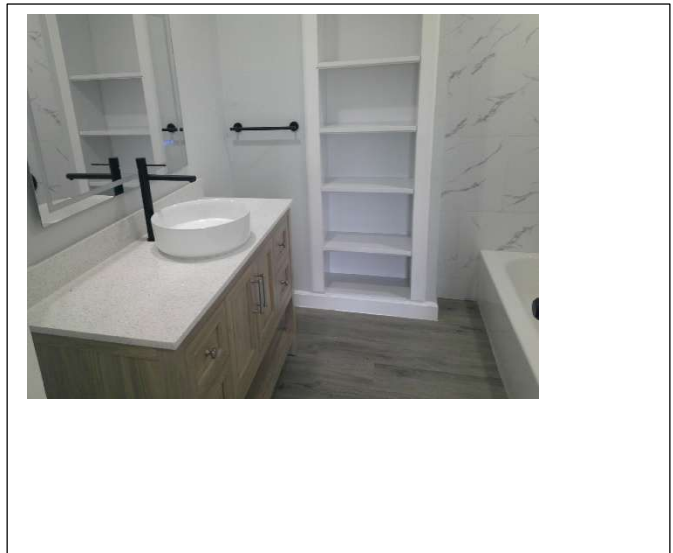
Kitchen and Hall Bath Remodel

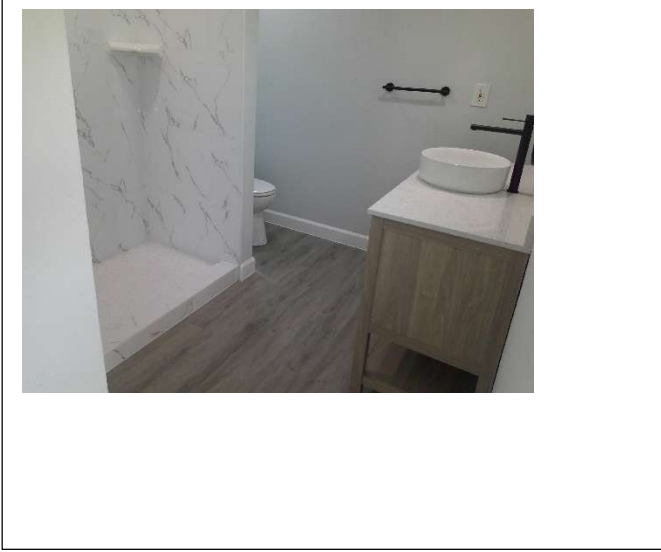
Master Bath Remodel

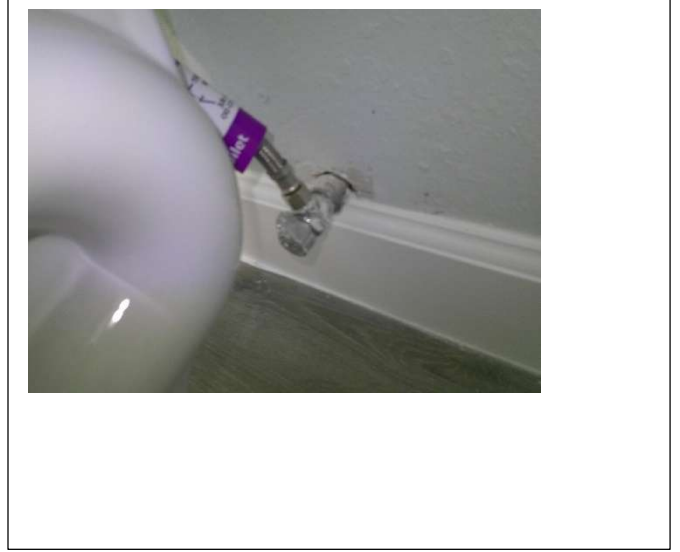
Toilets - New shutoffs and stainless supply lines
