# Costa Del Sol

## Condominium Association, Inc.

Inspected: July 29, 2024 • Revised on: November 19, 2024  
Cape Canaveral, FL

**STRUCTURAL INTEGRITY  
RESERVE STUDY**

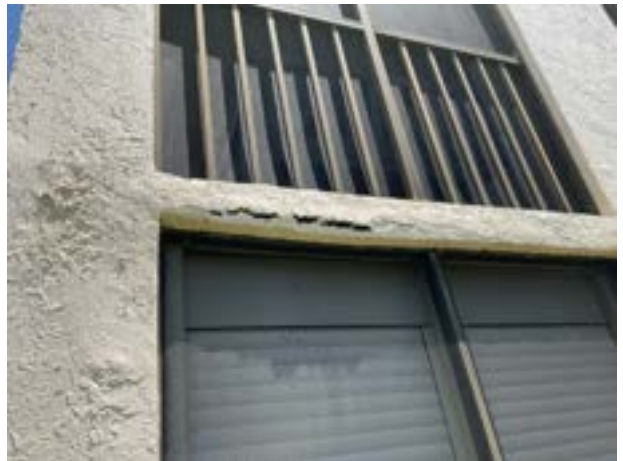
**Edge cracks**

**Useful Life:** Capital repairs including a close-up visual inspection, patching of delaminated concrete, routing and filling of cracked concrete, and waterproof gemstone coating applications every 20- to 25-years with the benefit of interim sealant applications performed every two- to four-years.

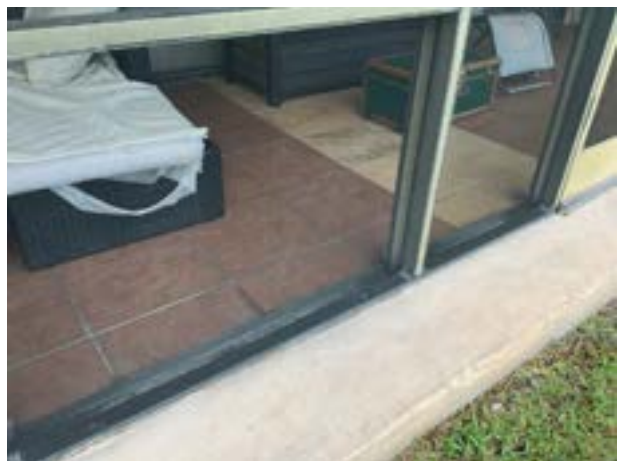
**Concrete deterioration**

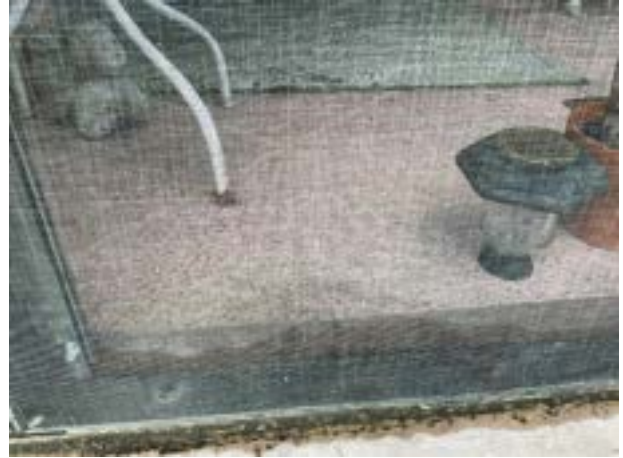
**Concrete crack**

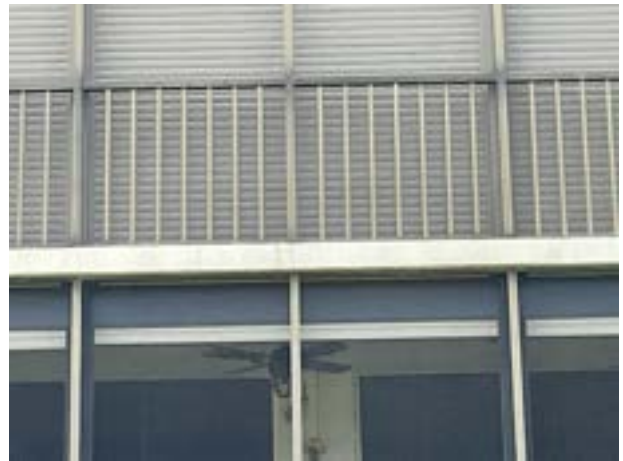
**Coating deterioration**

**Rust stains**

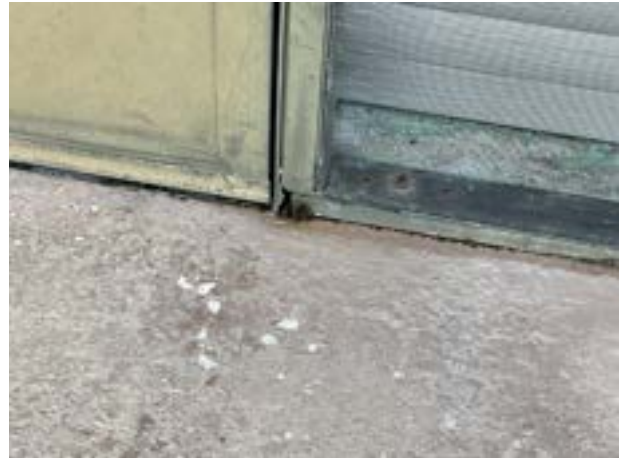
**Torn Screen**

**Frame damage**

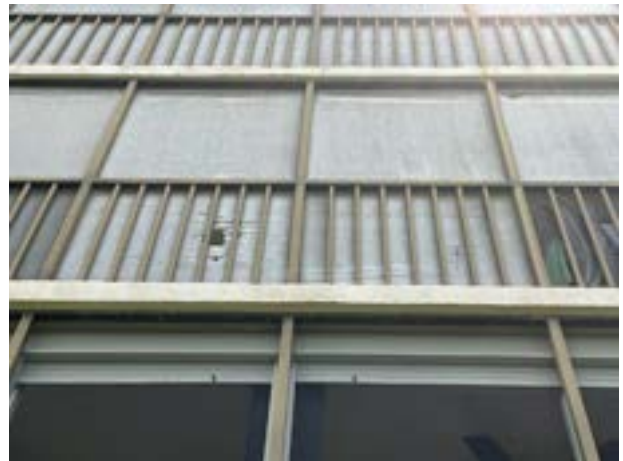
**Balcony screens with frame finish deterioration**

**Torn screen**

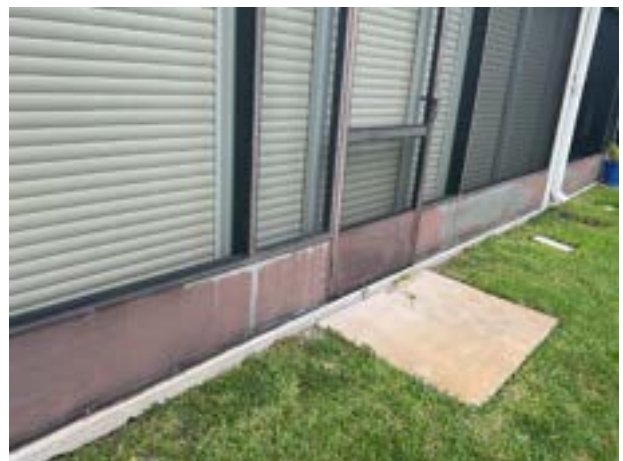
**Frame finish deterioration**

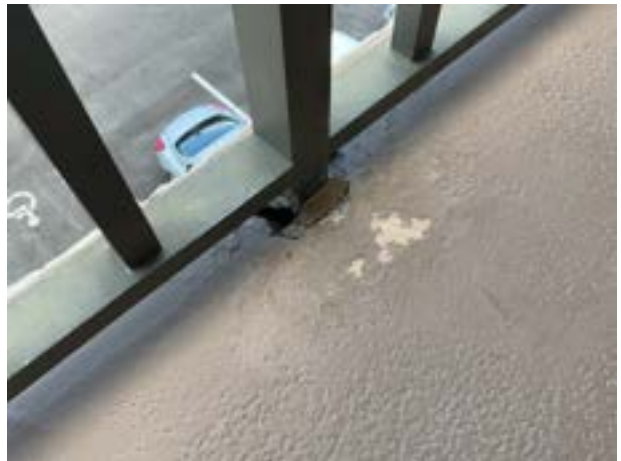
**Deterioration at railing breezeway connection**

**Useful Life:** Capital repairs including a close-up visual inspection, patching of delaminated concrete, routing and filling of cracked concrete, and waterproof coating applications every 8- to 12-years.

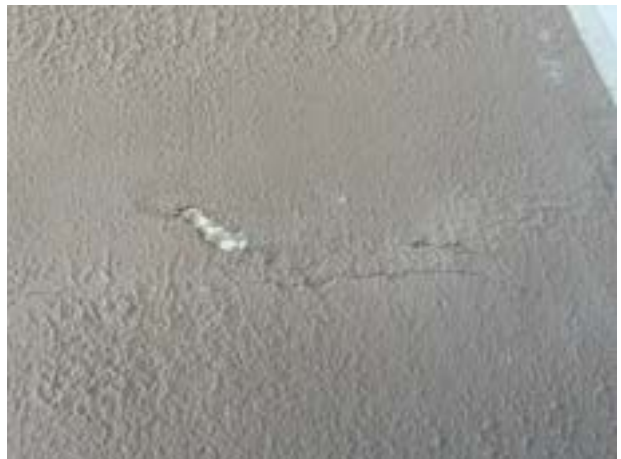
**Cracks**

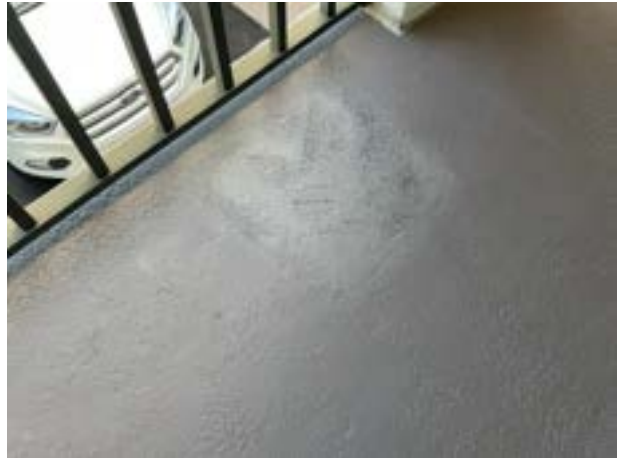
**Evidence of partial replacement**

**Evidence of previous replacement**

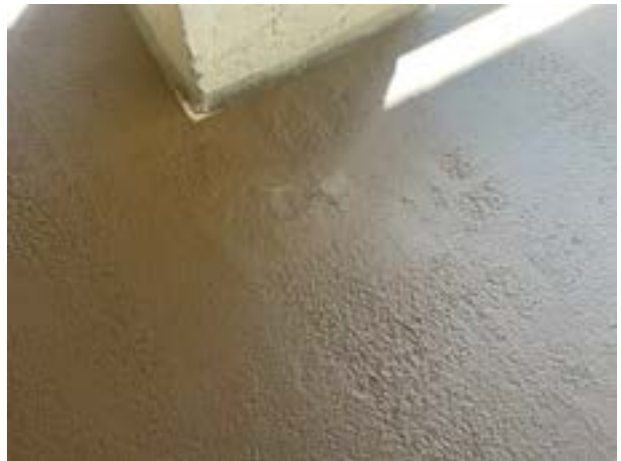
**Sealant deterioration**

**Concrete cracks**

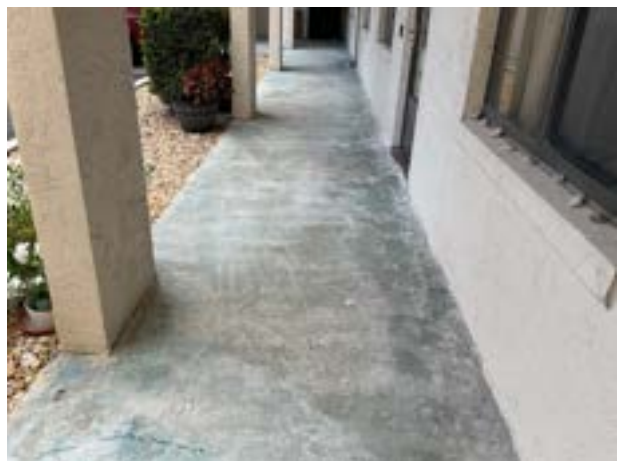
**Concrete deterioration**

**Concrete restoration ongoing**

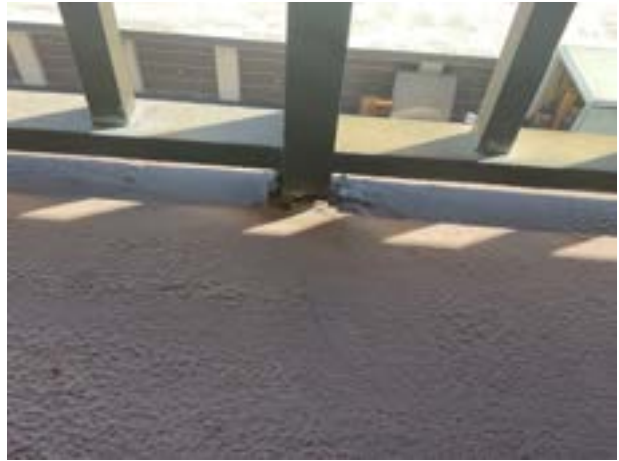
**Corrosion**

**Railing post embedded in concrete**

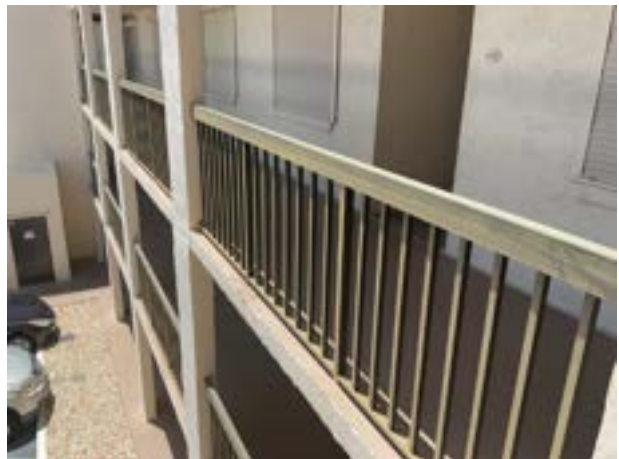
**Finish deterioration**

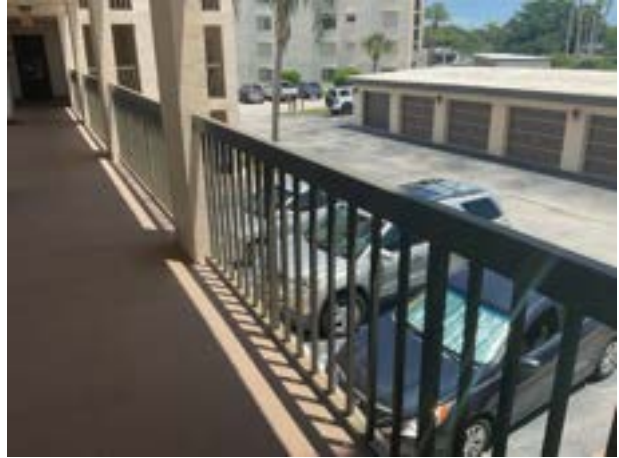
**Finish deterioration**

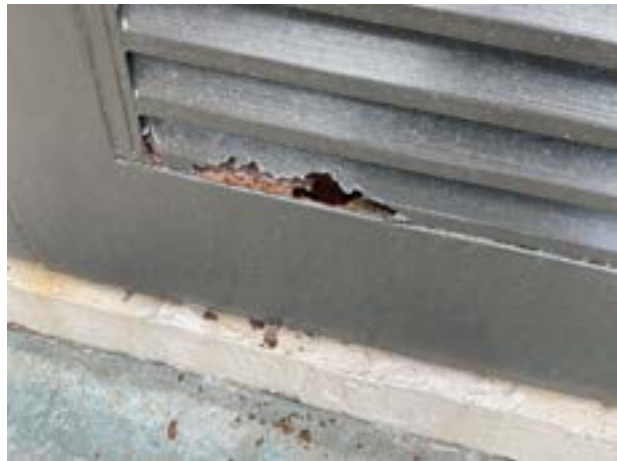
Rust

Frame deterioration

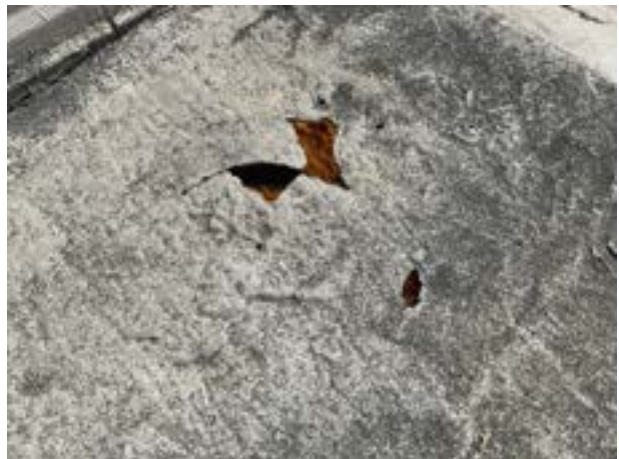
**Damaged foam**

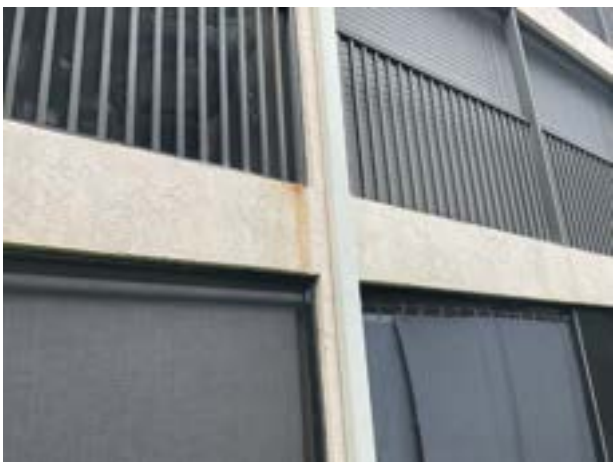
**Rust stain**

**Useful Life:** We recommend inspections, repairs and paint finish applications every five- to seven-years.

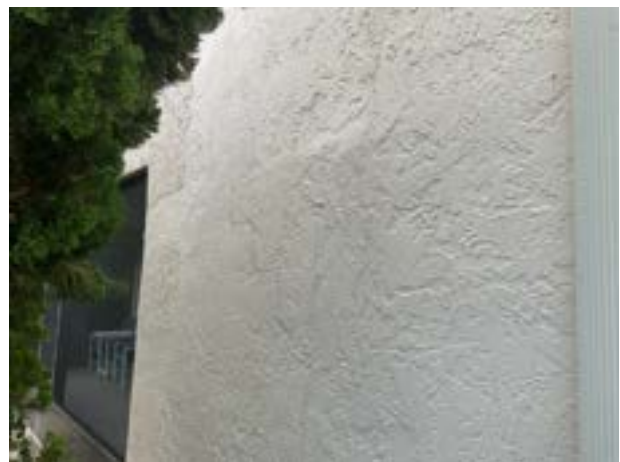
**Stair step stucco cracks**

**Evidence of moisture**

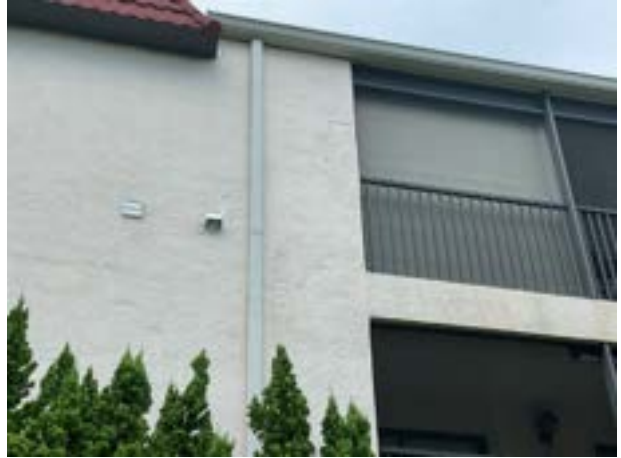
**Stucco cracks**

**Stair step crack**

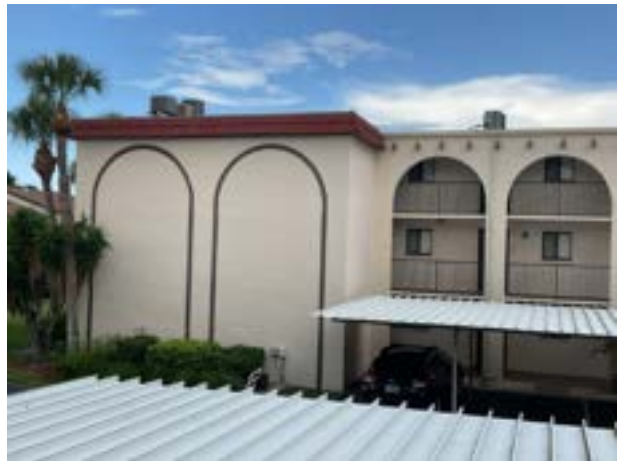
**Mildew build up**

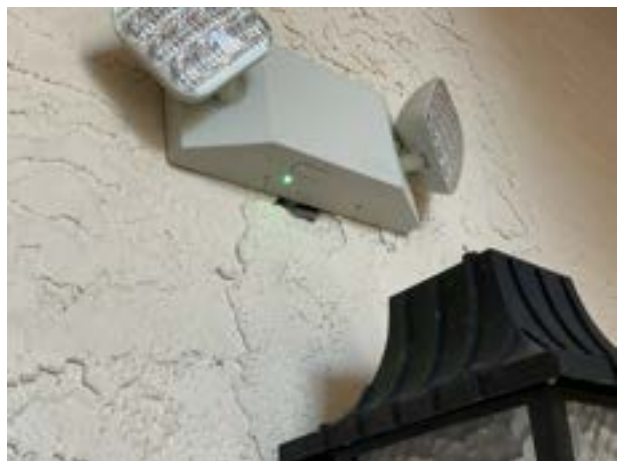
**Spall at device connection**

**Stucco cracks**

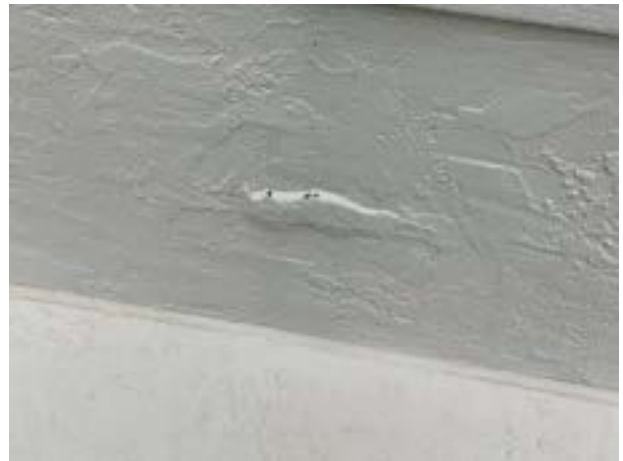
**Deterioration at grade**

**Stucco bubble**

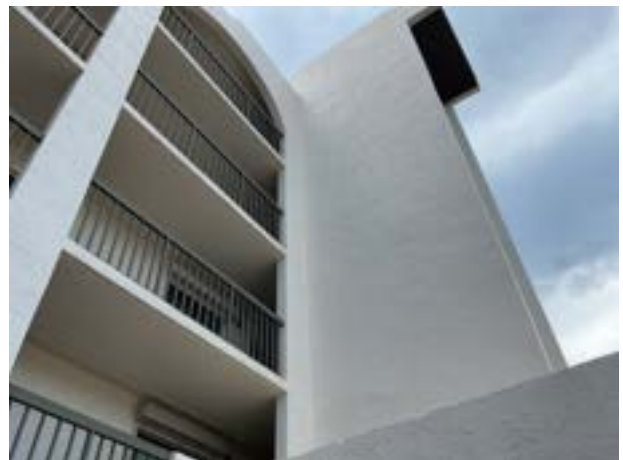
**Drainage stains**

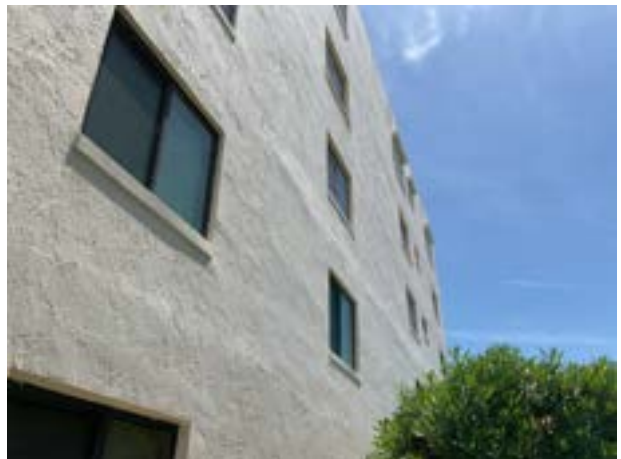
**Finish deterioration near grade**

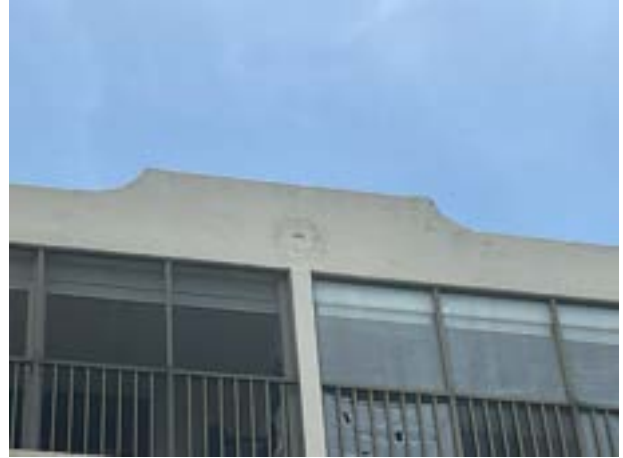
**Stucco finish deterioration**

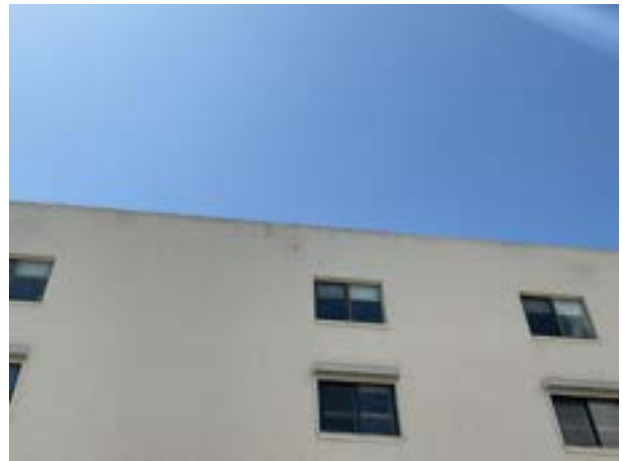
**Stains**

**Finish deterioration**

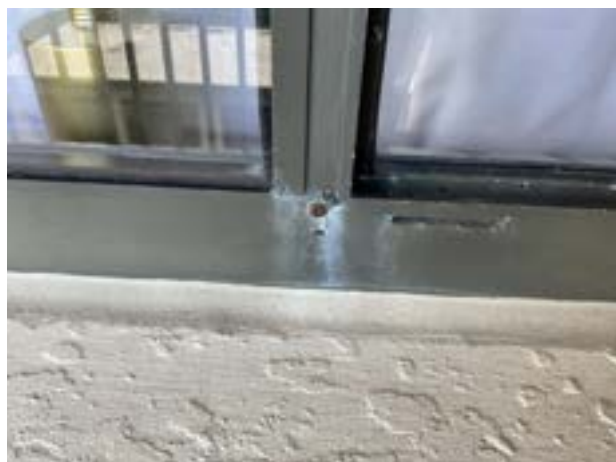
Frame finish deterioration

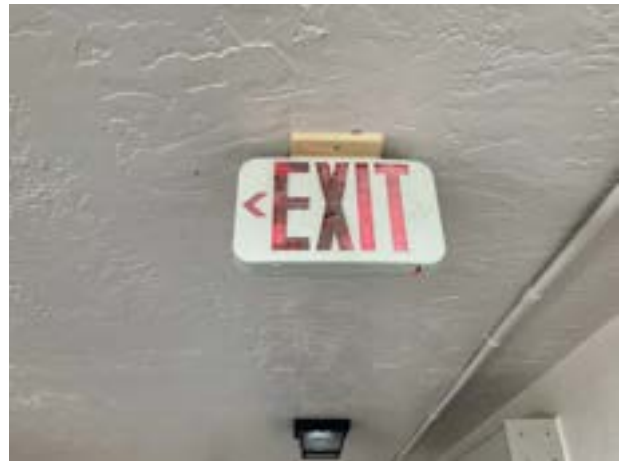
**Cracked exit sign**

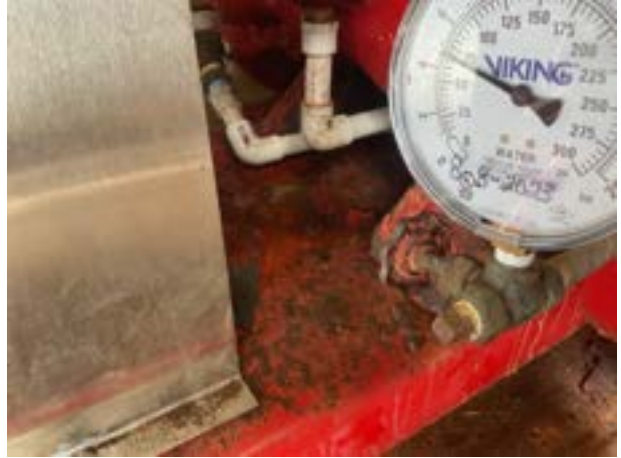
**Water leaking**

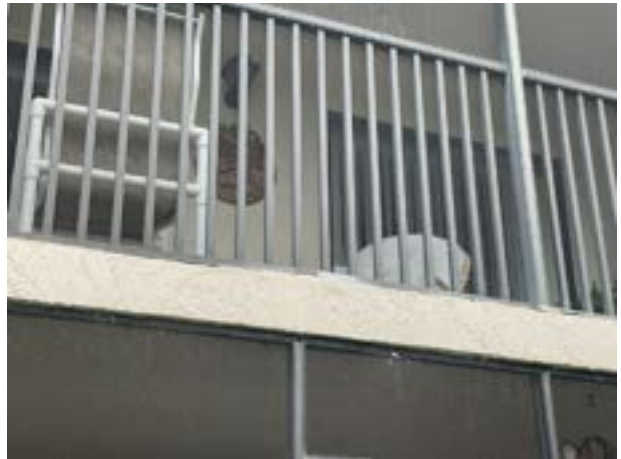
**Finish deterioration**

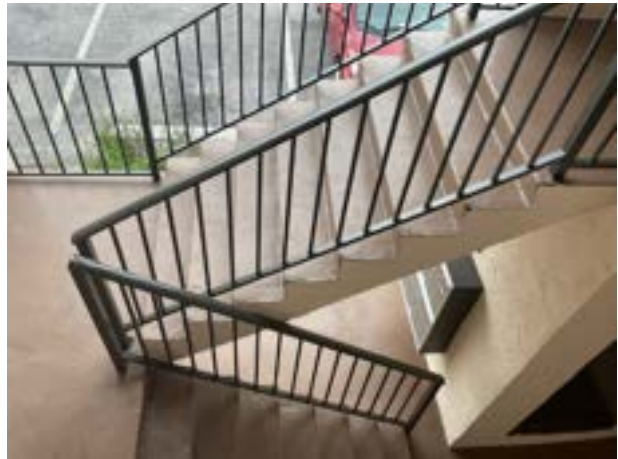
**Railing finish fade**

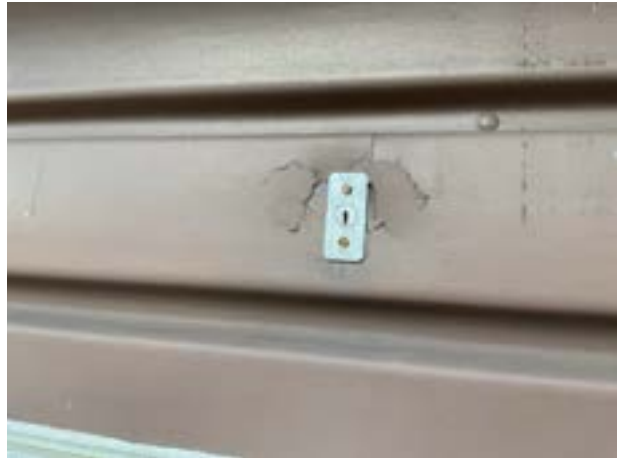
**Damage evident**

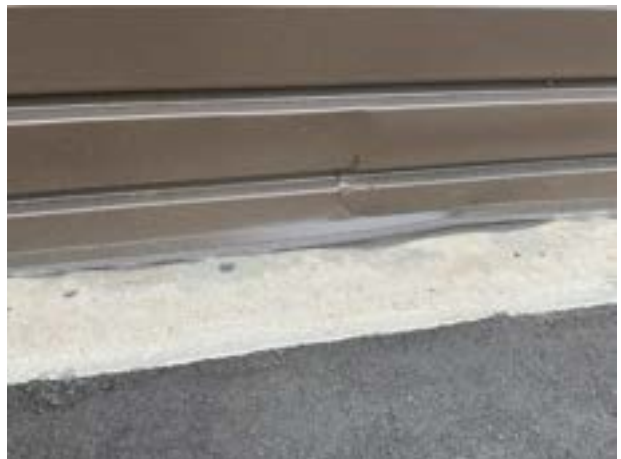
**Garage door not on track**

**Garage door damage**

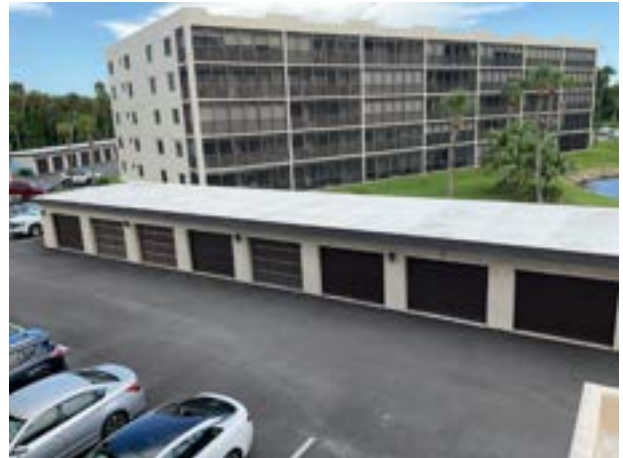
**Damaged fascia**

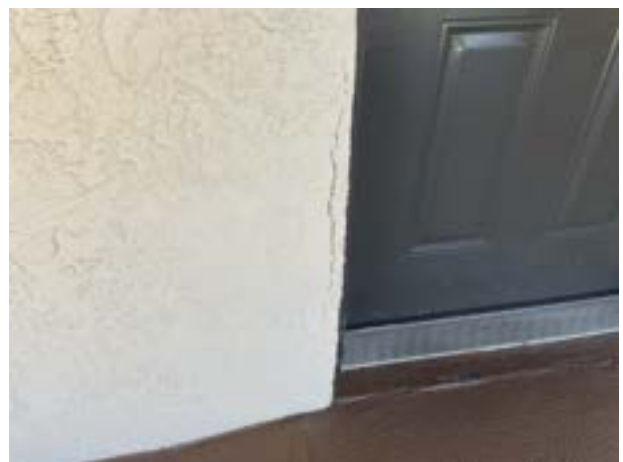
**Stucco cracks**

***Useful Life:*** We recommend inspections, repairs and paint finish applications every five- to seven-years.

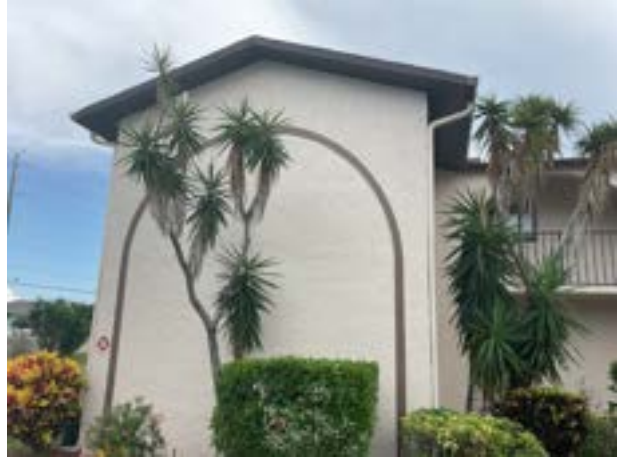
**Finish deterioration**

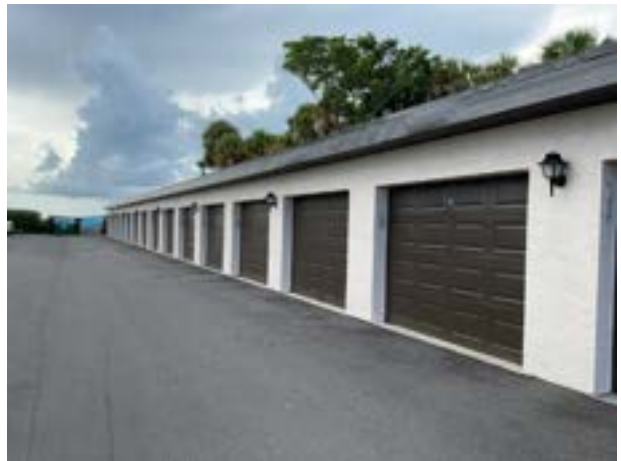
**Stains**

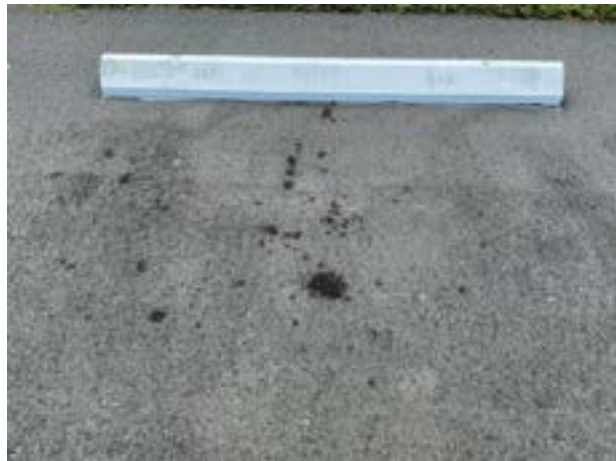
Vehicle stains

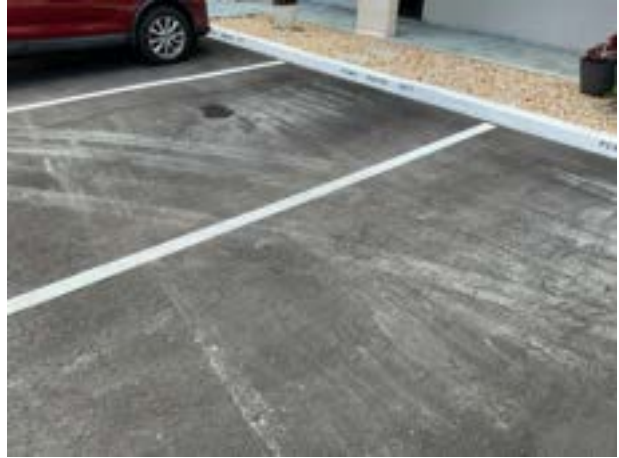
**Pavement deterioration**

***Useful Life:*** 15- to 20-years with the benefit of crack repair and patch events every three- to five-years

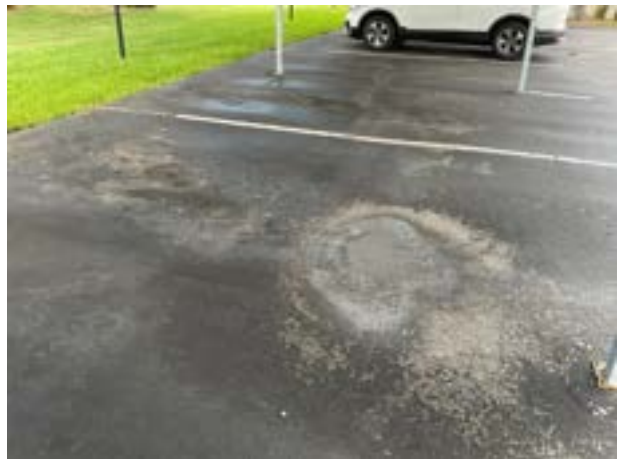
**Pavement cracks**

**Pavement deterioration**

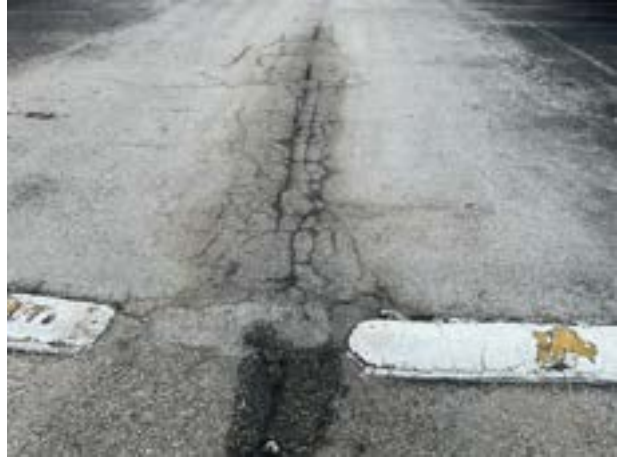
**Pavement cracks**

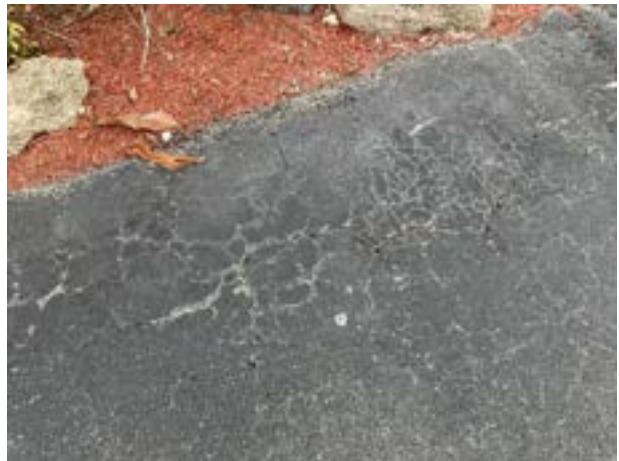
**Pavement cracks**

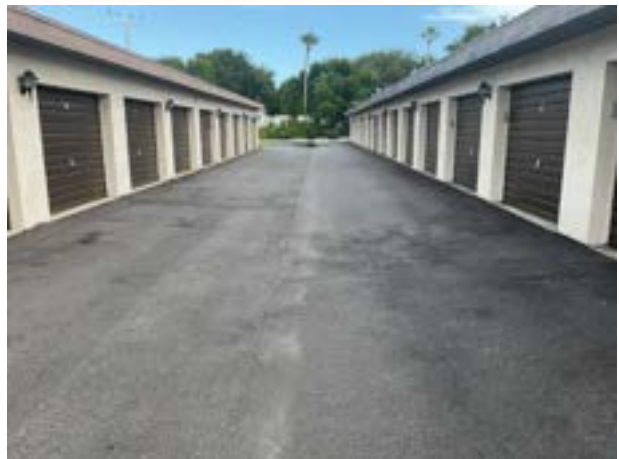
**Evidence of previous repairs**

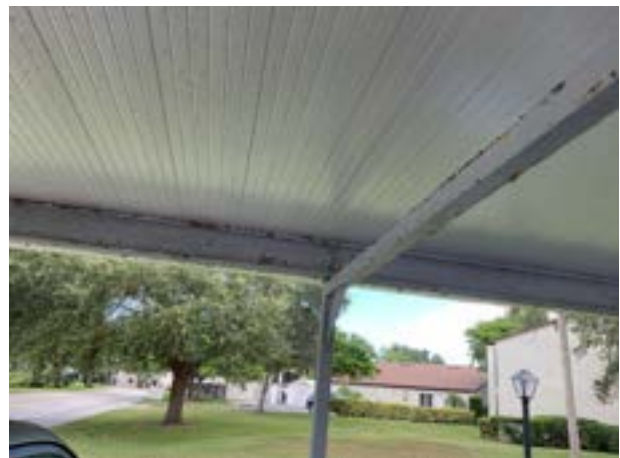
**Rusted metal frame**

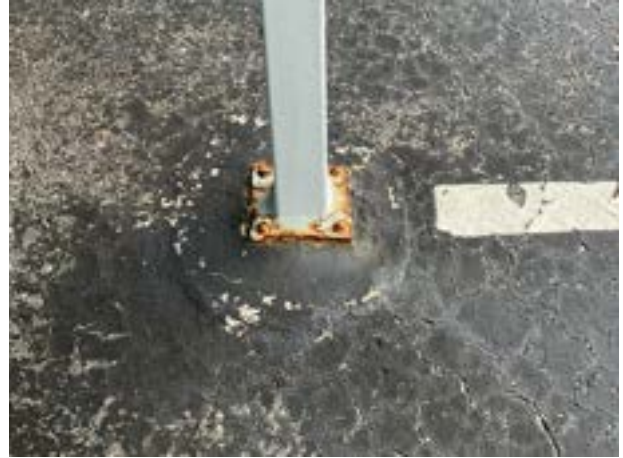
**Rusted metal frame**

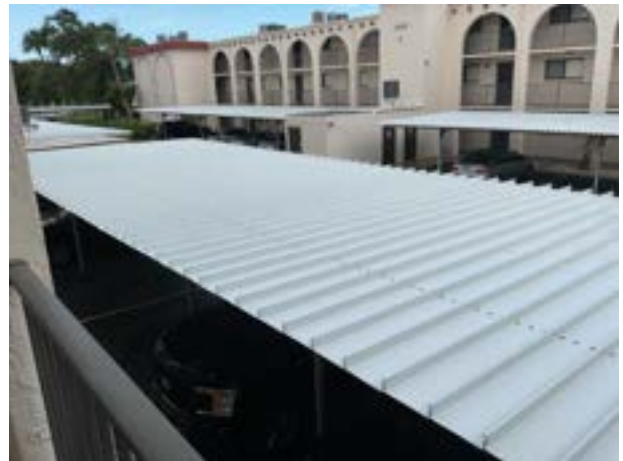
**Rusted metal frame**

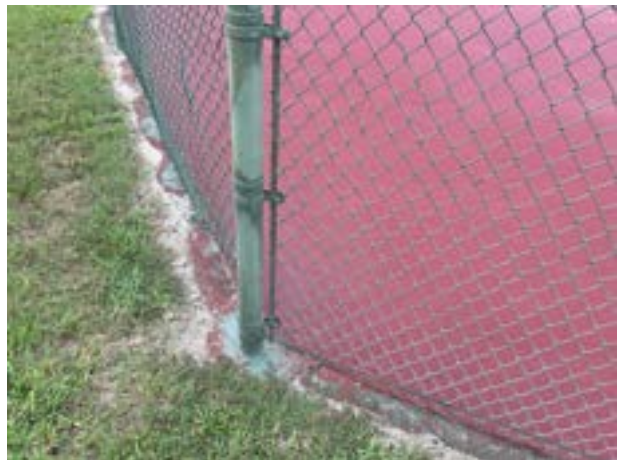
**Broken fence link with rust**

**Finish deterioration**

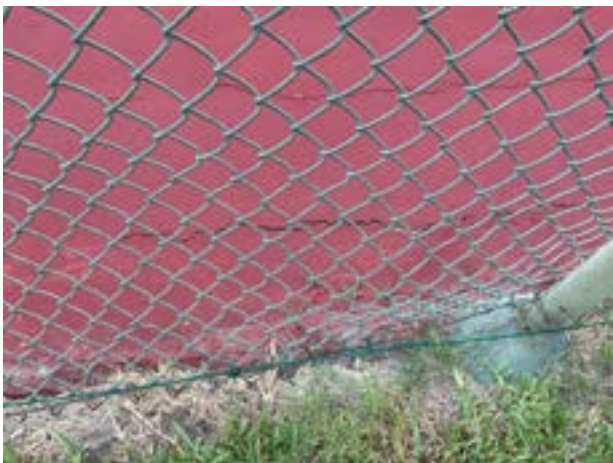
**Surface cracks**

**Useful Life:** Up to 25 years for replacement of the surface with the benefit of color coat applications and repairs every four- to six-years

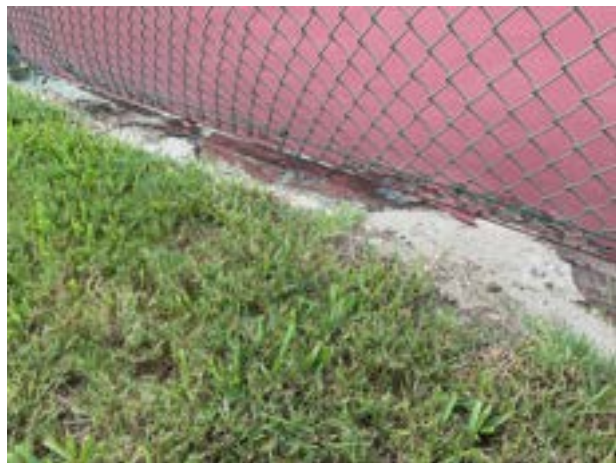
**Surface deterioration at edge**

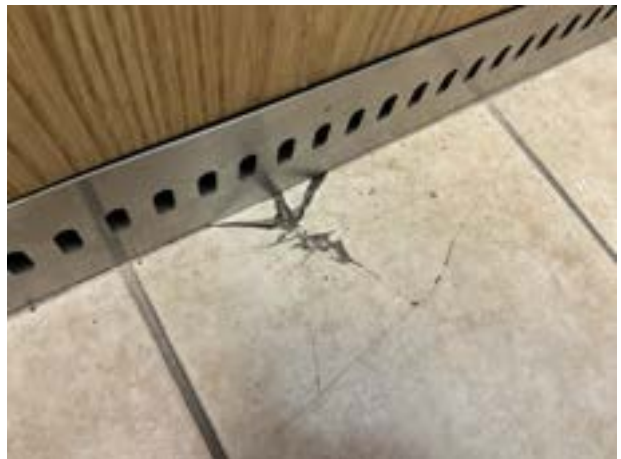
**Tile damage**

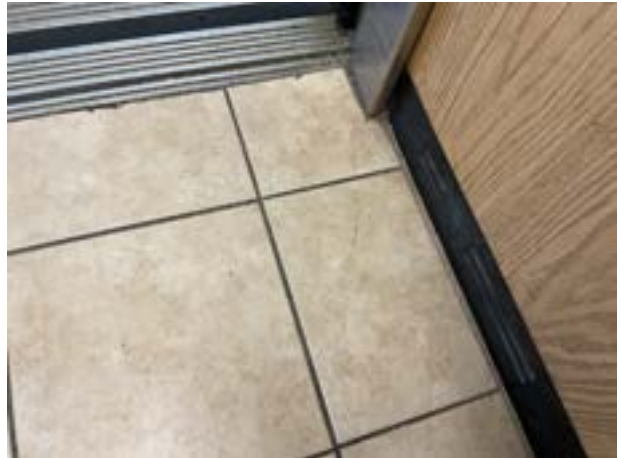
**Cracks**

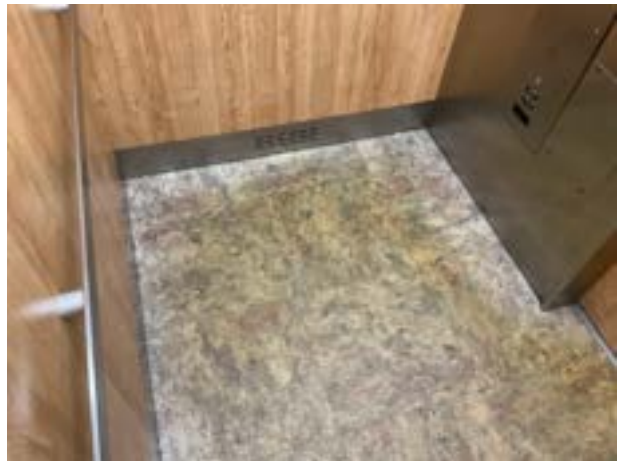
**Stained veneer**

**Tile floor coverings with faded finish**

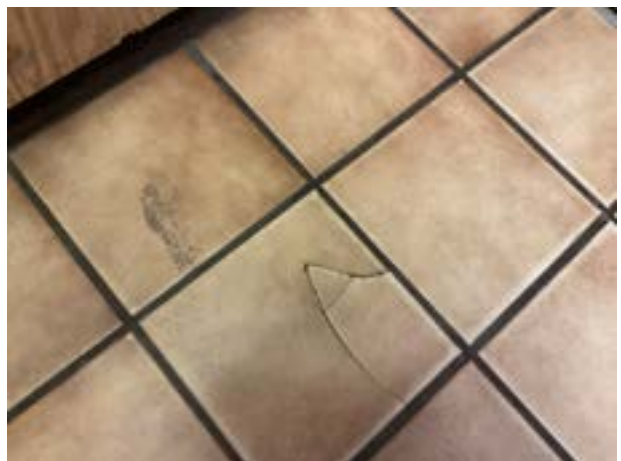
**Wall damage**

**Tile cracks**

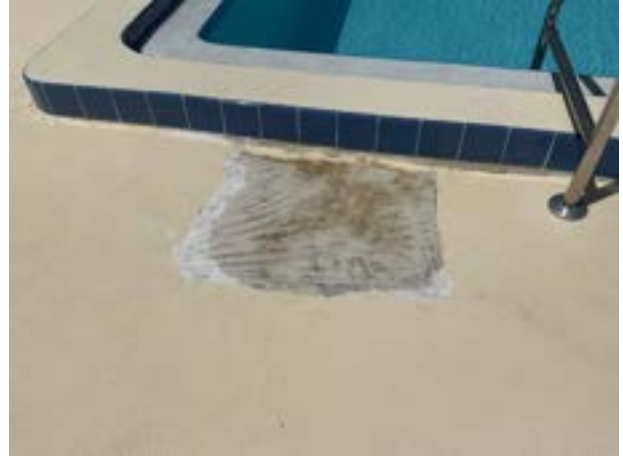
**Evidence of ongoing repairs**

**Useful Life:** The useful life of a concrete pool deck is up to 60 years or more with timely repairs. We recommend the Association conduct inspections, partial replacements and repairs to the deck every 8- to 12-years in conjunction with coating replacements.

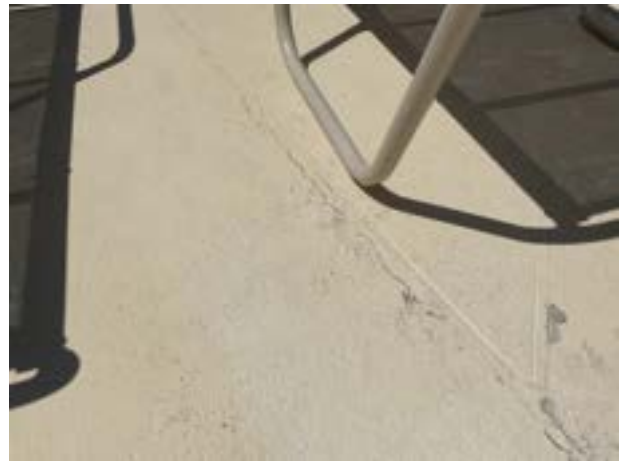
**Concrete cracks**

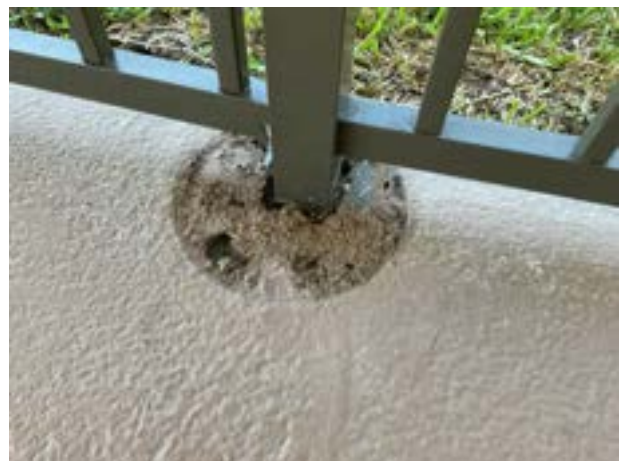
**Finish deterioration**

**Deterioration at fence post connection**
