# Canaveral Bay Condominium Association, Inc.

October 15, 2024 • Cape Canaveral, FL

STRUCTURAL INTEGRITY  
RESERVE STUDY

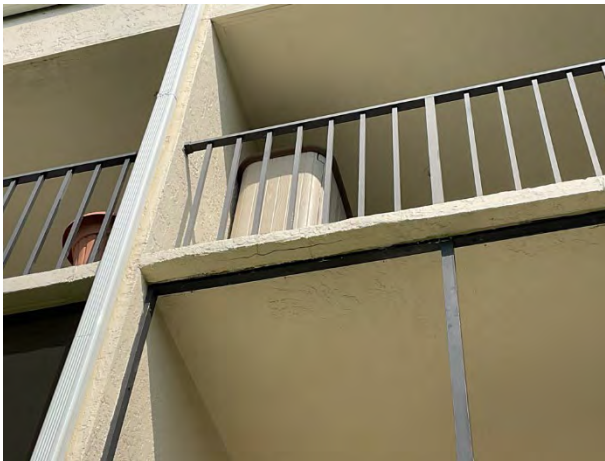
**Concrete cracks**

**Useful Life:** As noted above, we recommend the Association conduct near term inspections and extensive repairs. Subsequent to these repairs, we recommend the Association anticipate the need for capital repairs including a close-up visual inspection, patching of delaminated concrete, routing and filling of cracked concrete, and waterproof coating applications every 10- to 15-years.

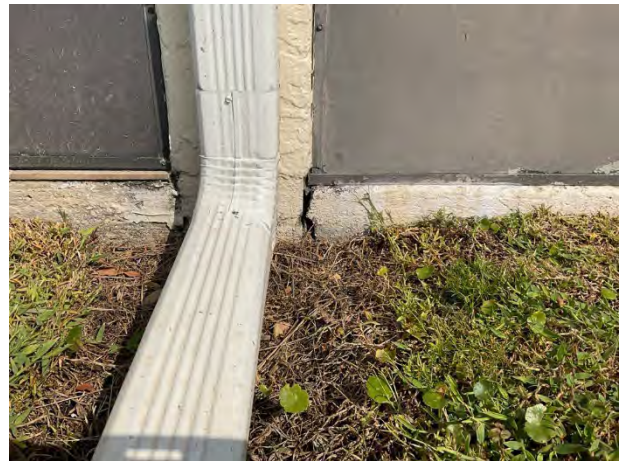
**Concrete cracks**

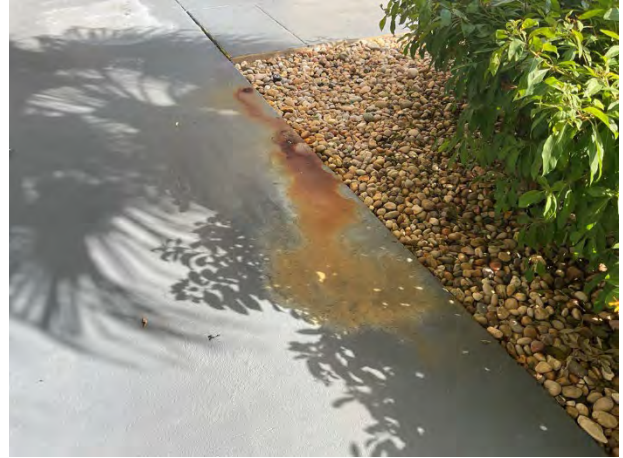
**Rust stains**

**Useful Life:** Capital repairs including a close-up visual inspection, patching of delaminated concrete, routing and filling of cracked concrete, and waterproof coating applications every five- to seven-years.

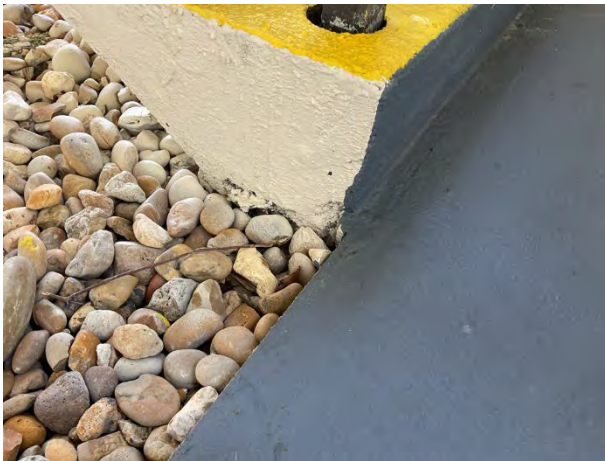
**Concrete edge spall**

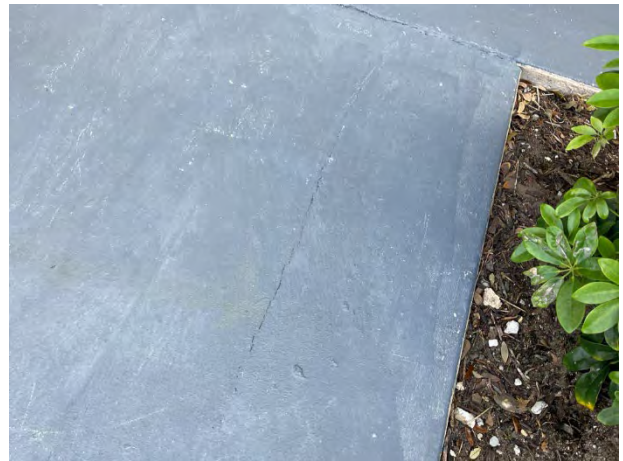
**Concrete cracks**

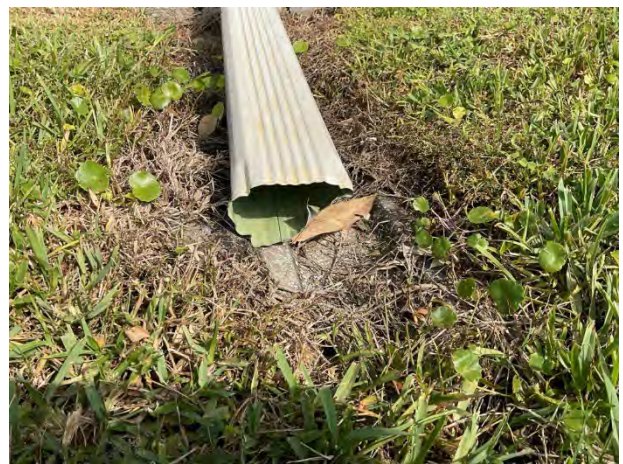
**Condition:** Good to fair overall with damage evident

**Downspout damage**

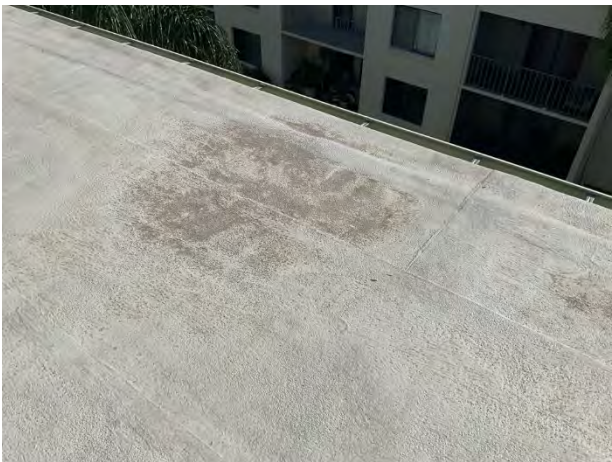
**Coating deterioration**

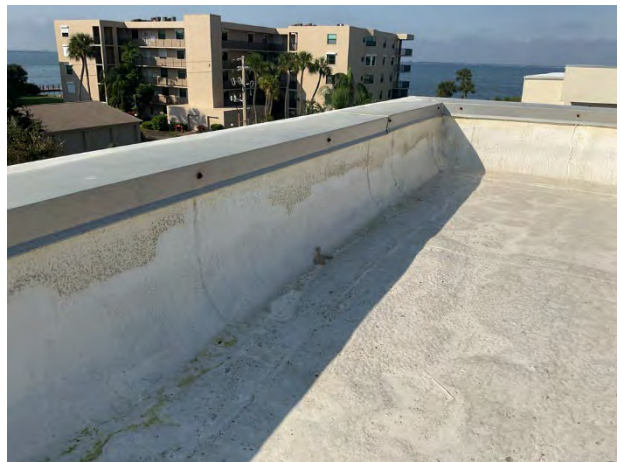
**Coating deterioration**

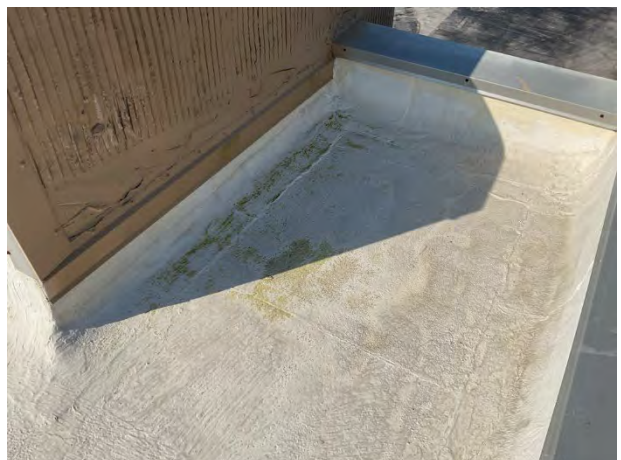
**Coating deterioration**

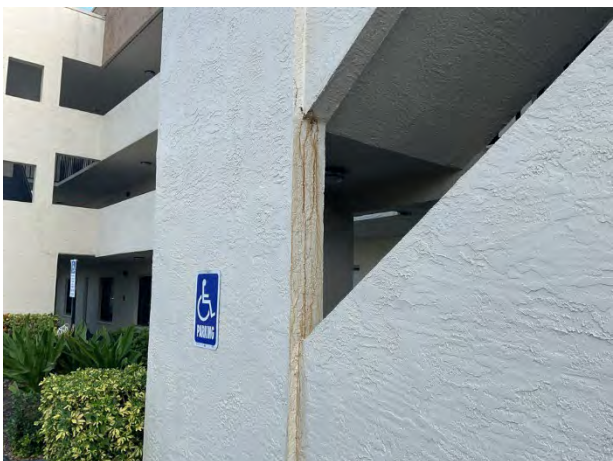
**Condition:** Good to fair overall with isolated cracks and rust stains evident. We note the following:

**Rust stains**

**Useful Life:** We recommend inspections, repairs and paint finish applications every five- to seven-years.

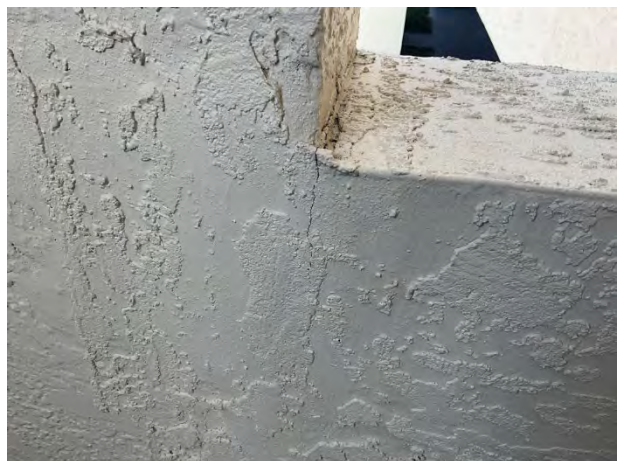
- We not isolated stucco cracks
- No significant stucco damage evident
- Sealants are in good condition
- Stucco does not terminate 2” above grade
- Stucco does not terminate 4” above grade

**Stucco cracks**

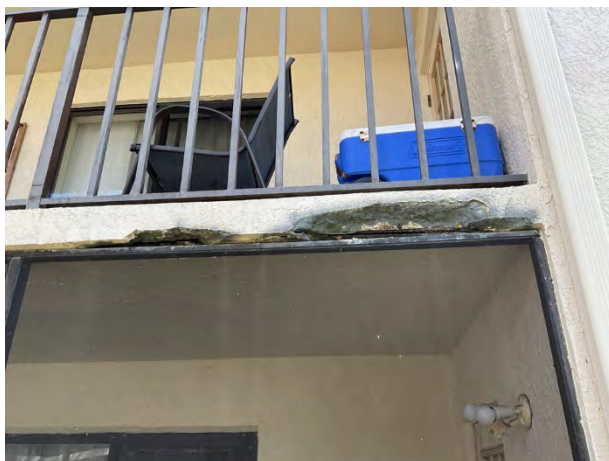
**Condition:** Due to the non-invasive nature of our inspection, we are unable to fully verify the condition of the balconies. However, we note isolated balconies with exposed reinforcement. In addition we note isolated deflection, spalls, cracks, coating deterioration and the use of carpet floor coverings. Carpet conceals concrete deterioration, retains water and inhibits drainage. Water trapped by the carpet can result in accelerated concrete deterioration. Therefore, we do not recommend the use of carpet on balcony surfaces.

**Balcony edge deterioration**

**Useful Life:** As noted above, we recommend the Association conduct near term inspections and extensive repairs. Subsequent to these repairs, we recommend the Association anticipate the need for capital repairs including a close-up visual inspection, patching of delaminated concrete, routing and filling of cracked concrete, and waterproof coating applications every 10- to 15-years.

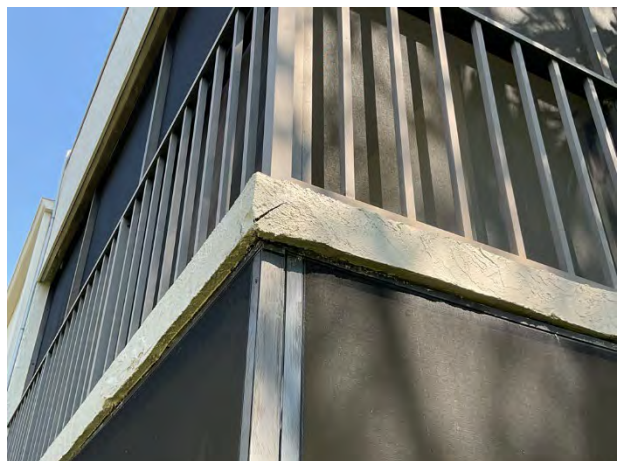
**Balcony edge spalls**

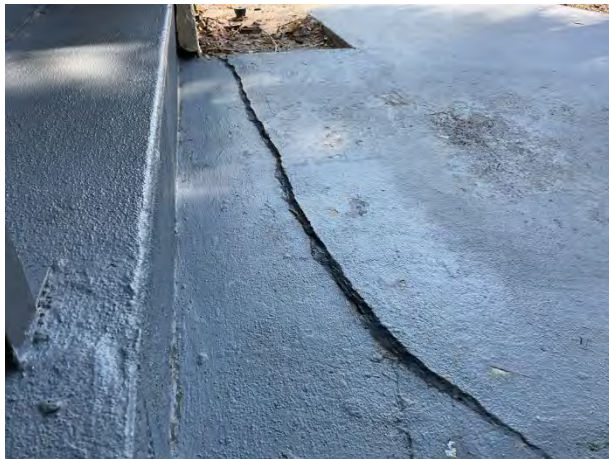
**Condition:** Good to fair overall with isolated cracks and spalls evident

**Concrete crack**

**Useful Life:** Capital repairs including a close-up visual inspection, patching of delaminated concrete, routing and filling of cracked concrete, and waterproof coating applications every five- to seven-years.

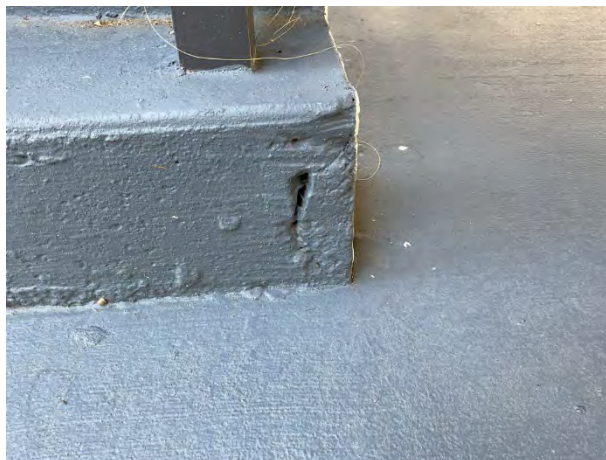
**Concrete edge spall**

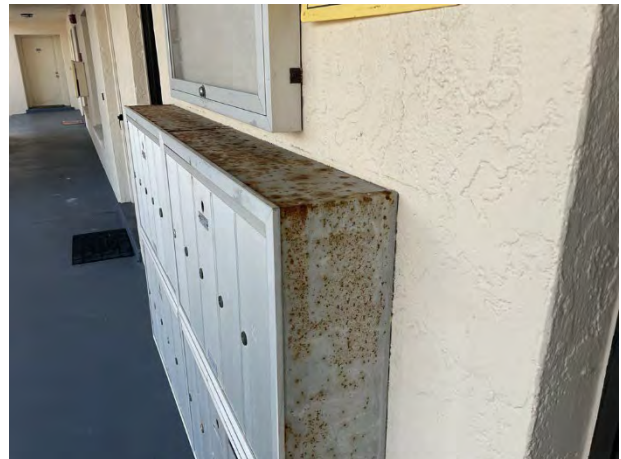
**Mailbox station rust**

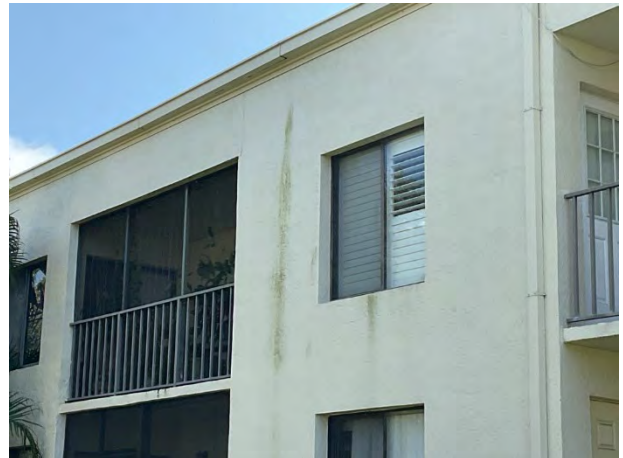
**Stucco finish stains**

**Useful Life:** We recommend inspections, repairs and paint finish applications every five-to seven-years.

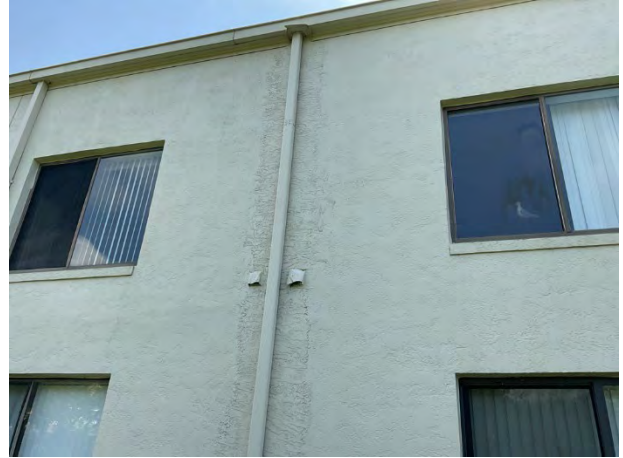
**Stucco finish fade**

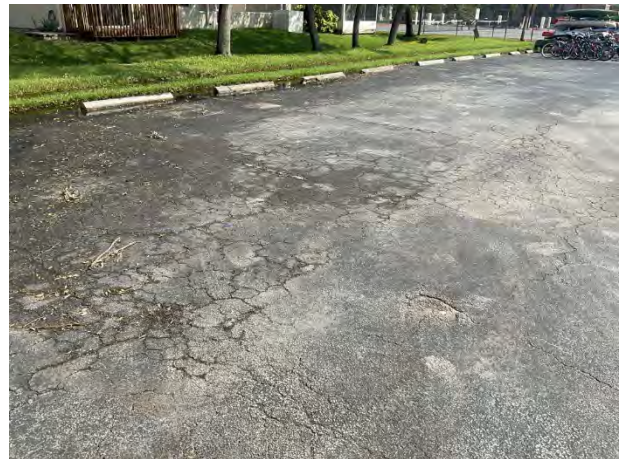
**Asphalt pavement cracks**

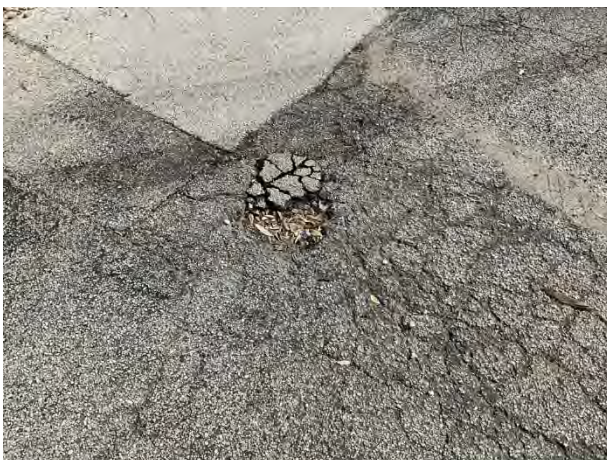
**Asphalt pavement pothole**

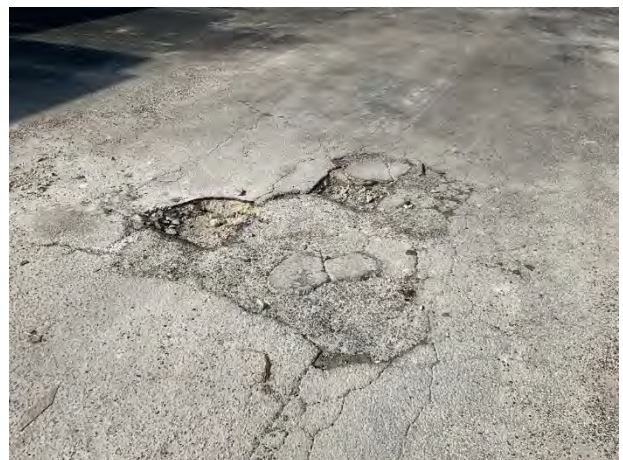
**Asphalt pavement cracks and potholes**

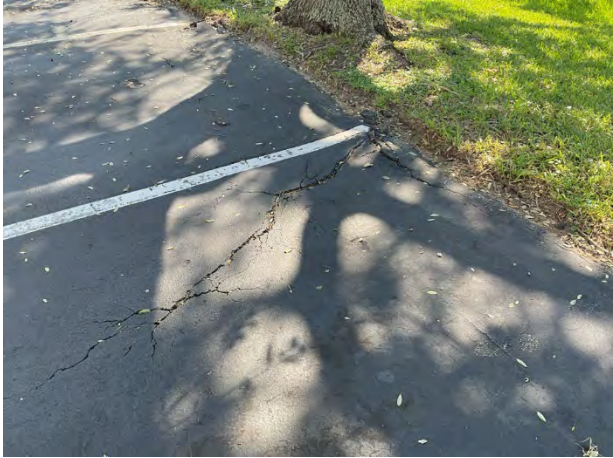
**Asphalt pavement cracks**

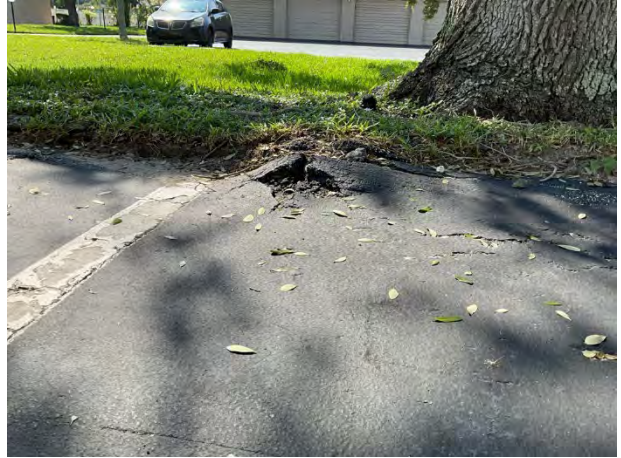
**Asphalt pavement upheaval**

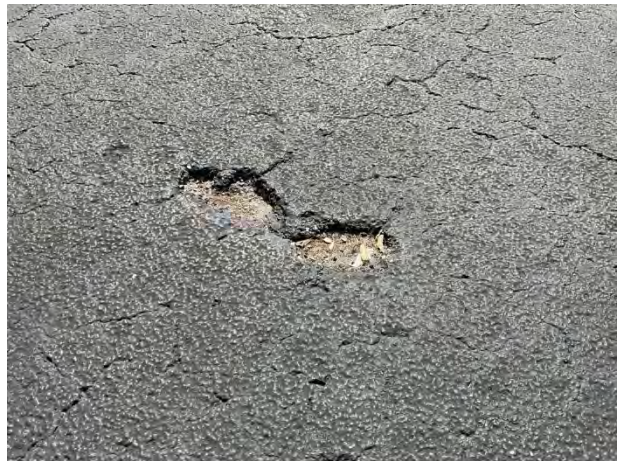
**Asphalt pavement spall**

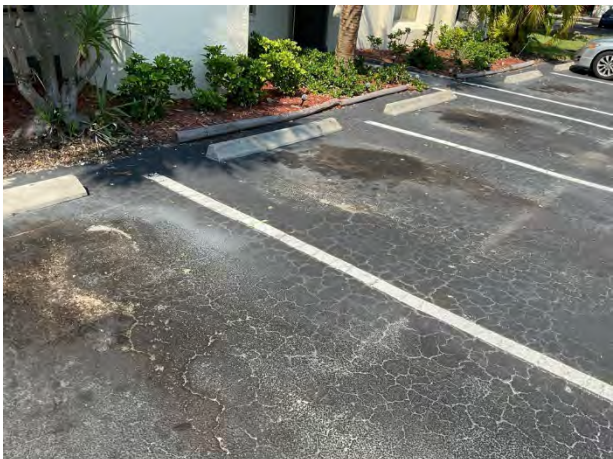
**Vehicle stains**

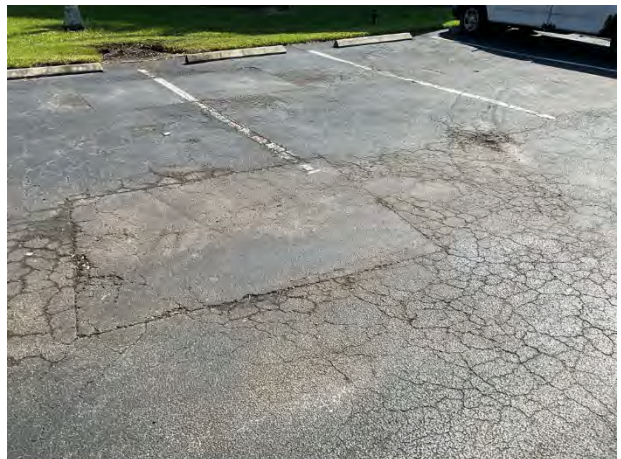
**Asphalt pavement cracks**

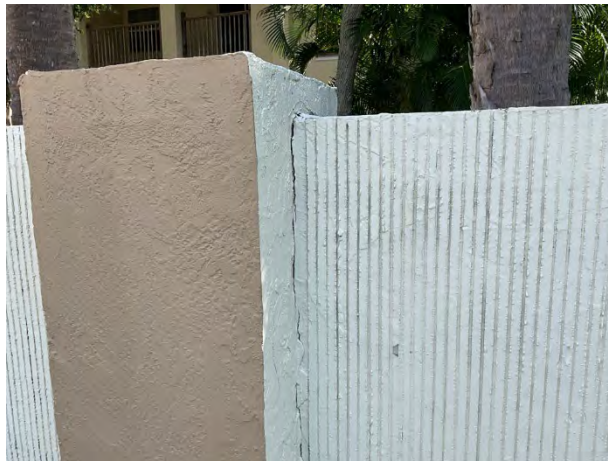
**Condition:** Good to fair overall with cracks evident

**Wall stucco cracks**

**Useful Life:** Indefinitely long with periodic finish applications and proper maintenance every five- to seven-years

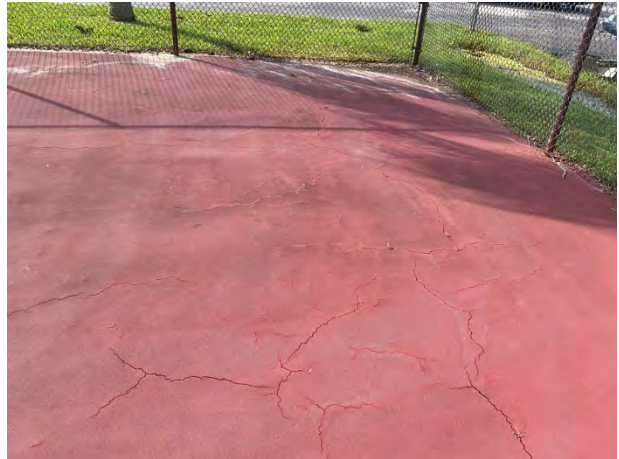
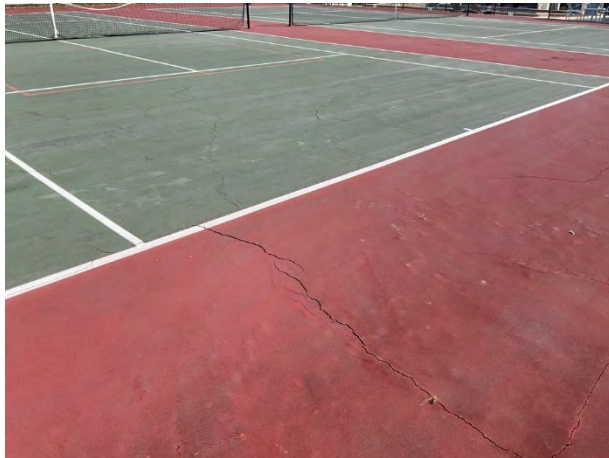
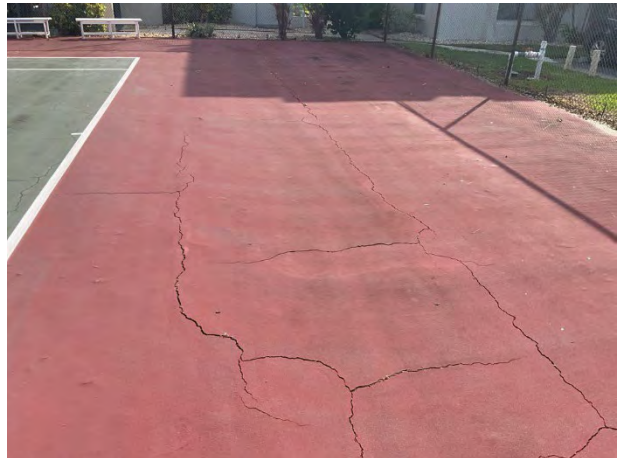
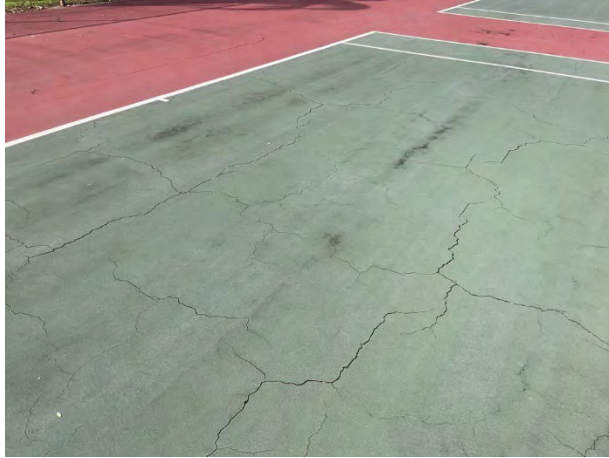
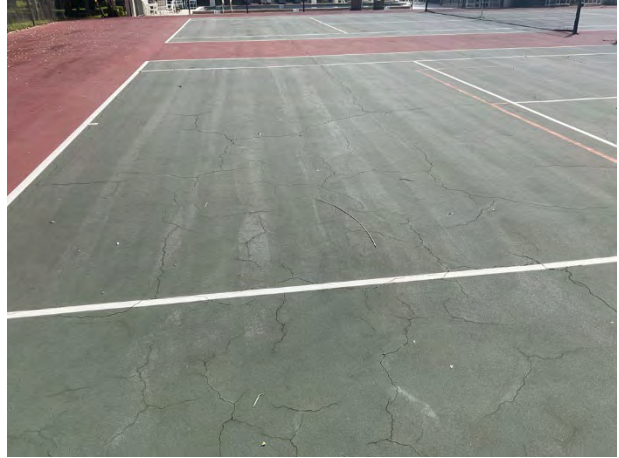
**Condition:** The color coat is in fair condition with finish fade evident. The playing surface is in fair condition with systematic cracks evident.

**Surface cracks**

**Useful Life:** Up to 25 years for replacement of the surface with color coat applications conducted four- to six-years

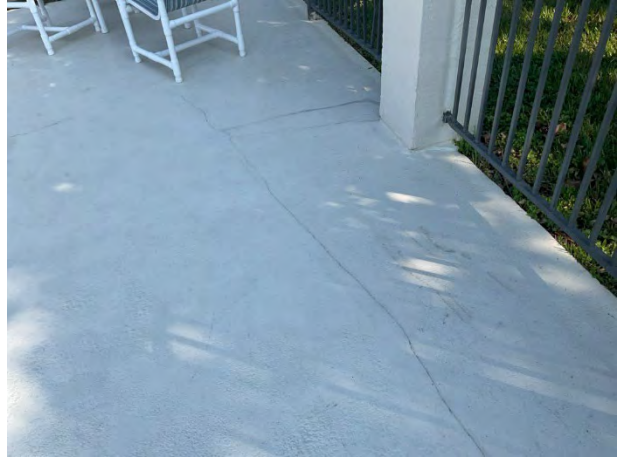
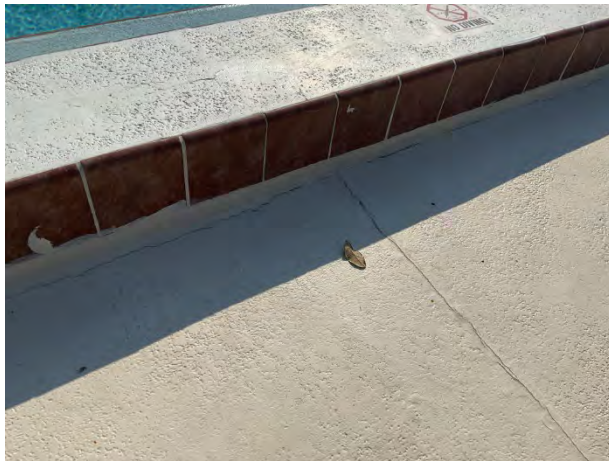
**Condition:** Fair overall with cracks evident

**Concrete cracks**

**Useful Life:** The useful life of a concrete pool deck is up to 60 years or more with timely repairs. We recommend the Association conduct inspections, partial replacements and repairs to the deck every 8- to 12-years.

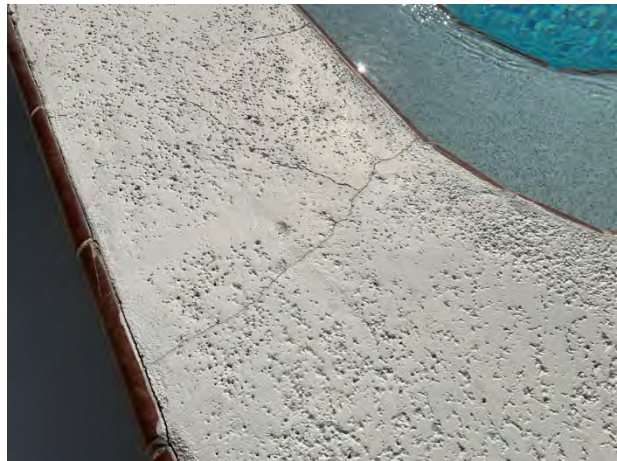
**Coping cracks**

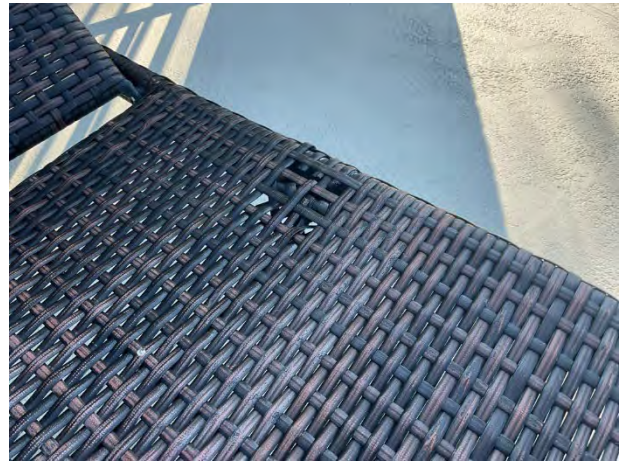
**Condition:** Fair overall with finish deterioration and damage evident.

**Furniture damage**

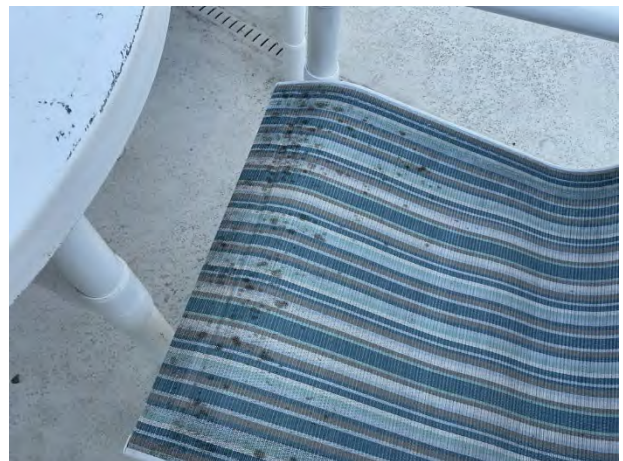
**Furniture finish deterioration**

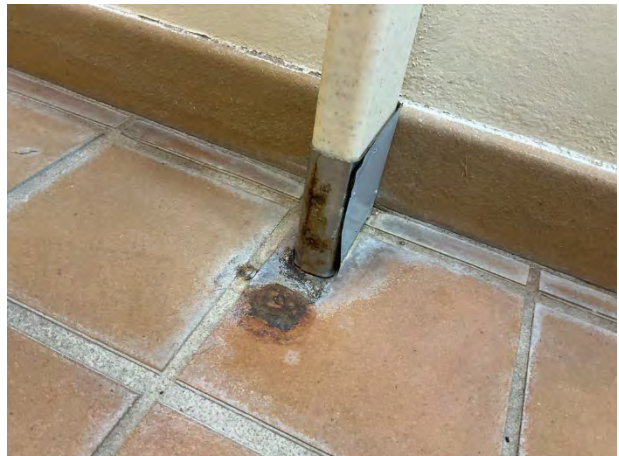
**Condition:** Fair overall with isolated damage, finish deterioration and rust evident

Rust at partition base
