# Surfside South Condominium Association, Inc.

March 2, 2023 • Madeira Beach, FL

FULL RESERVE STUDY

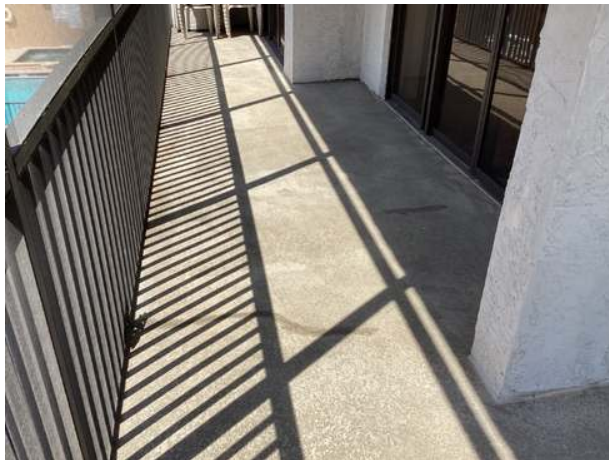
- No significant sealant deterioration
- Isolated concrete coating deterioration is evident
- Isolated concrete cracks are evident
- No surface spalls evident
- No edge spalls evident
- No underside spalls evident
- Isolated damage at the ceiling of the common balcony
- The most recent milestone inspection noted hairline cracks throughout the building at the balcony edges.

**Balcony overview with cracks**

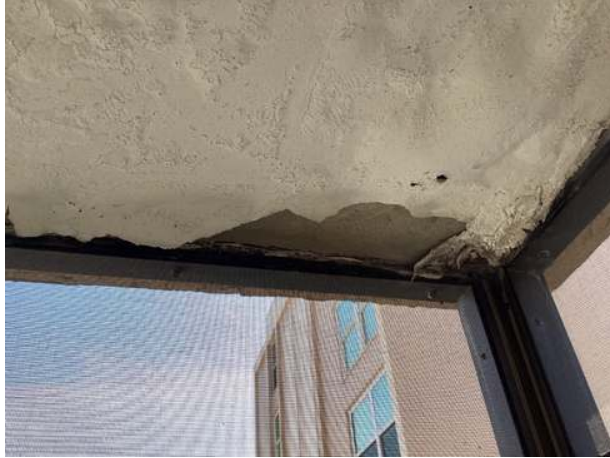
**Ceiling damage at common balcony**

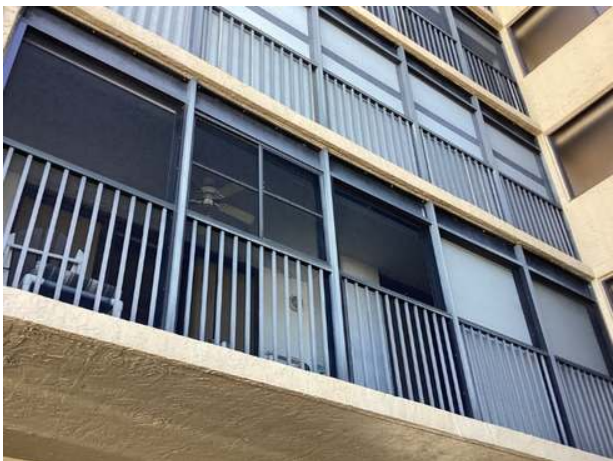
- Isolated rust is evident
- Isolated loose railings are evident

Aluminum railings and screens at north tower first floor balconies

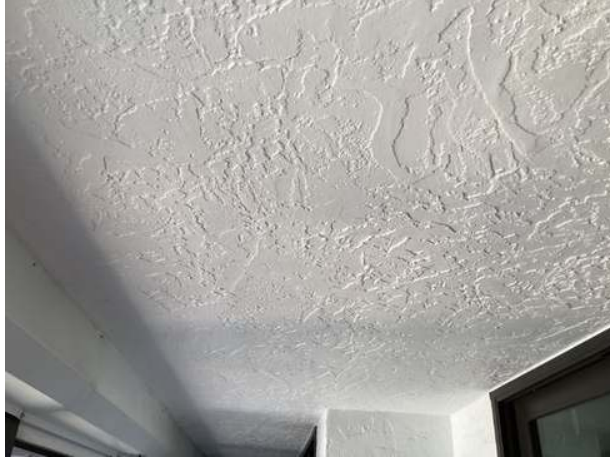
- Sealants appear in good condition
- Isolated concrete coating deterioration is evident
- Isolated concrete cracks are evident
- No surface spalls evident
- No edge spalls evident
- No underside spalls evident

**Unit 304 balcony underside**

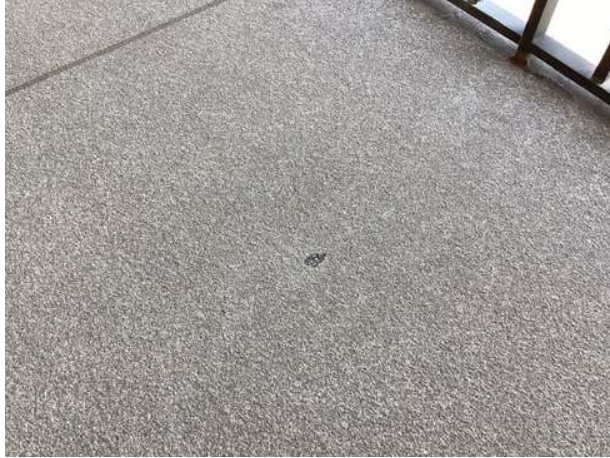
**Coating crack and damage at first floor**

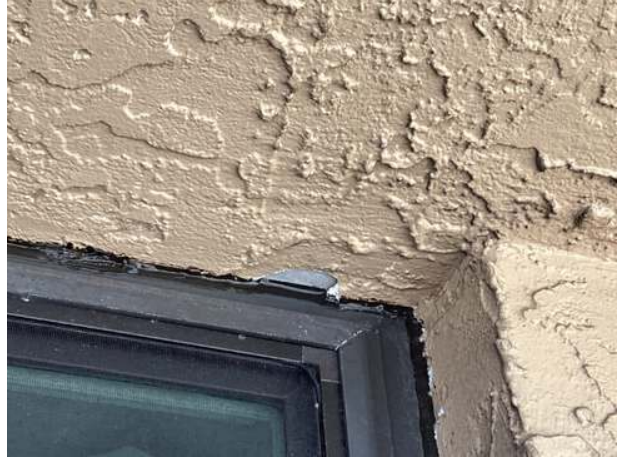
**Finish deterioration at underside of third floor breezeway at unit 212 front window**

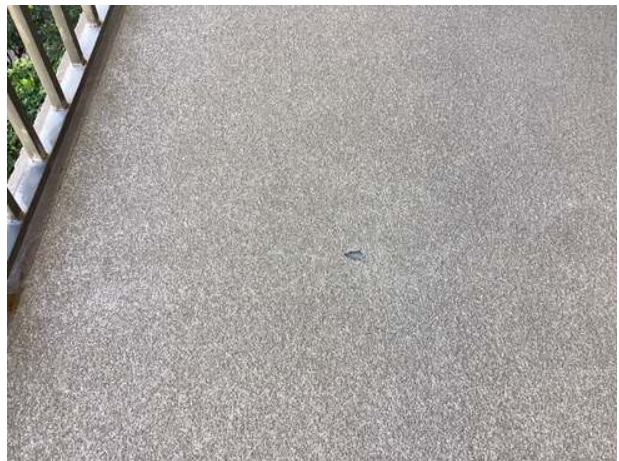
**Isolated cracks and coating deterioration at unit 102 entrance**

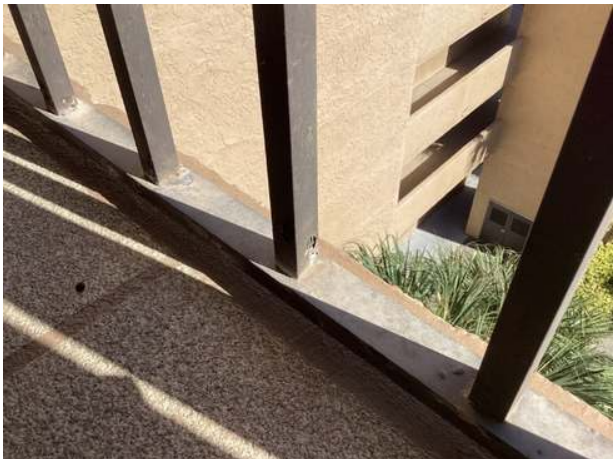
**Finish deterioration at fifth floor breezeway**

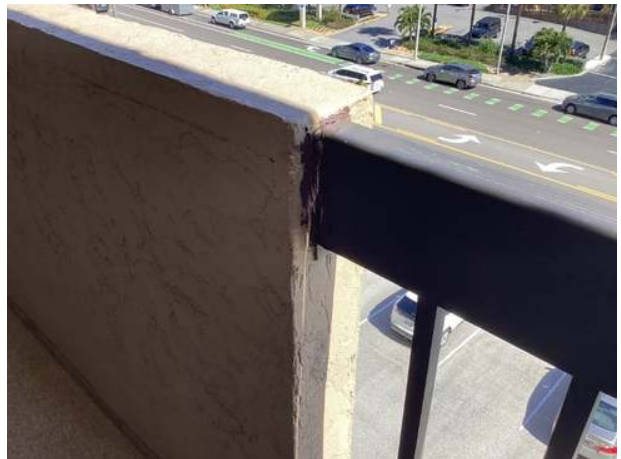
**Loose connection outside unit 410**

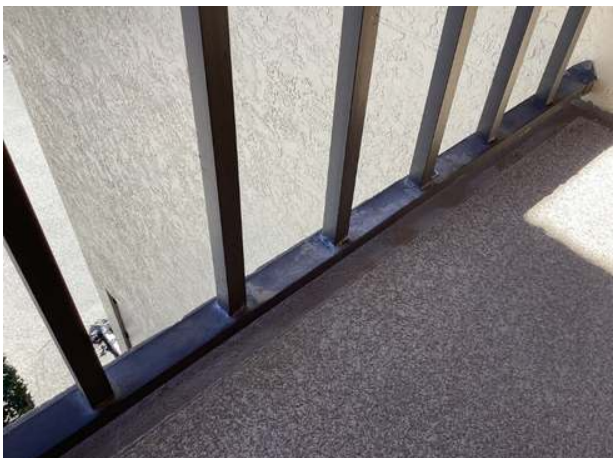
**Railing finish fade at second floor north tower breezeway**

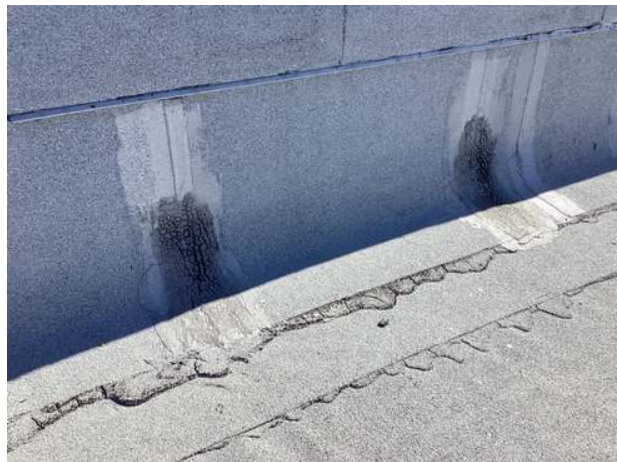
Cracks in sealant throughout

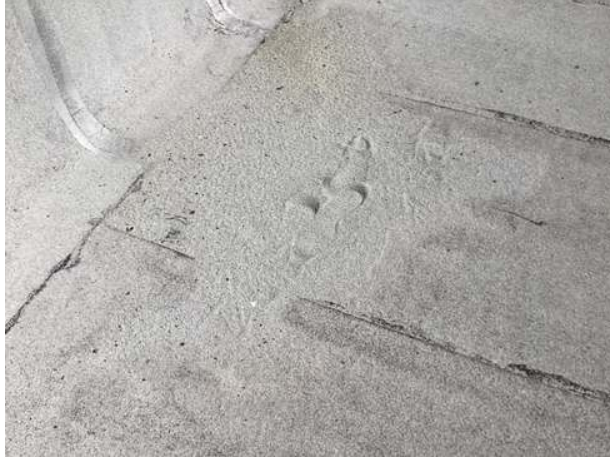
**Granular loss**

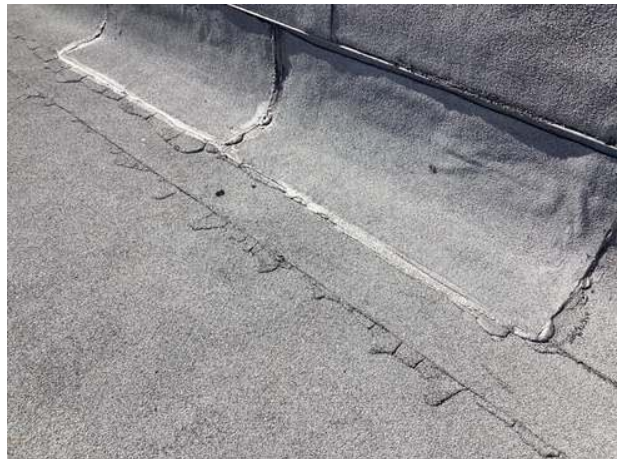
**Recent repairs evident at the west elevation  
parapet of the north tower**

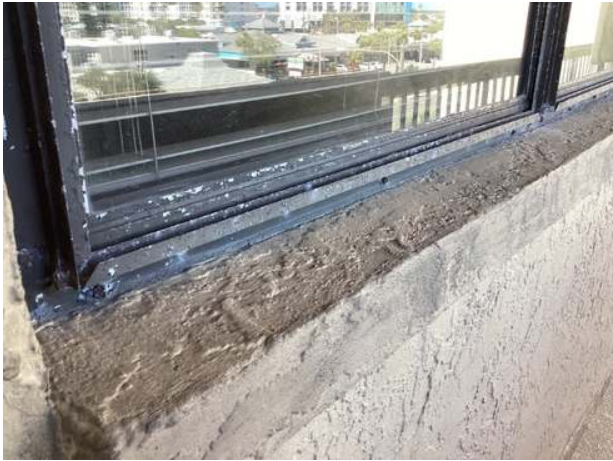
- Minor cohesion failure is evident
- Isolated adhesion failure is evident
- Minor cracks are evident
- Minor brittle sealants are evident

Sealant deterioration at unit 303 front window

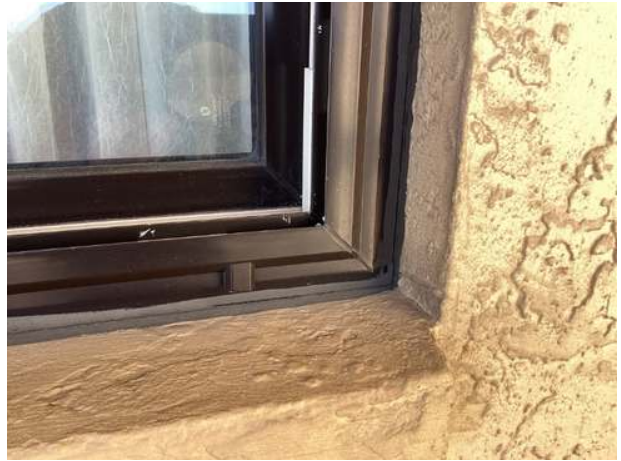
Sealant deterioration at unit 404 front window

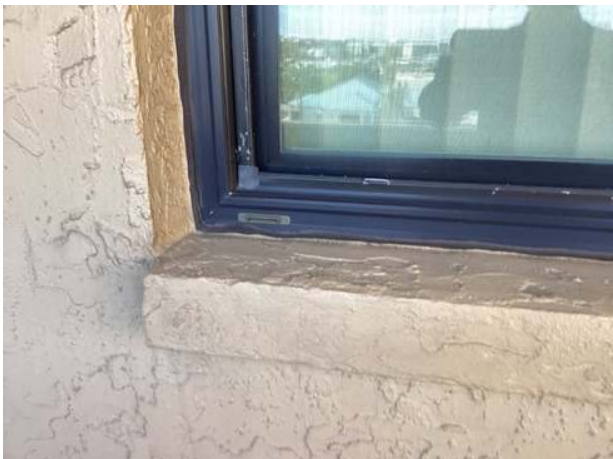
Sealant deterioration at unit 406 front window

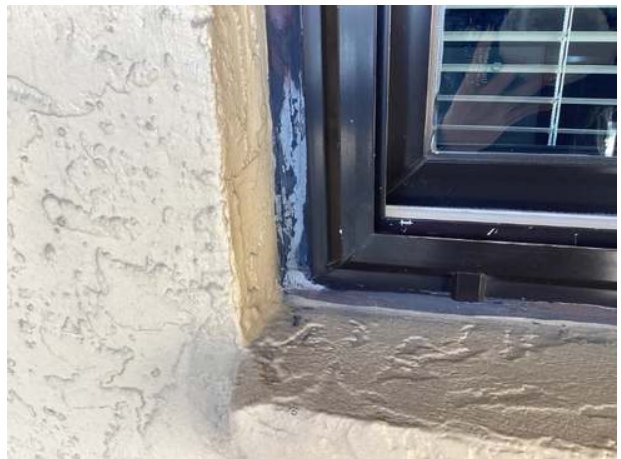
Sealant deterioration at unit 505 front window

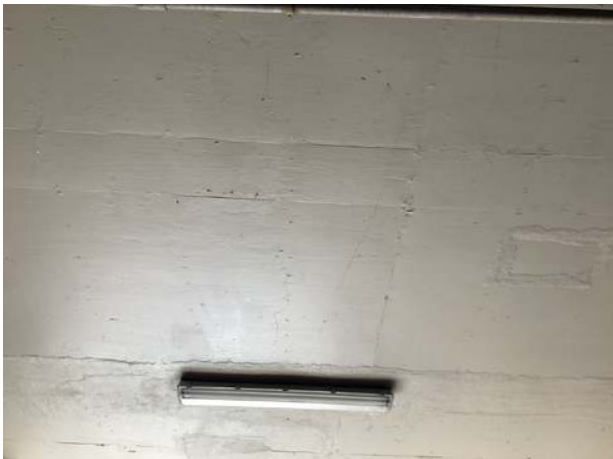
Isolated cracks at underside of the north tower first floor at the south elevation

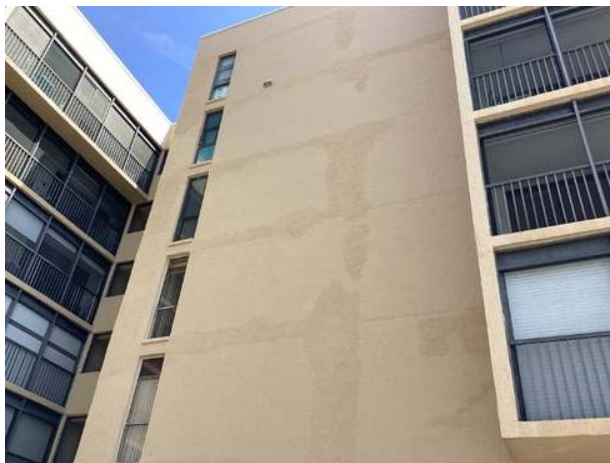
**Previous stucco repairs**

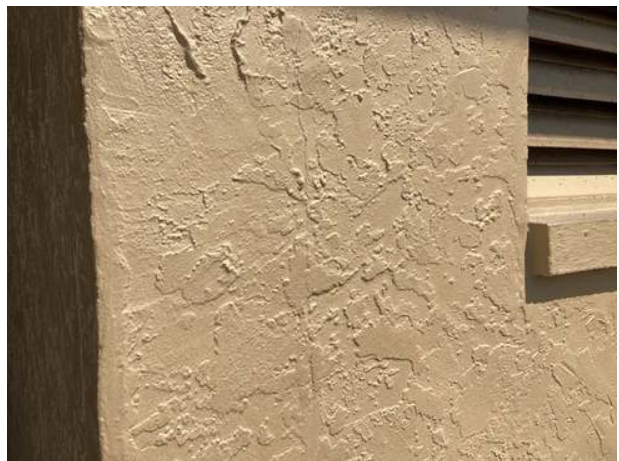
**Stucco crack at fire alarm room**

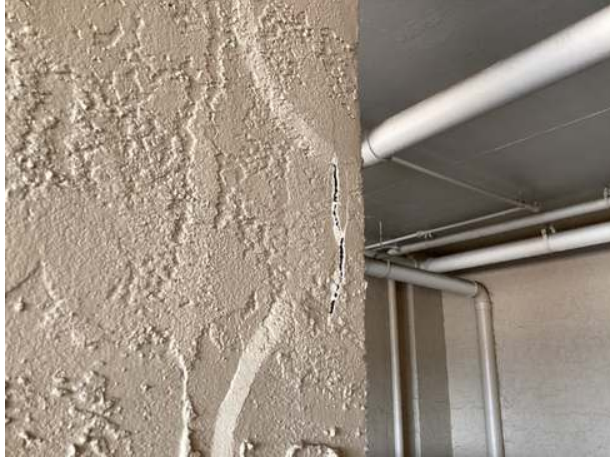
**Stucco crack at garage**

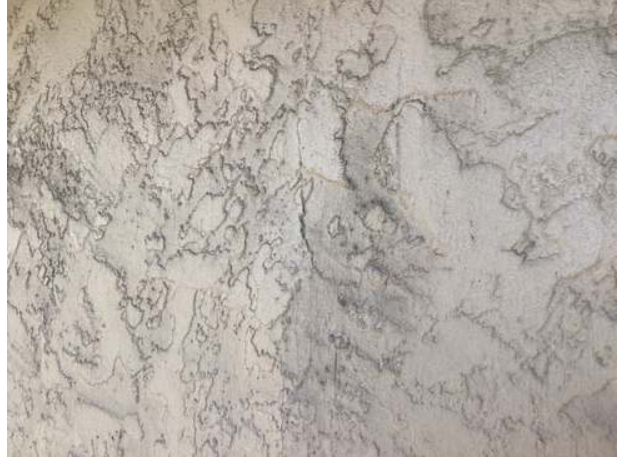
**Stucco cracks and damage at 5th floor breezeway across from north tower trash room**

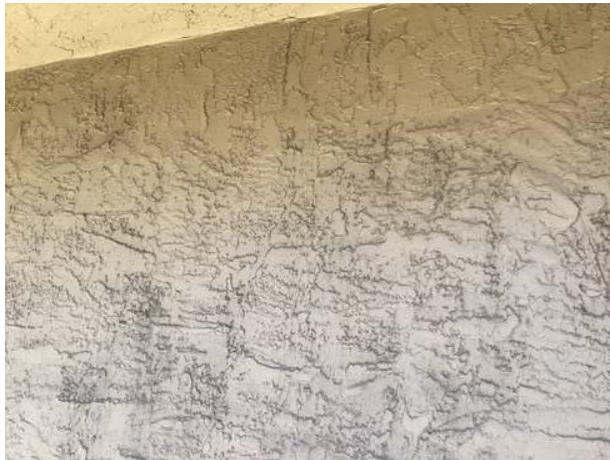
**Stucco cracks at fourth floor outside the north tower trash room**

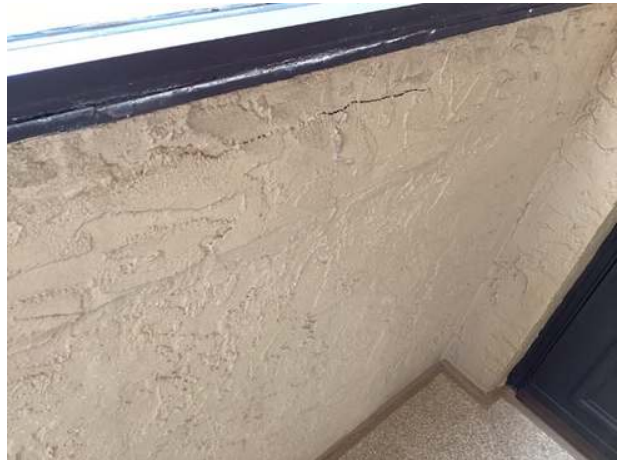
**Stucco cracks at second floor breezeway**

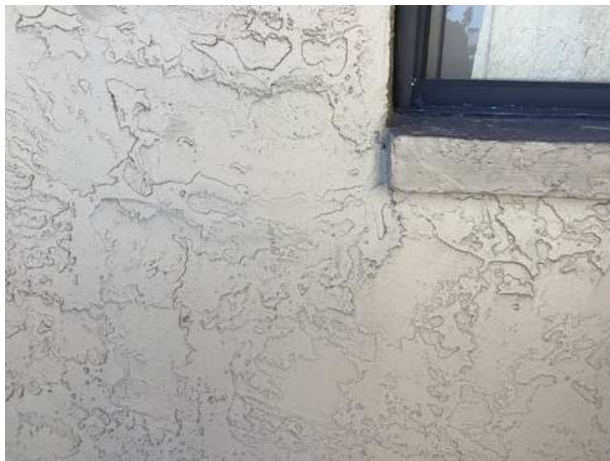
**Stucco cracks at unit 213 front window**

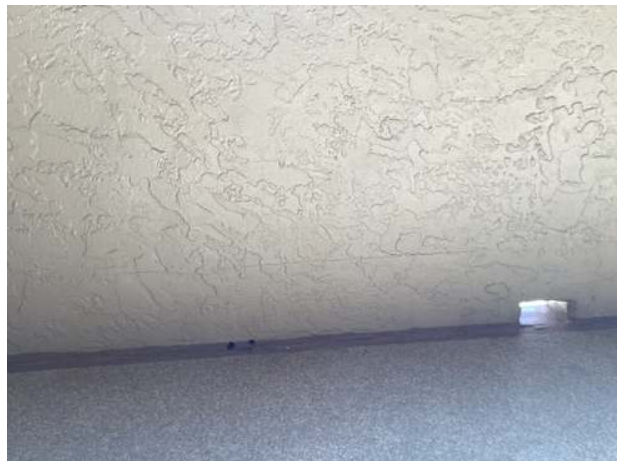
**Stucco cracks at unit 305**

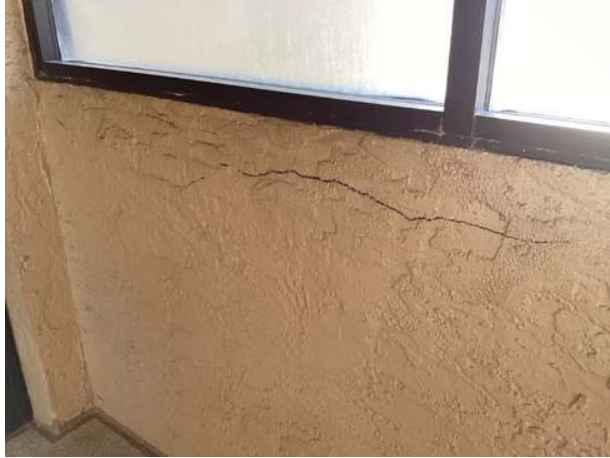
**Stucco cracks at unit 507 entrance**

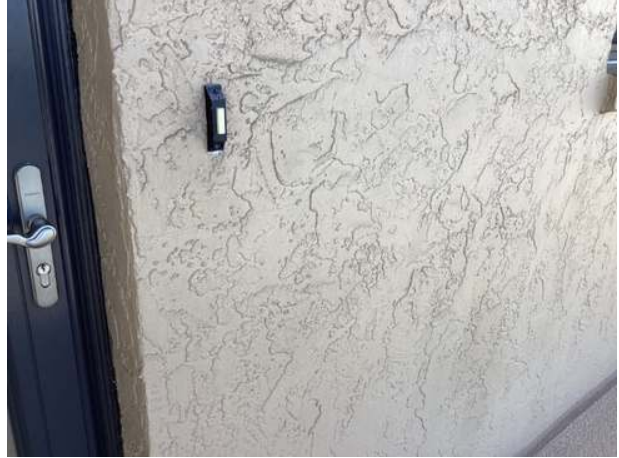
**Stucco cracks at unit 508 front entrance**

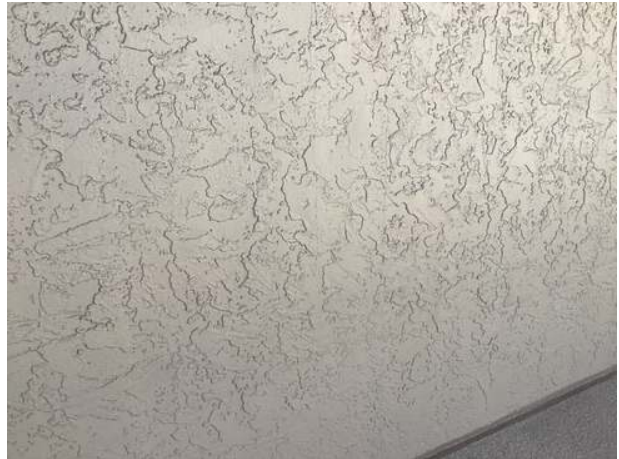
**Stucco cracks in between units 506 and 507**

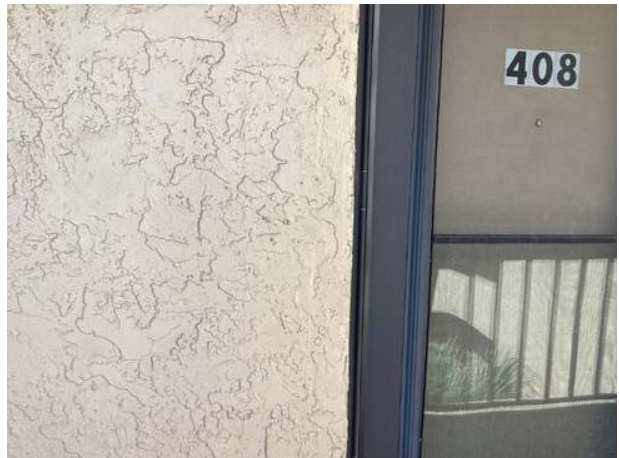
**Stucco damage at unit 408 entrance**

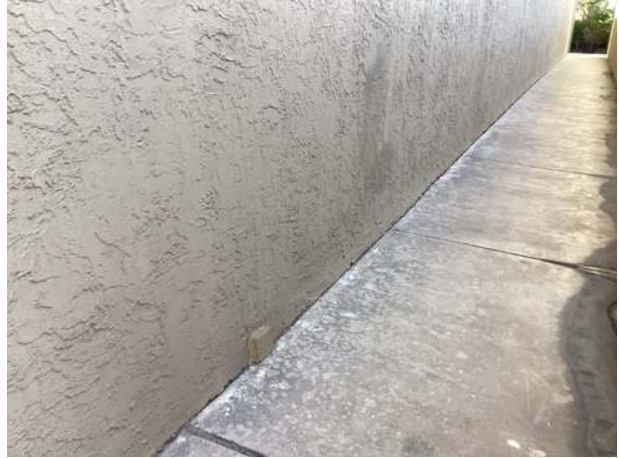
- Minor cracks are evident
- Isolated damage is evident
- Stucco finishes do not terminate 4” above the ground
- Stucco finishes terminate 2” above the roof

**Stucco terminates at grade**

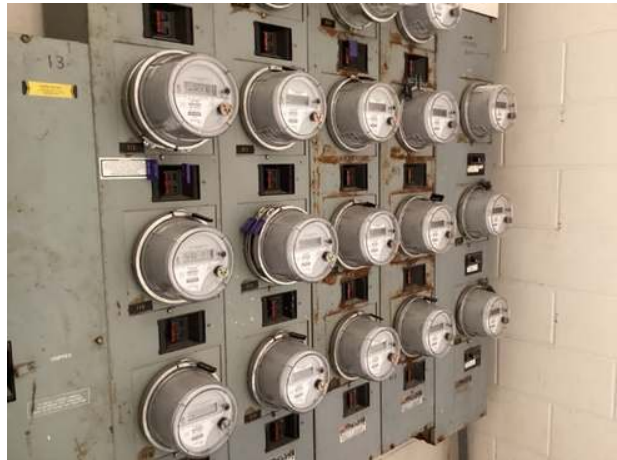
**Electrical meters for north tier rust evident**

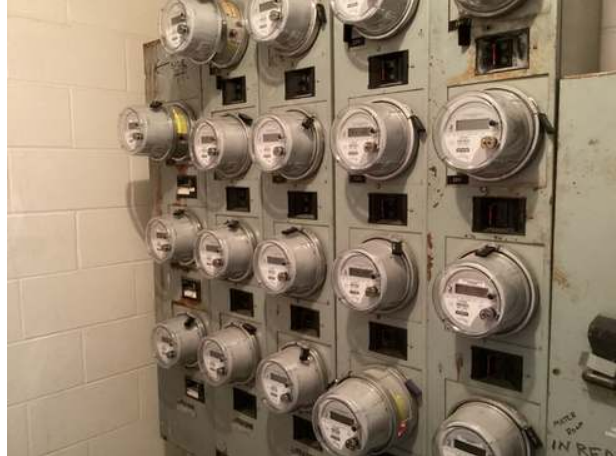
**South tower meters rust evident**

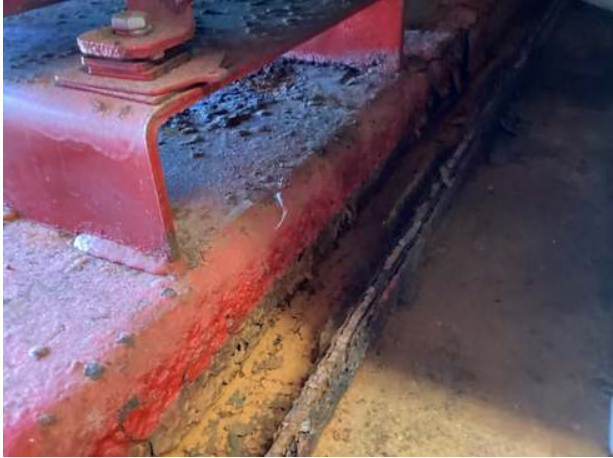
**Rust at base**

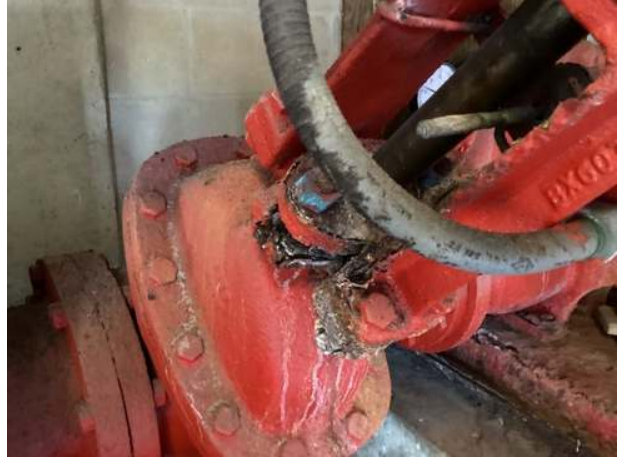
**Rusted valve**

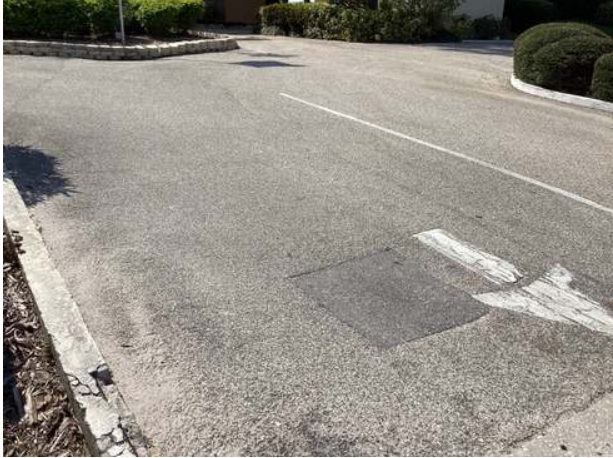
**Condition:** Fair overall with periodic cracks, settlement and patches evident.

**Asphalt pavement entrance overview with patch**

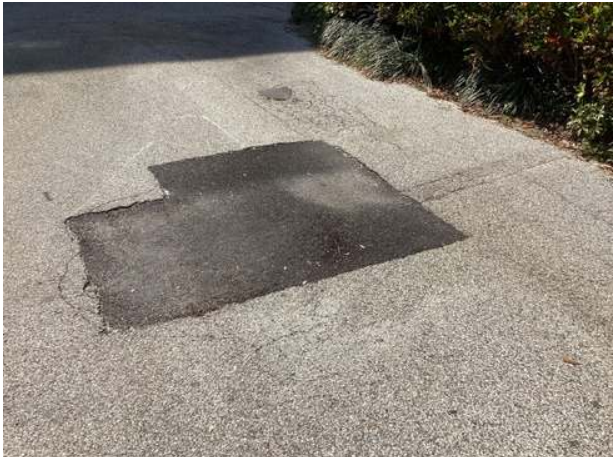
**Pavement cracks, patches and settlement**

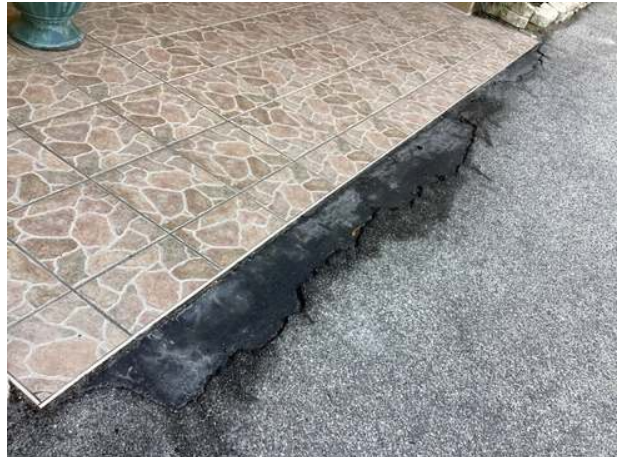
**Pavement edge deterioration**

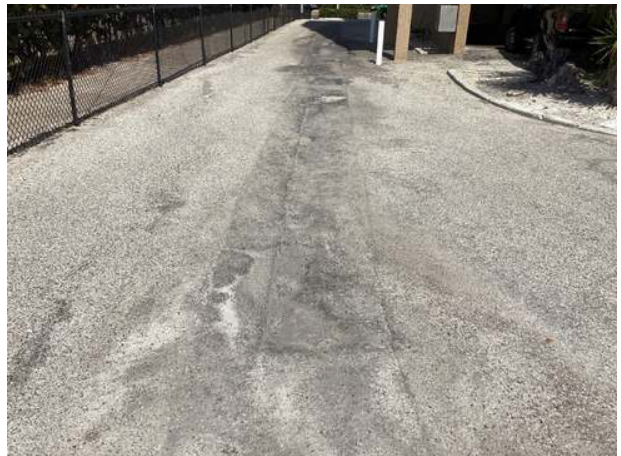
**Pavement deterioration**

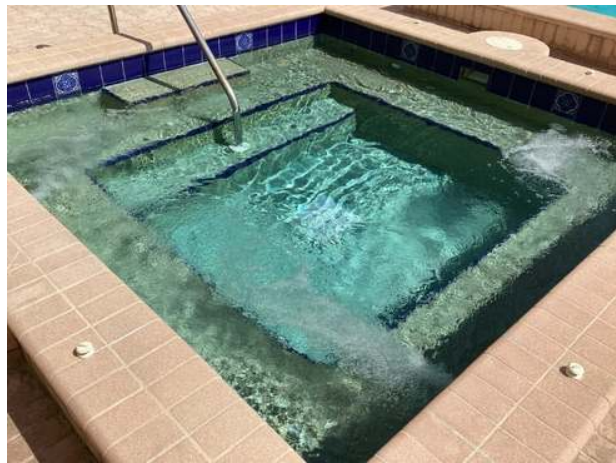
**Condition:** Good to fair overall with discoloration evident at the spa.

Spa overview with stained plaster
