Re: Country Club Condominiums Bldg. VI  
Structural Integrity Reserve Study (SIRS)  
1200 Country Club Drive  
Largo, FL 33771  
UES Project No: 0811.2300010.0000

UES Milestone Inspections, LLC (UES) has completed the mandatory Structural Integrity Reserve Study ("SIRS") as required for condominiums and cooperative buildings for the above referenced property. UES's assessment was performed in general accordance with Florida Statute (FS) 718.112(2)(g) (or 719.106(3)(k) for Cooperatives) (effective May 26, 2022) and local requirements of the Authority Having Jurisdiction (AHJ).

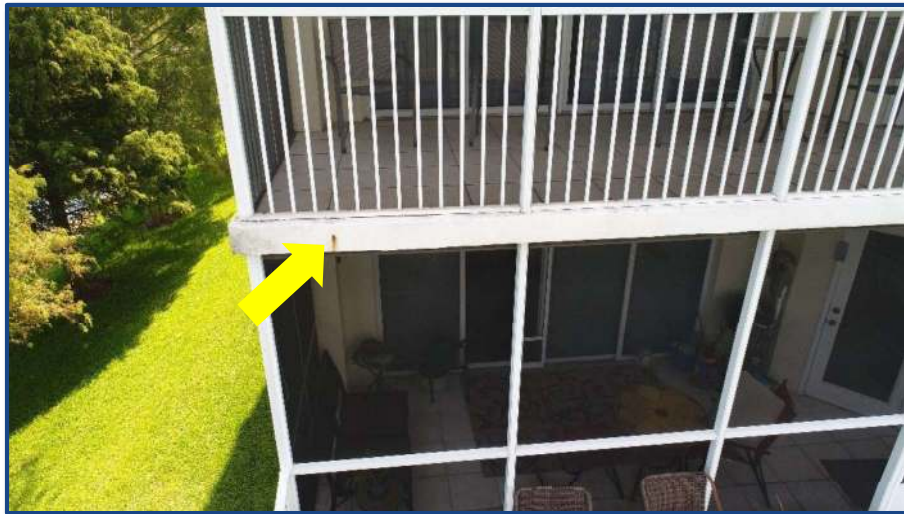
The building is composed of concrete load bearing walls, concrete shear walls, concrete beams and columns, concrete slab mat foundation, and post-tensioned floor slabs. At the time of inspection corroded steel and rust staining was observed along the balcony slab edge located at the 2<sup>nd</sup> floor balcony. Hairline cracks were observed in the interior wall of the stairwells. Also, a void was observed at the base of the exterior walkway railing post located on the 3<sup>rd</sup> floor. See **Appendix C** Photographs 7, 20, and 22 through 24.

- **Surface corroded steel and rust staining was observed along the balcony slab edge at the 2<sup>nd</sup> floor. See Appendix C Photograph No. 7.**
- **Damage to the stucco finish and surface imperfections were observed along the 1<sup>st</sup> floor balcony slab edge and in the exterior wall stucco finish located in Unit 6506. See Appendix C Photographs No. 9, 10, 14, and 15.**

Photograph No. 7: View of surface corrosion and rust staining along the balcony edge located at the 2nd floor balcony.

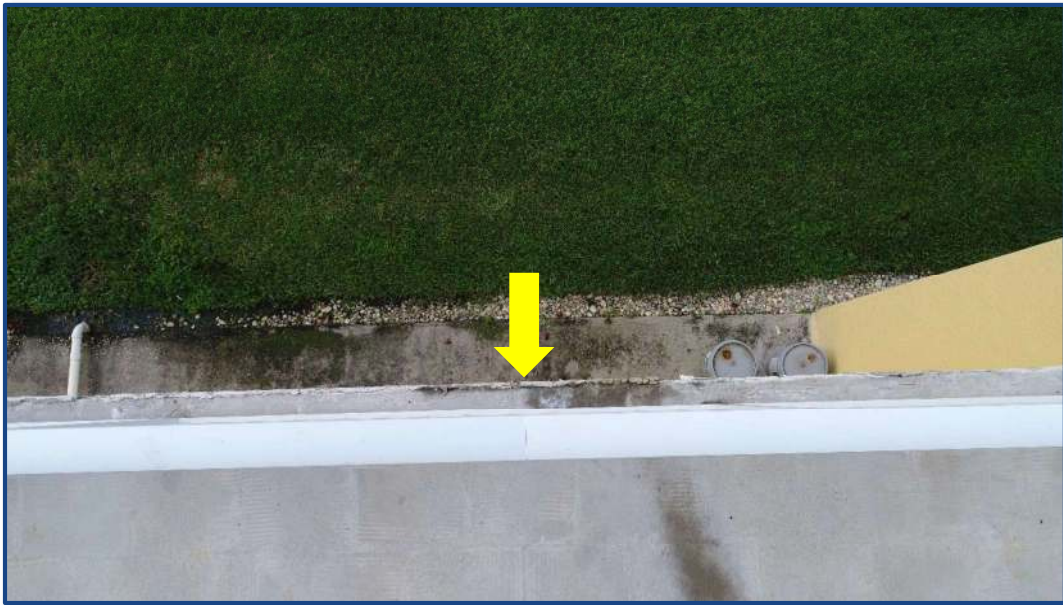
The exterior walkways are covered with a Gemstone Concrete coating and appear to be in good to fair condition. The exterior balconies along the west elevation consist of bare concrete, tile, or waterproof coating. The exterior finish of the building consists of painted stucco finishes and was observed to be in fair condition. Also, at the time of inspection, damage to the stucco finish and surface imperfections were observed along the 1<sup>st</sup> floor balcony slab edge. Cracks were also observed in the exterior wall stucco finish located in Unit 6506. See **Appendix C** Photographs No. 9, 10, 14, and 15.

Photograph No. 9: View of stucco damage and separation along the 1st floor balcony slab edge.

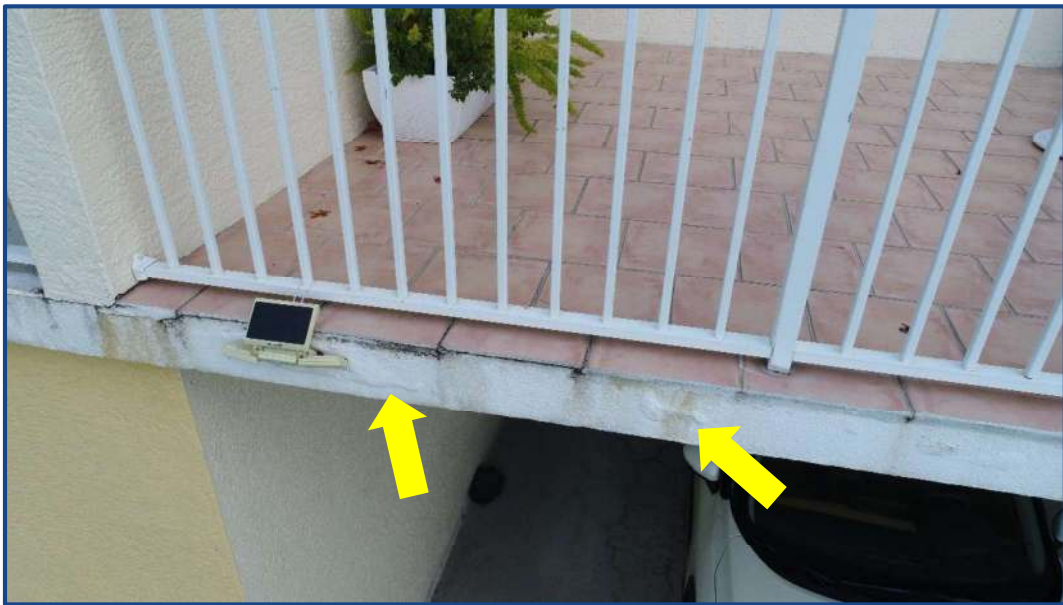
Photograph No. 10: View of bubbling in the exterior stucco finishes located along the exterior balcony edge.

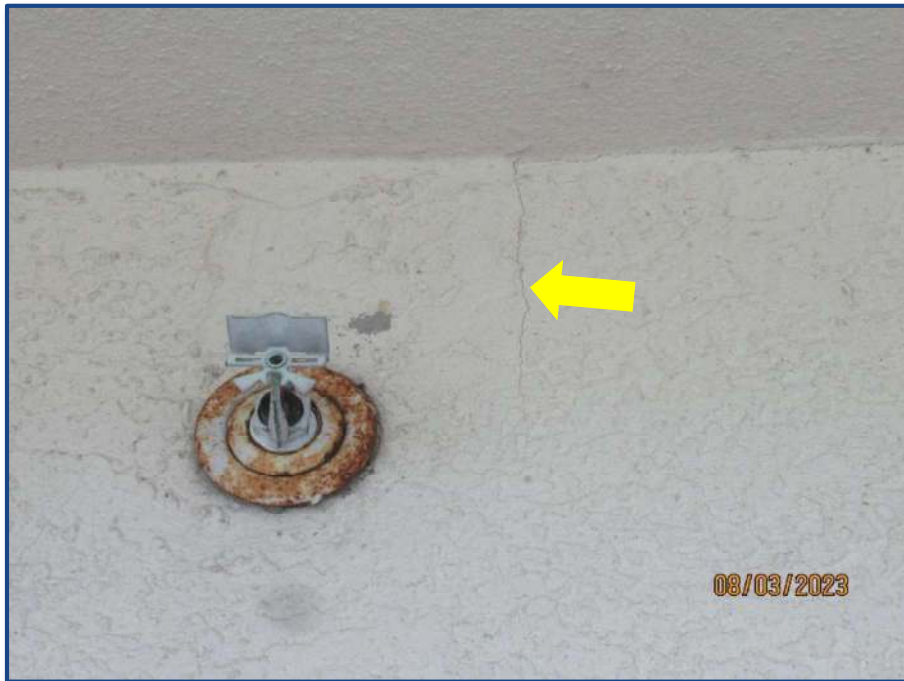
Photograph No. 14: View of crack in the exterior wall stucco finish located in the balcony of Unit 6506.

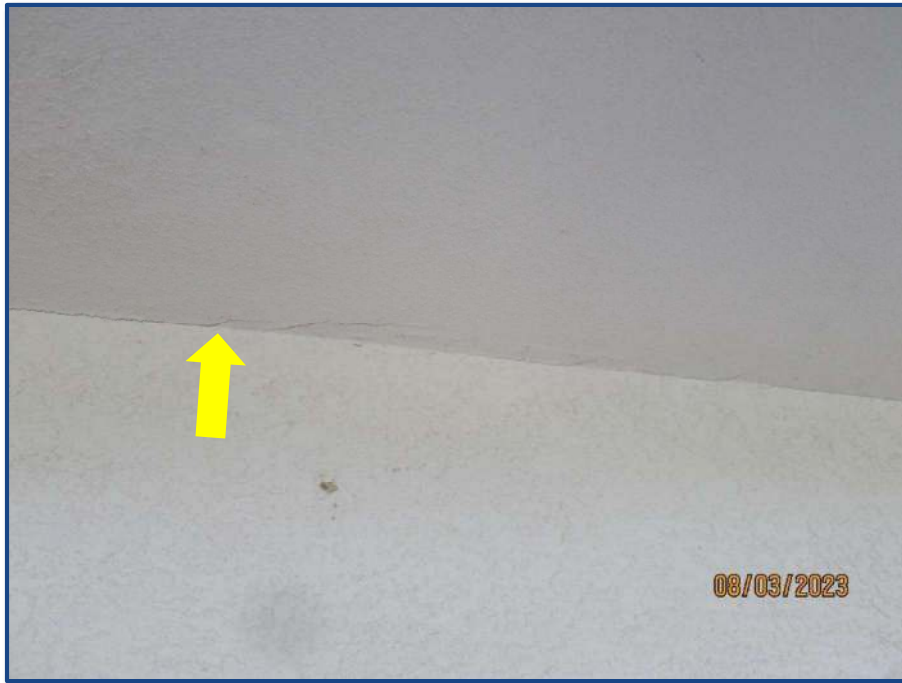
Photograph No. 15: View of crack in the exterior ceiling finish located in the balcony of Unit 6506.

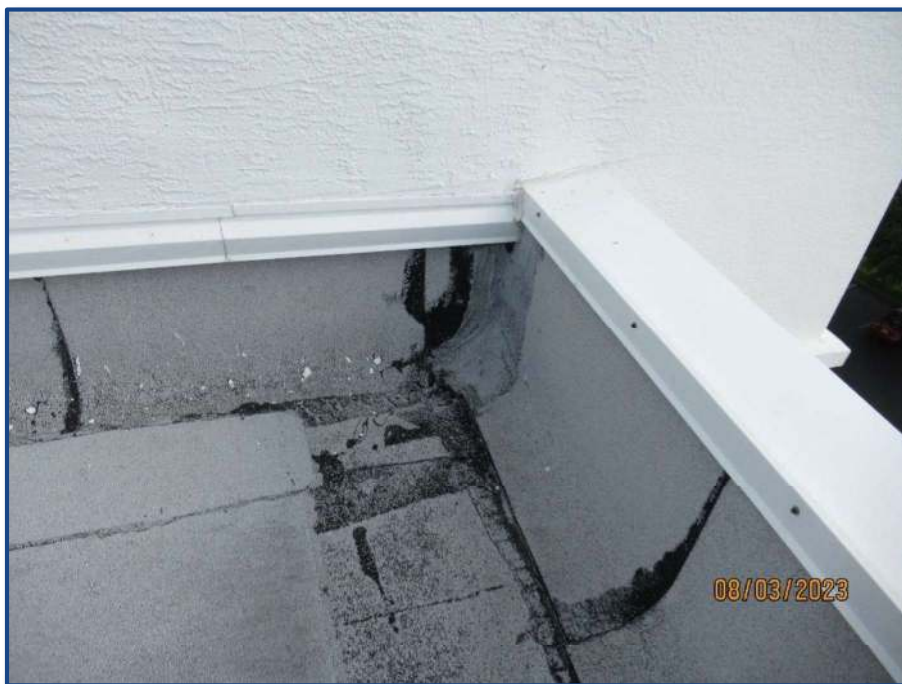
The roof system of the building is composed of a modified bitumen roof. At the time of inspection, the overall condition of the roof was observed to be in poor condition. The roof was observed with granular loss and significant deterioration in the roof membrane throughout the entire roof system. Additionally, roof repairs were also observed. The association is aware of the roof condition and is currently in the process of deciding on a new roof system. See **Appendix C** Photographs No. 5, and 16 through 19 for examples of deficiencies observed. All roof drains were observed to be clean of debris.

- **Significant granular loss and significant deterioration was observed in the roof membrane throughout the entire roof system. See Appendix C Photographs No. 16 through 18.**

Photograph No. 16: View of granular loss and significant deterioration in the roof membrane.

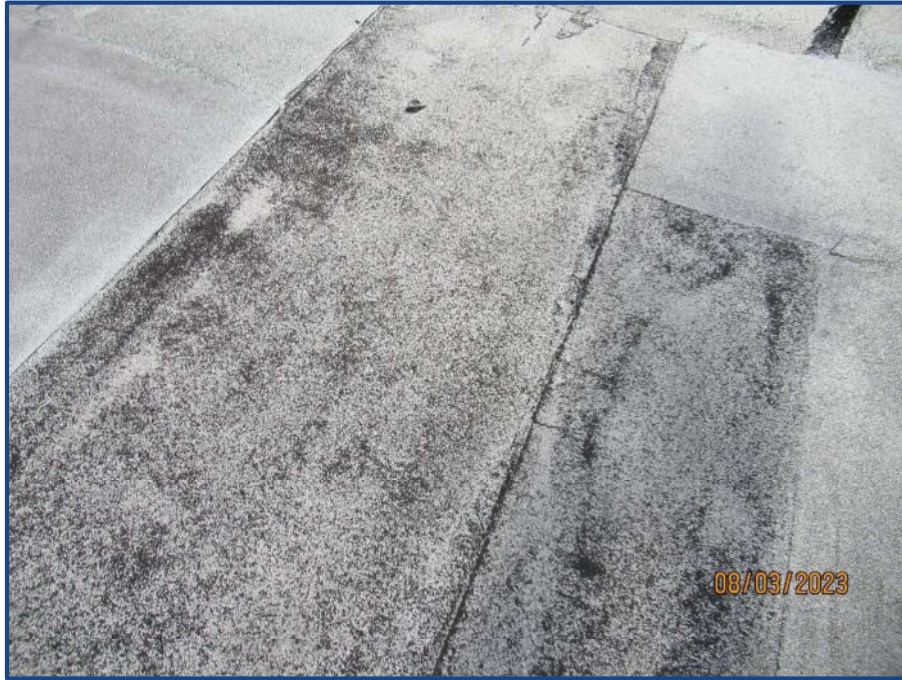
Photograph No. 17: View of granular loss and significant deterioration in the roof membrane.

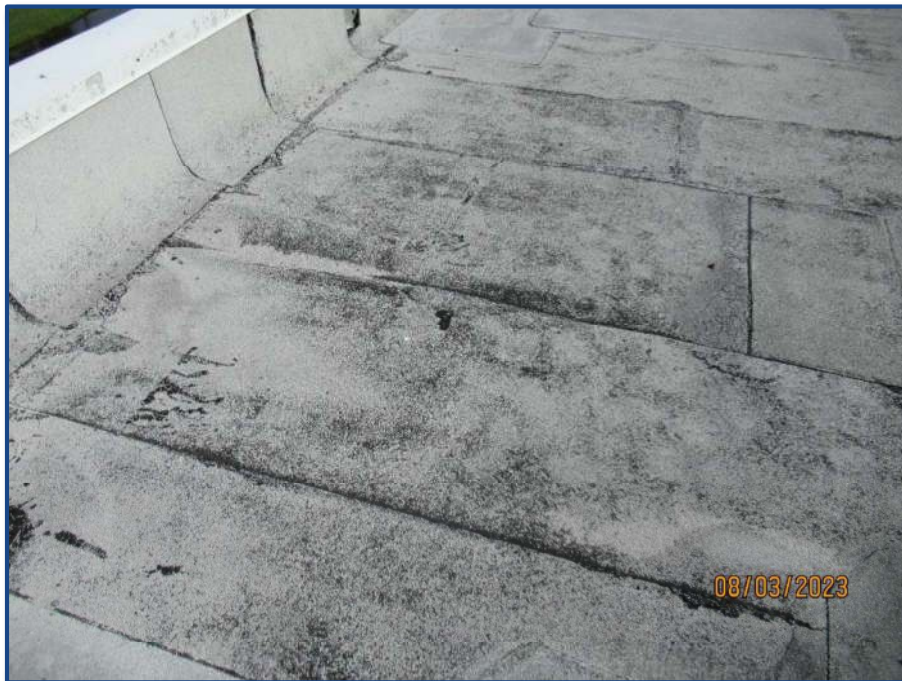
Photograph No. 18: View of granular loss and significant deterioration in the roof membrane.

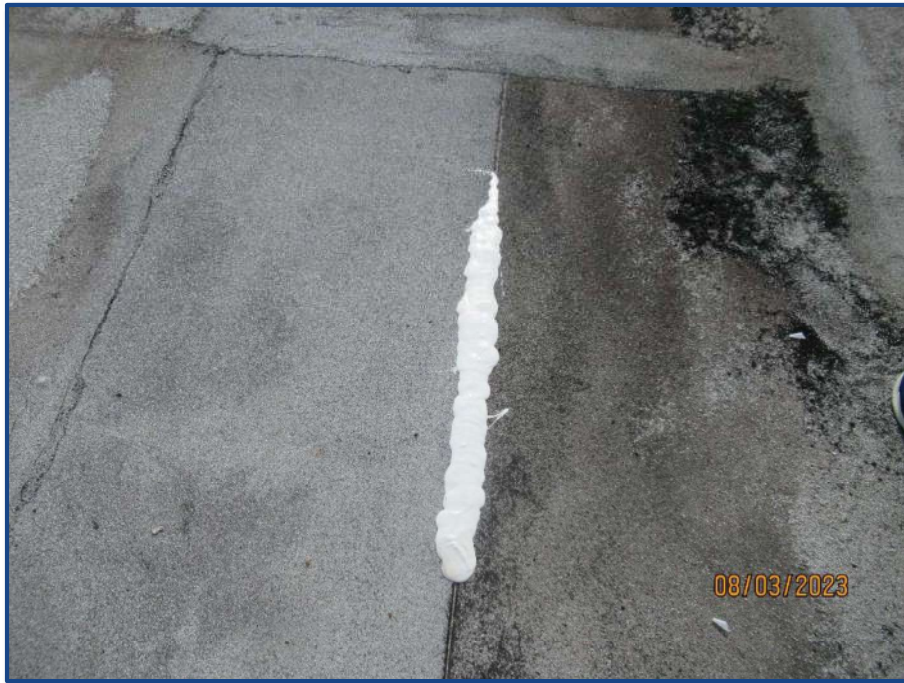
Photograph No. 19: View of previous roof patch repair.

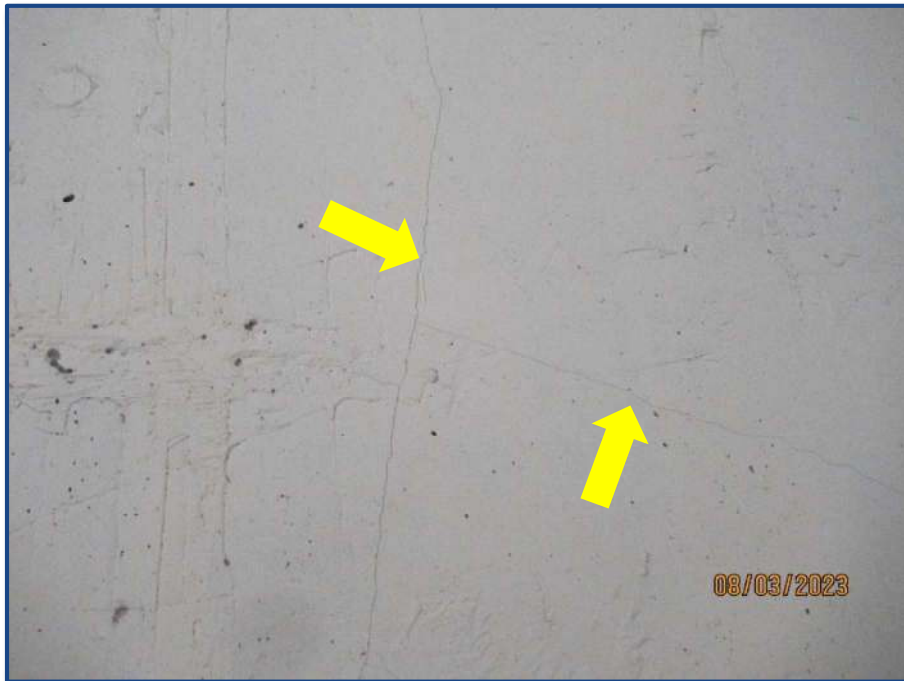
- **Cracks were observed in the interior stairwell walls. See Appendix C Photographs No. 20 and 24.**
- **A void was observed at the base of the exterior walkway railing post located on the 3<sup>rd</sup> floor. See Appendix C Photographs No. 22 and 23.**

Photograph No. 20: View of cracks in the interior wall of Stair 1 Floor 5.

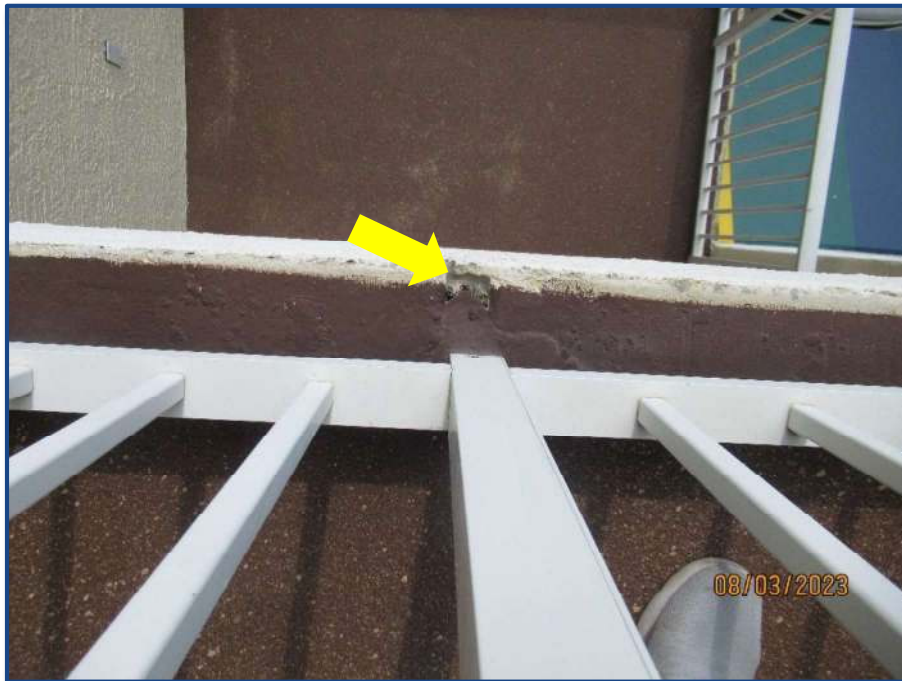
Photograph No. 22: View of void at the exterior walkway railing post located on the 3rd floor.

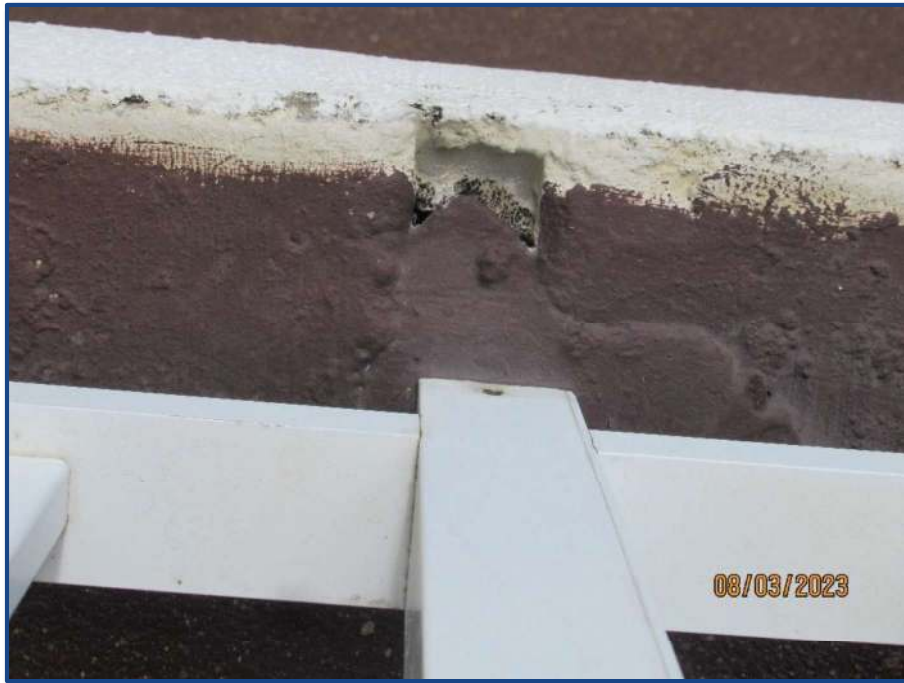
Photograph No. 23: Close-up view of Photograph 22.

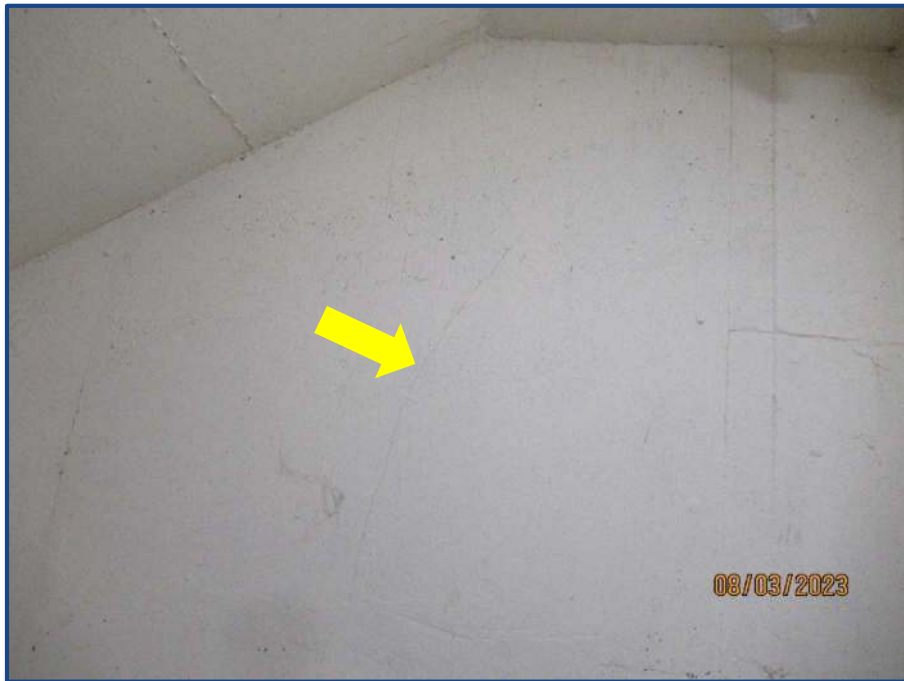
Photograph No. 24: View of crack in the interior wall of Stair 1 Floor 2.

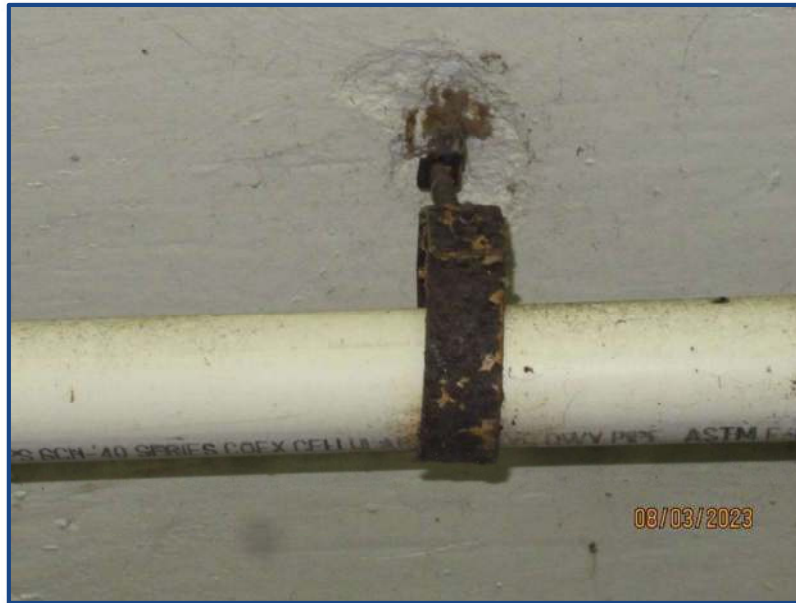
The visible building plumbing inspected at the time of inspection included: schedule 40 PVC connecting to the roof drains, air conditioning drains, and waste piping. At the time of inspection, no damage or deficiencies were observed to the plumbing systems. Support plumbing hangers in the garage level were observed with significant corrosion in multiple hanger locations. See **Appendix A** Photographs No. 31 through 34.

- **Support plumbing hangers located in the garage level were observed with significant corrosion. See Appendix C Photograph No. 33 as an example.**

Photograph No. 33: View of corroded plumbing hangers located in the garage level.

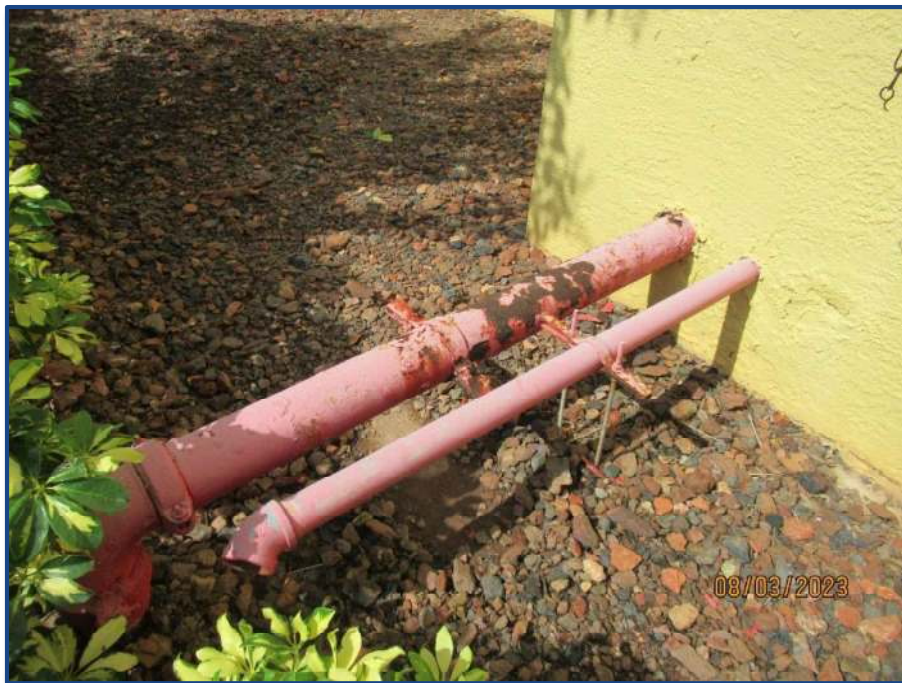
Photograph No. 42: Corroded fire riser pipe.
