# Uniform Mitigation Verification Inspection Form

| Inspection Date: 06/23/2023 | | |
| Address: 668 ATWOOD AVE N | | Home Phone: |

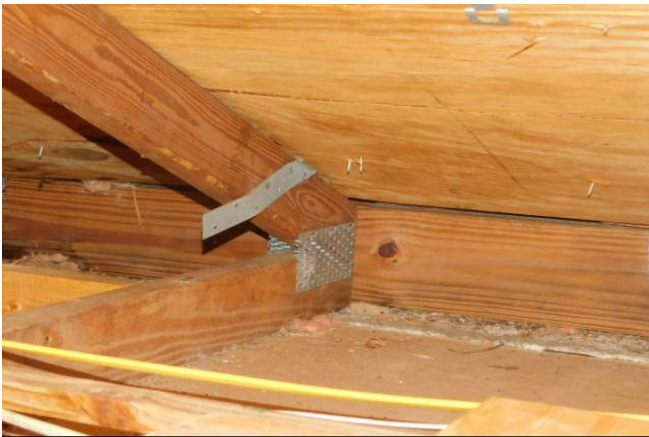
TRUSS TO WALL CONNECTION

- ☒ Secured to truss/rafter with a minimum of three (3) nails, **and**
- ☒ Attached to the wall top plate of the wall framing, or embedded in the bond beam, with less than a ½" gap from the blocking or truss/rafter **and** blocked no more than 1.5" of the truss/rafter, **and** free of visible severe corrosion.

- ☒ B. Clips
  - ☒ Metal connectors that do not wrap over the top of the truss/rafter, **or**
  - ☐ Metal connectors with a minimum of 1 strap that wraps over the top of the truss/rafter and does not meet the nail position requirements of C or D, but is secured with a minimum of 3 nails.

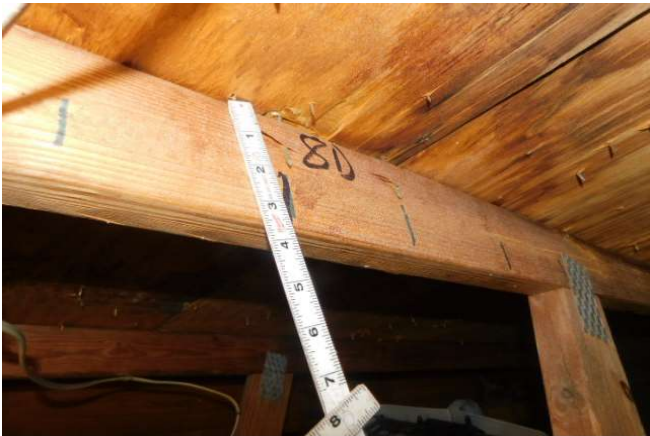
ROOF DECK ATTACHMENT SIZE

- ☒ C. Plywood/OSB roof sheathing with a minimum thickness of 7/16" attached to the roof truss/rafter (spaced a maximum of 24 inches o.c.) by 8d common nails spaced a maximum of 6" inches in the field. -OR- Dimensional lumber/Tongue & Groove decking with a minimum of 2 nails per board (or 1 nail per board if each board is equal to or less than 6 inches in width). -OR- Any system of screws, nails, adhesives, other deck fastening system or truss/rafter spacing that is shown to have an equivalent

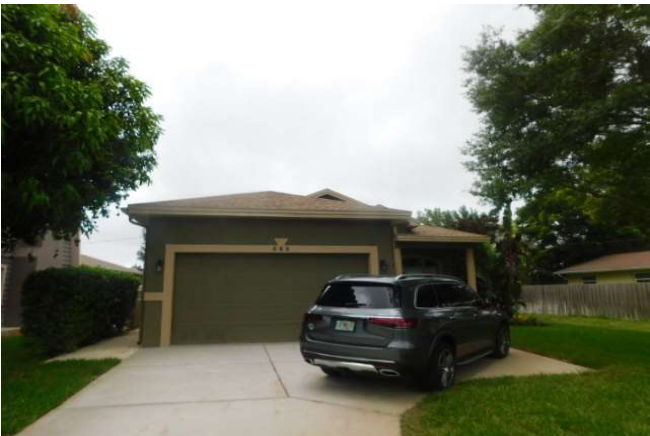
ROOF SHAPE

- ☒ A. Hip Roof Hip roof with no other roof shapes greater than 10% of the total roof system perimeter.  
Total length of non-hip features: 15 feet; Total roof system perimeter: 178 feet
- ☐ B. Flat Roof Roof on a building with 5 or more units where at least 90% of the main roof area has a roof slope of less than 2:12. Roof area with slope less than 2:12 \_\_\_\_\_ sq ft; Total roof area \_\_\_\_\_ sq ft
- ☐ C. Other Roof Any roof that does not qualify as either (A) or (B) above.
