# Costa Del Sol

## Condominium Association, Inc.

Inspected: July 29, 2024 • Revised on: November 19, 2024  
Cape Canaveral, FL

**STRUCTURAL INTEGRITY  
RESERVE STUDY**

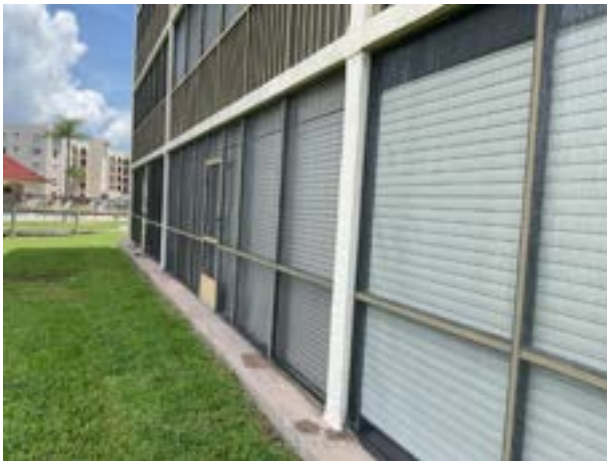
**Balcony screens with frame finish deterioration**

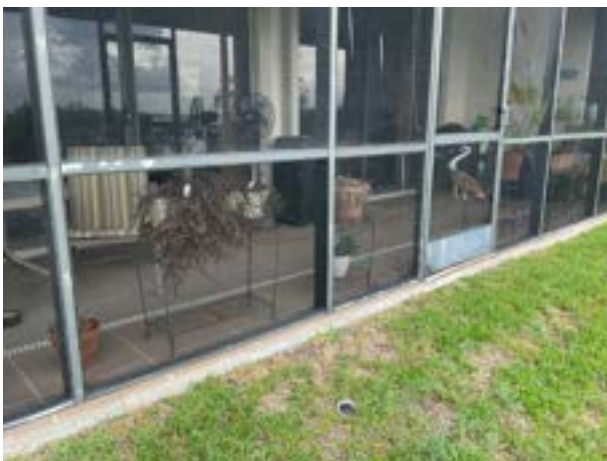
**Frame finish deterioration**

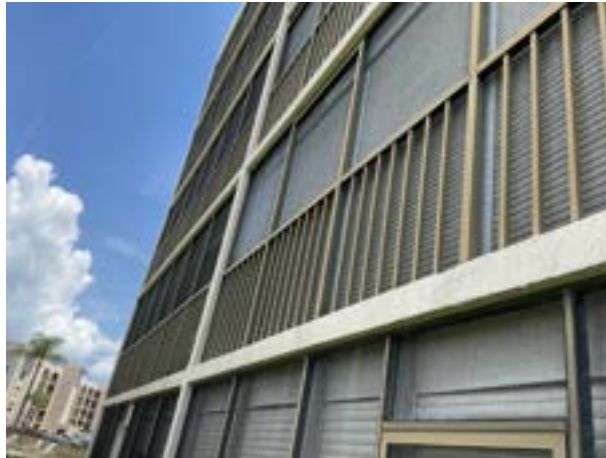
**Aluminum railings with finish deterioration**

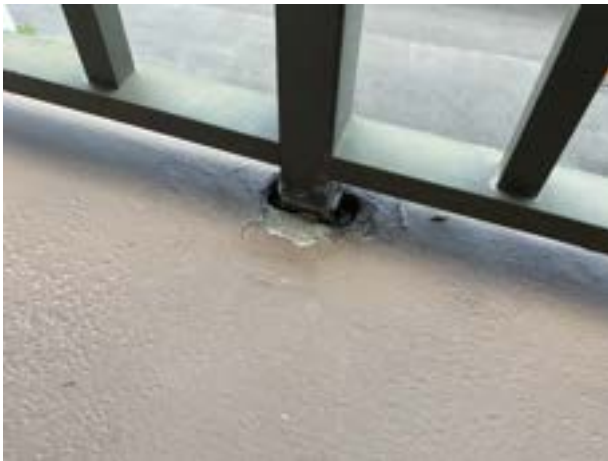
**Deterioration at railing breezeway connection**

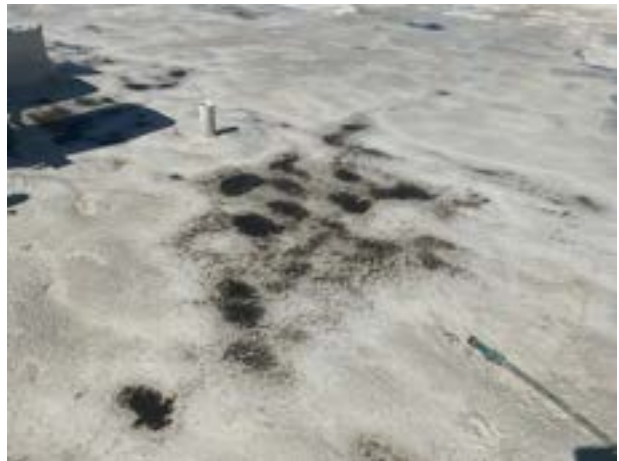
**Condition:** Fair overall with standing water, damage and deterioration evident. Management and the Board do not report a history of leaks.

**Evidence of standing water**

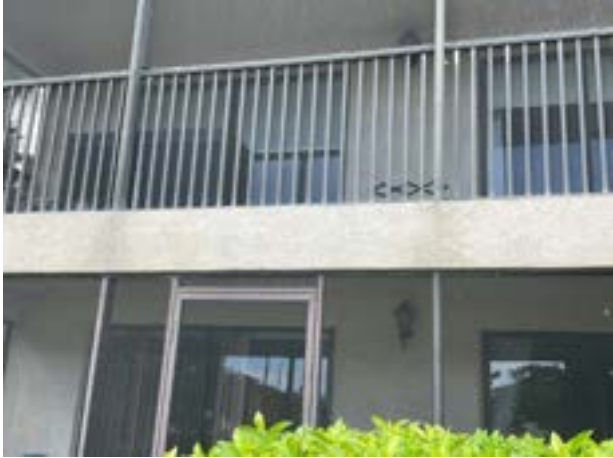
**Evidence of moisture**

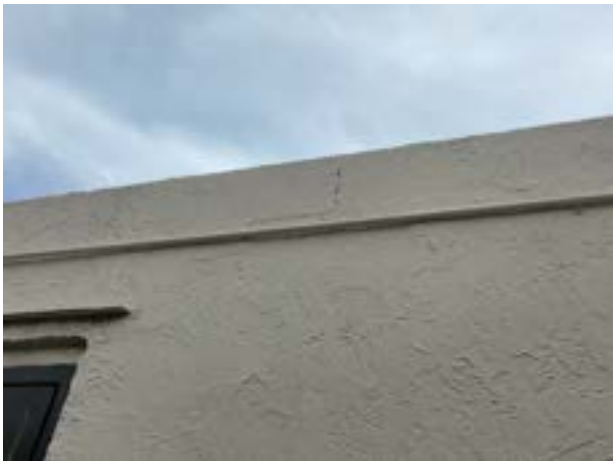
**Condition:** Fair overall with cracks, spalls, rust stains and deterioration evident. We note the following:

**Stair step crack**

- Complete inspection of the stucco
- Crack repairs as needed (Each paint product has the limited ability to cover and seal cracks but we recommend repair of all cracks which exceed the ability of the paint product to bridge.)
- Replacement of up to one percent (1%), of the stucco walls (The exact amount of area in need of replacement will be discretionary based on the actual future conditions and the desired appearance.)
- Replacement of up to one percent (1%) of the sealants in coordination with each paint finish application.

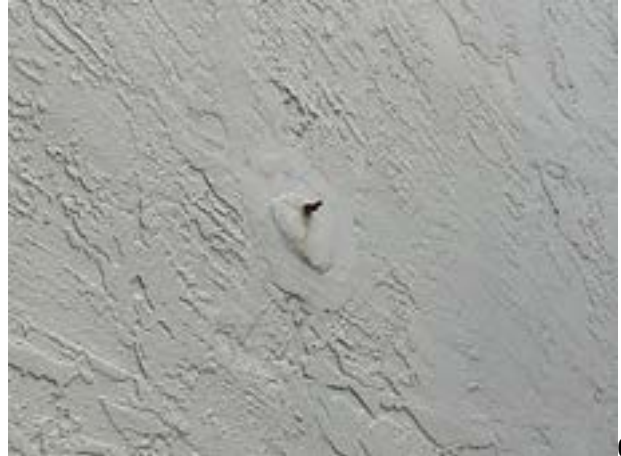
**Penetration at stucco**

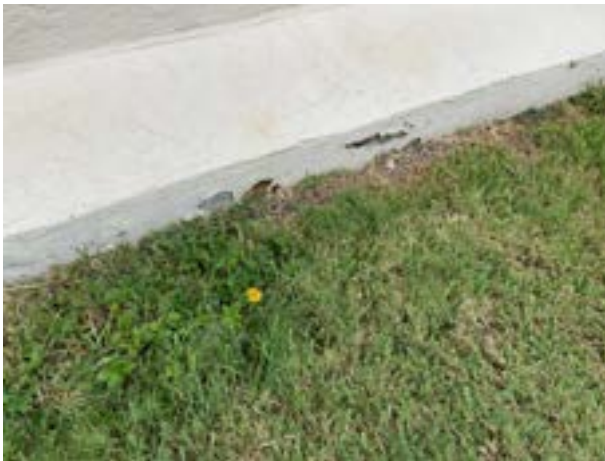
- We identify cracks, spalls and stucco deterioration at the time of inspection. Our investigation is not exhaustive, and we recommend the association plan for a periodic inspection to identify areas of deterioration
- Sealants are in good condition
- The stucco improperly terminates under two inches above grade. This condition may result in accelerated deterioration

**Deterioration at grade**

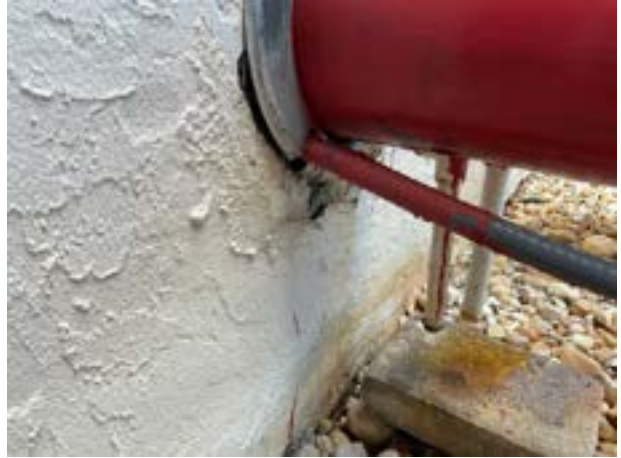
**Peeling finish near fire outlet pipe**

Correct and complete preparation of the surface before application of the paint finish maximizes the useful life of the paint finish and surface. The contractor should remove all loose, peeled or blistered paint before application of the new paint finish. The contractor should then power wash the surface to remove all dirt and biological growth. Water-soluble cleaners that will not attack Portland cement are acceptable for removing stains.

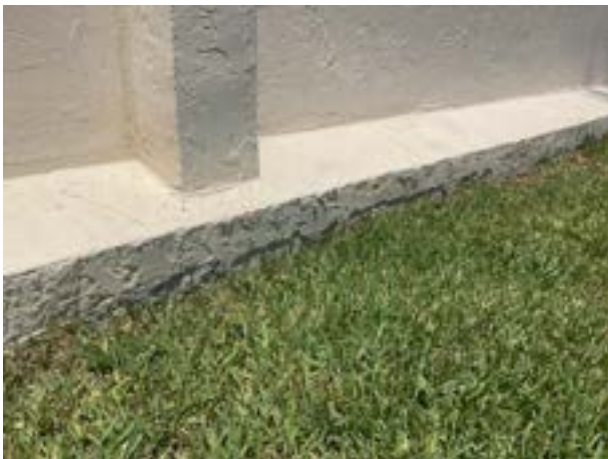
**Finish deterioration near grade**

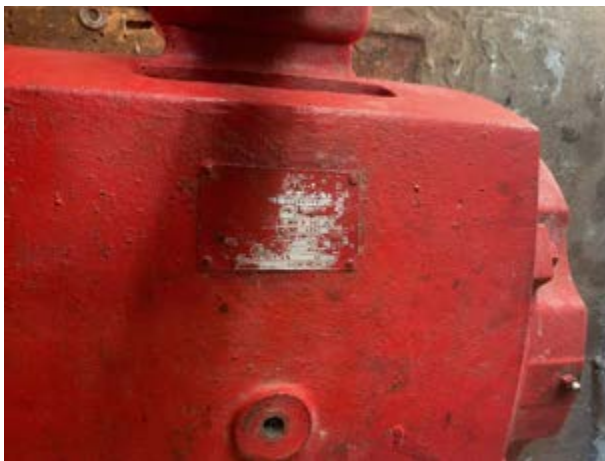
- July 2024 inspection date
- Faded tag coloring
- Water leaking

**Fire suppression pump tag**

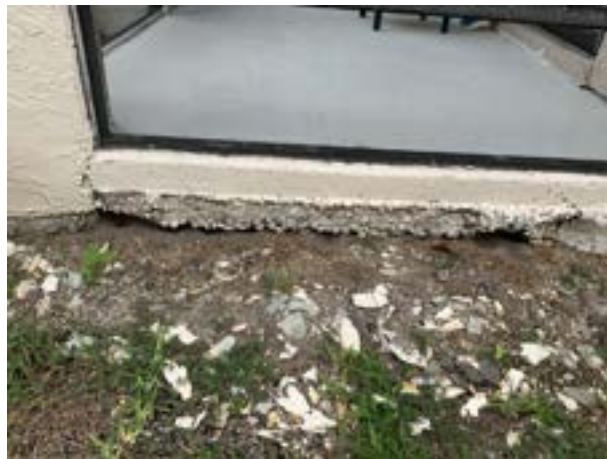
**Condition:** Good to fair overall with undermining at the balcony edge evident

**Undermining at on-grade balcony**

**Useful Life:** Two- to four-years for interim sealant applications. Capital repairs including a close-up visual inspection, patching of delaminated concrete, routing and filling of cracked concrete, and waterproof coating applications every 20- to 25-years.

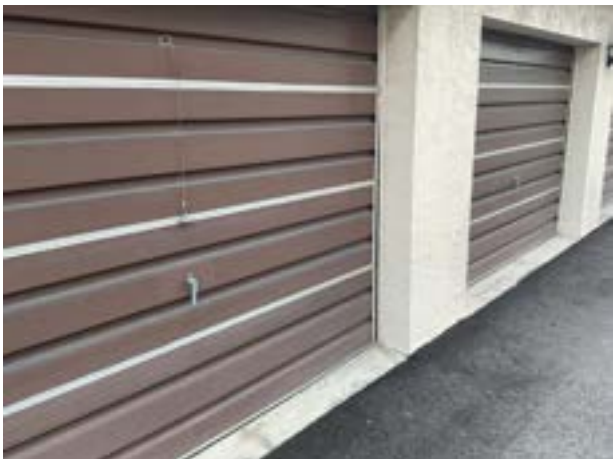
**Condition:** Good to fair overall with damage and off track doors evident

**Garage door not on track**

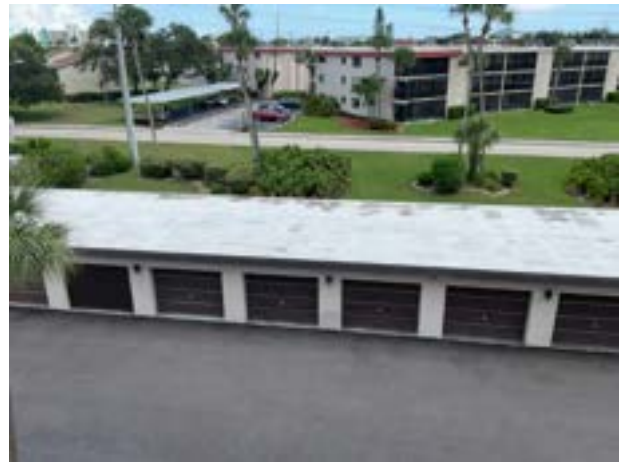
**Condition:** Good to fair overall with standing water and damaged fascia evident

Foam roof with standing water

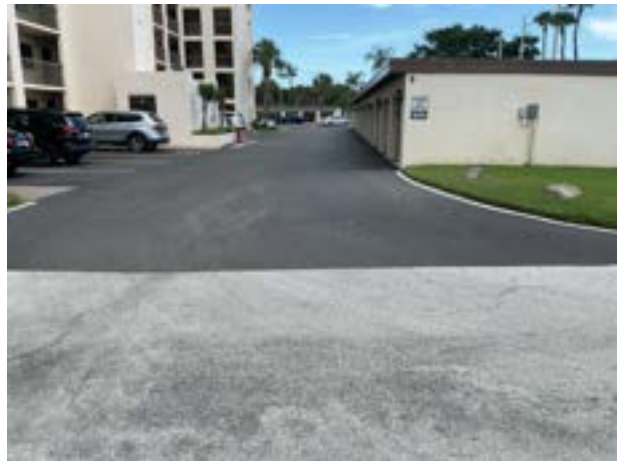
**New vs old pavement**

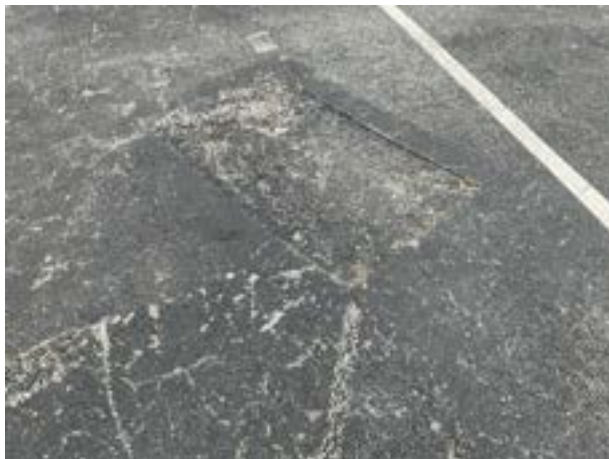
**Evidence of previous repairs**

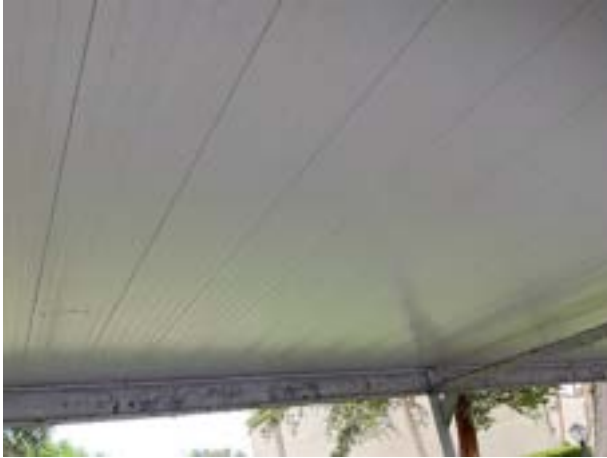
**Carport under side**

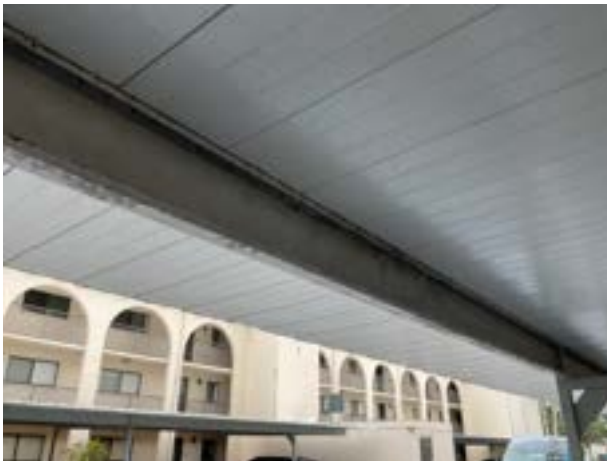
**Condition:** Fair overall with rusted metal frames evident

**Rusted metal frame**

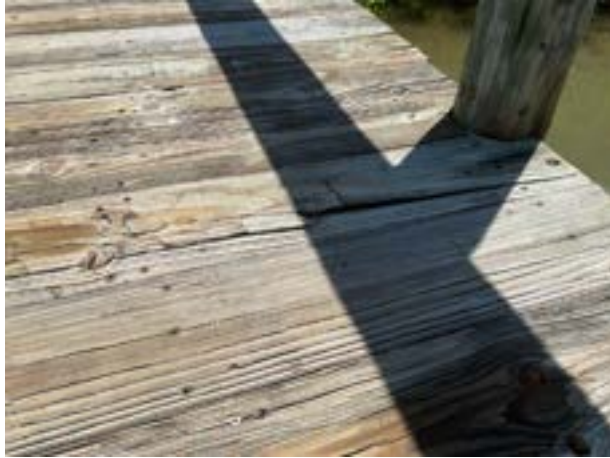
**Splintered wood deck**

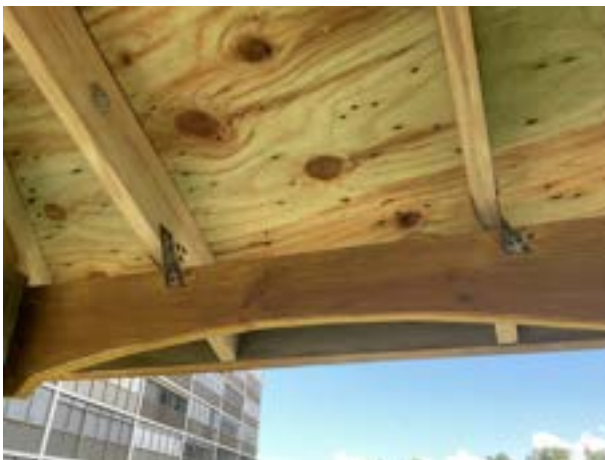
**Condition:** Good overall to fair overall with rusted metal drip edge evident

Rusted rafter ties

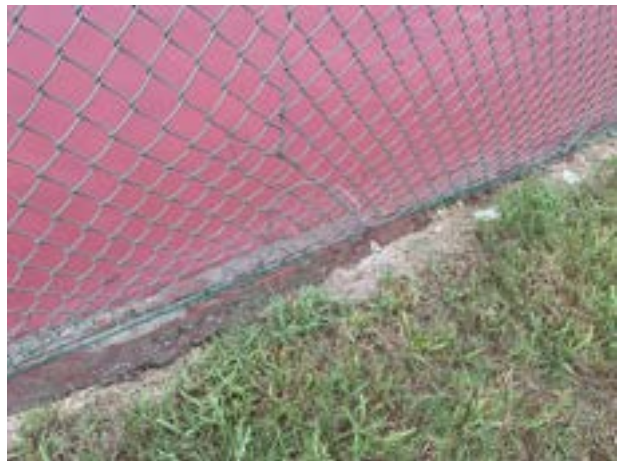
**Condition:** Fair overall with warped fence, broken fence links, rusting and finish deterioration evident

**Warped chain link fence**

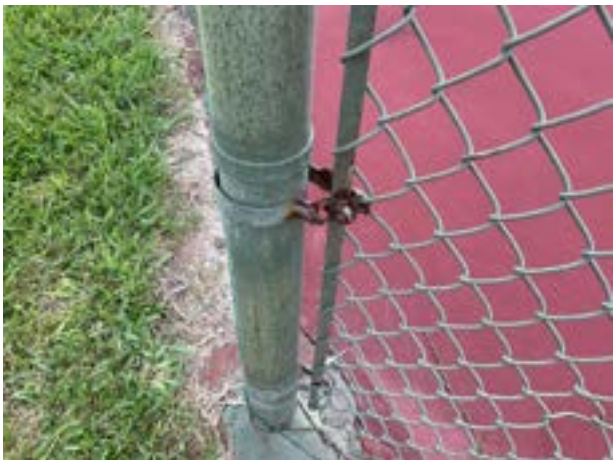
**Broken fence link with rust**

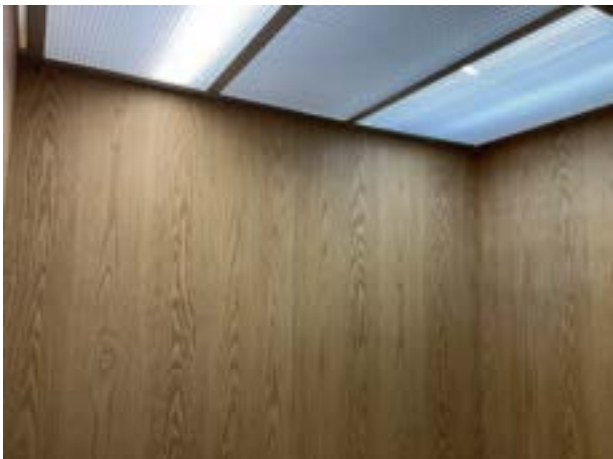
**Condition:** Fair overall with cracked tiles, faded finishes, damaged walls and stained veneer evident.

**Cab wall finishes**

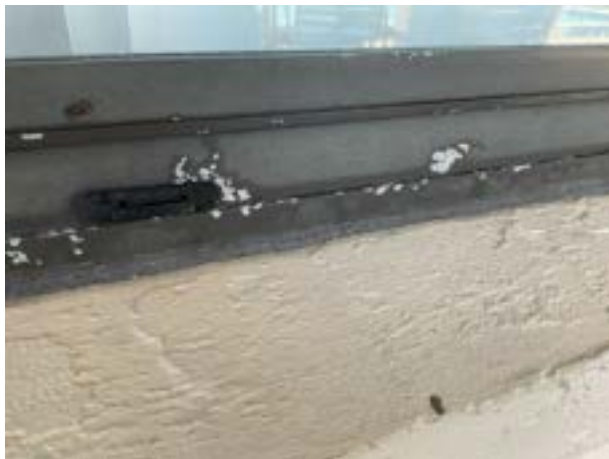
**Condition:** Good to fair overall with frame deterioration evident

Sealant deterioration at clubhouse windows

- As-needed:
  - Verify weep holes are unobstructed and not blocked with dirt or sealant, if applicable
  - Replace damaged or deteriorated sliding glass rollers, if applicable

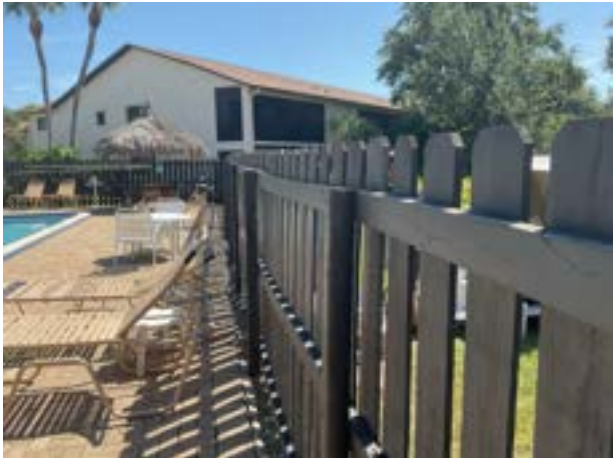
**Condition:** Good to fair overall with leaning sections and deterioration evident

**Wood fence overview**

**Component Detail Notes:** The Association should anticipate periodic partial replacements due to the non-uniform nature of wood deterioration. Along with these partial replacements, the Association should apply periodic paint applications as needed and fund these activities through the operating budget.

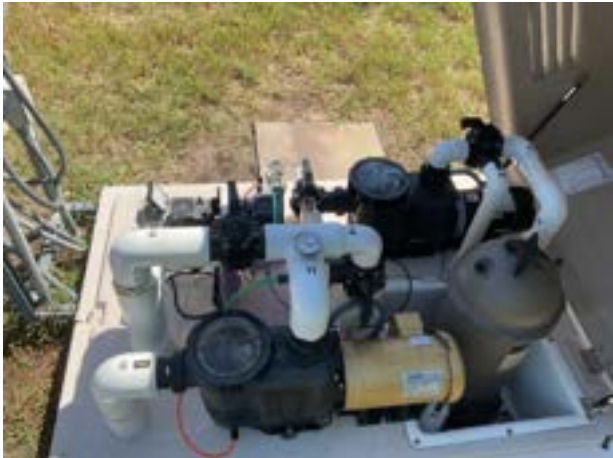
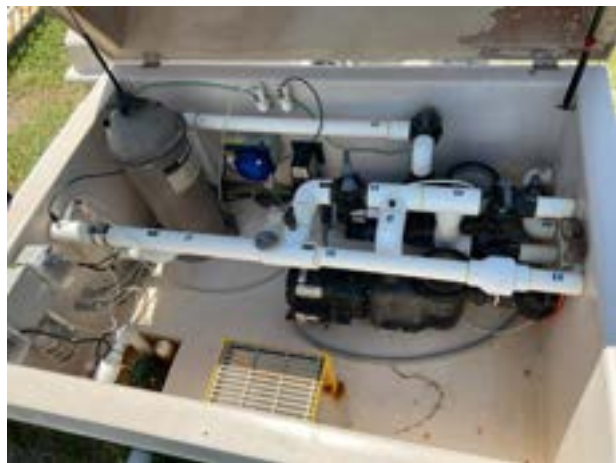
**Pool mechanical equipment**

**Condition:** Reported satisfactory with operational deficiencies

**Expenditure Detail Notes:** Expenditure timing and costs are depicted in the *Reserve Expenditures* table in Section 3. Failure of the pool mechanical equipment as a single event is unlikely. Therefore, we include replacement of up to fifty percent (50%) of the equipment per event. We consider interim replacement of motors and minor repairs as normal maintenance.

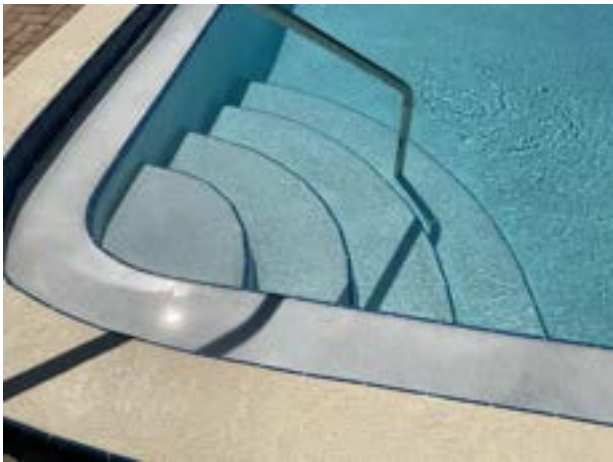
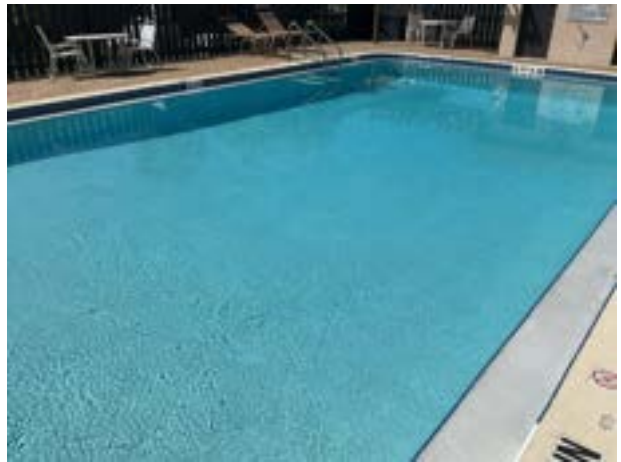
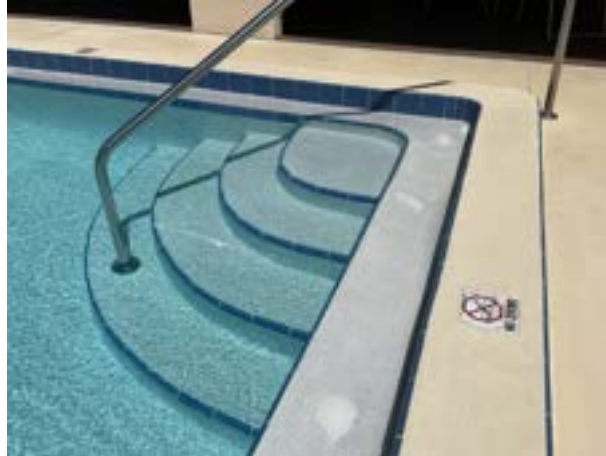
**Condition:** Good overall with no signs of significant deterioration

Plaster and tile finish at steps

Plaster finish at small pool

Tile finish

Plaster finish at clubhouse pool

- Removal and replacement of the plaster finishes
- Partial replacements of the scuppers and coping as needed
- Replacement of tiles as needed
- Replacement of joint sealants as needed
- Concrete structure repairs as needed
