# Canaveral Bay Condominium Association, Inc.

October 15, 2024 • Cape Canaveral, FL

STRUCTURAL INTEGRITY  
RESERVE STUDY

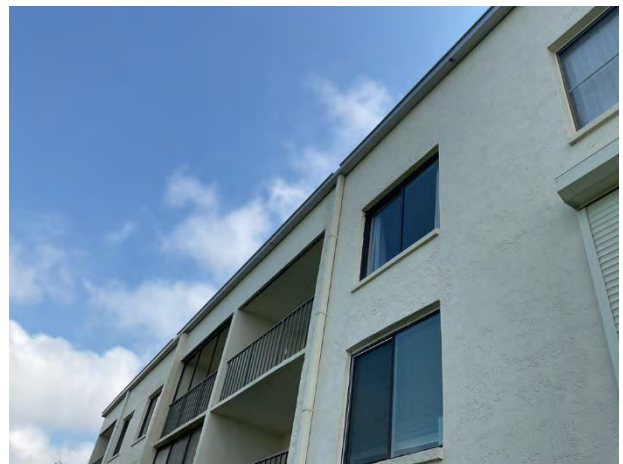
**Condition:** Good to fair overall with damage evident

**Metal gutters and downspouts**

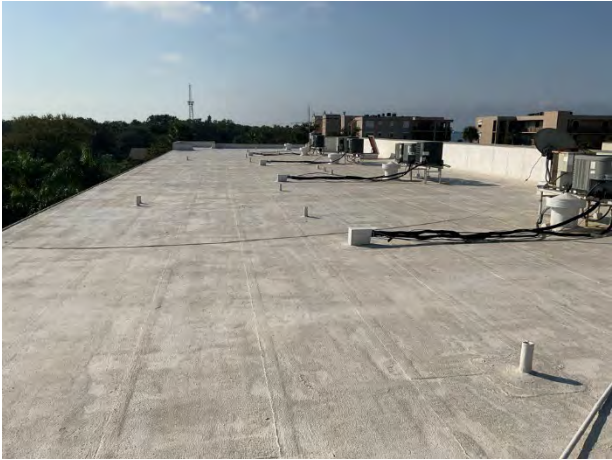
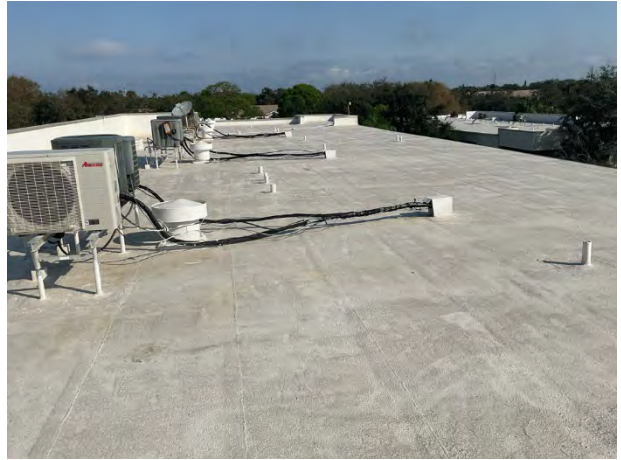
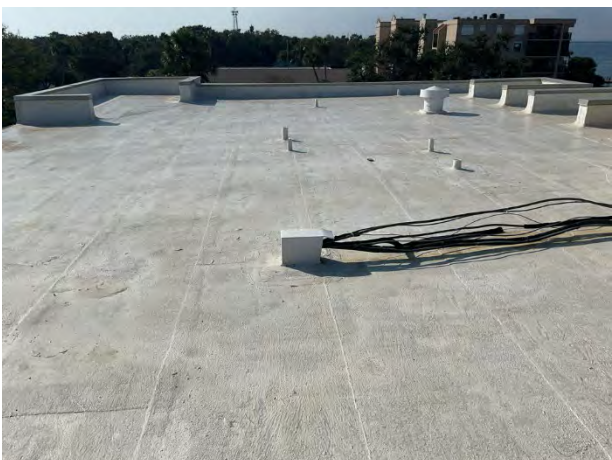
- Isolated sealant failure is evident
- Isolated expansion joint deterioration is evident
- Isolated blocked roof drains are evident

**Modified bitumen roof overview**

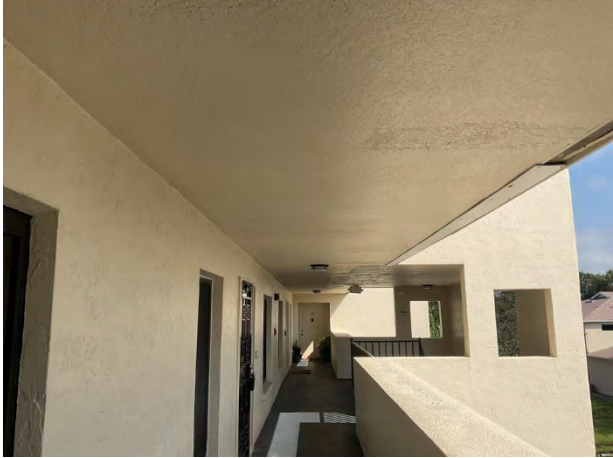
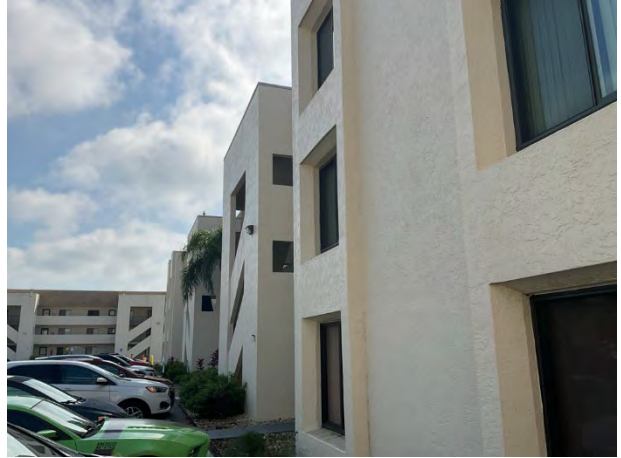
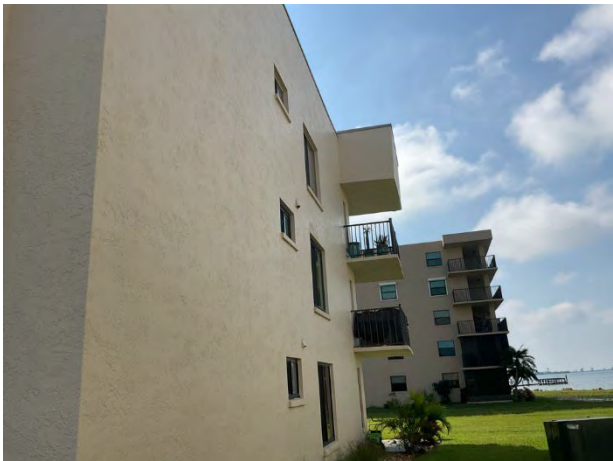
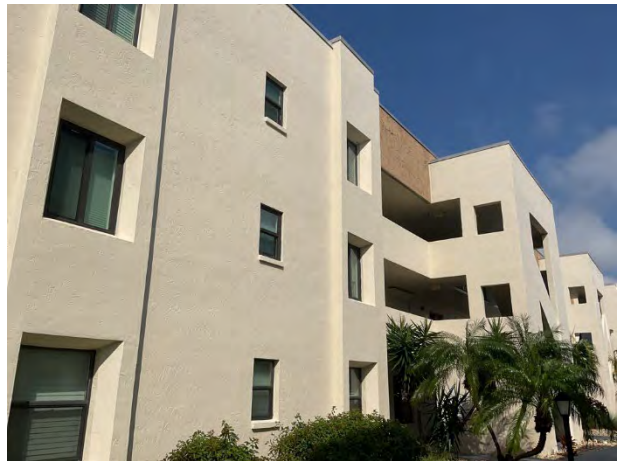
**Condition:** Good to fair overall with isolated cracks and rust stains evident. We note the following:

- We not isolated stucco cracks
- No significant stucco damage evident
- Sealants are in good condition
- Stucco does not terminate 2” above grade
- Stucco does not terminate 4” above grade

**Stucco wall finishes**

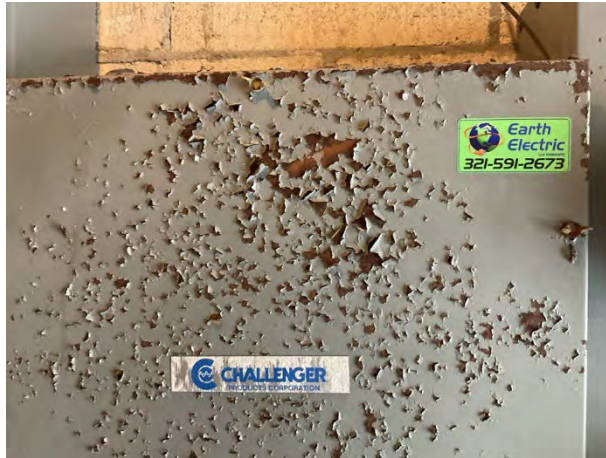
- No thermoscan inspection has been done
- No excessive buzzing/humming was present at the transformers we observed.
- No obvious combustible material storage was observed in electrical rooms. However, our inspection is not exhaustive and the Association should conduct periodic inspections of the electrical rooms to ensure compliance with 10.18.5 of NFPA 1.
- Some electrical rooms were not labeled. The Association should consider adding clear and proper signage to the electrical rooms.
- No obvious exposed wires were observed during our site inspection. However, our inspection is not exhaustive and the Association should conduct periodic inspections of the electrical rooms to ensure no unsafe conditions develop.
- Rust and peeling paint is noted at electrical panels.
- No apparent water was observed in or near the electrical rooms.

**Electrical system rust and peeling paint**

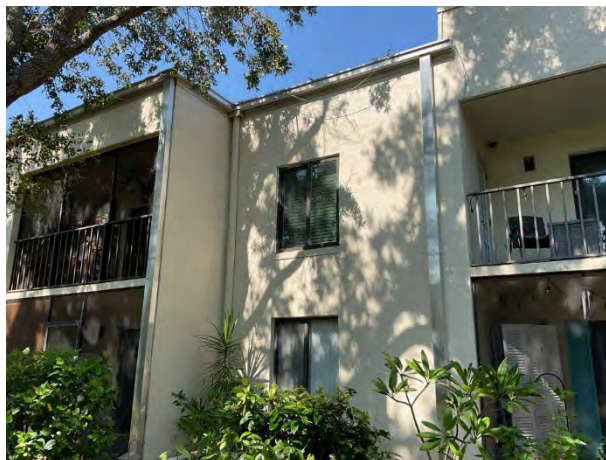
**Condition:** The condition of the gutters and downspouts varies from good to fair. We note isolated debris accumulation and evidence of seam leaks.

**Aluminum gutters and downspouts**

- Clean out debris and leaves that collect in the gutters
- Repair and refasten any loose gutter fasteners
- Repair and seal any leaking seams or end caps
- Verify downspouts discharge away from foundations

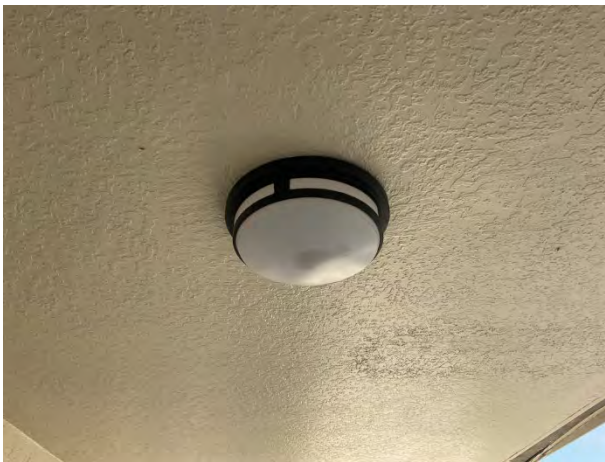
**Condition:** The breezeway light fixtures are in good to fair overall condition. The balcony light fixtures are in fair overall condition.

**Breezeway exterior light fixture**

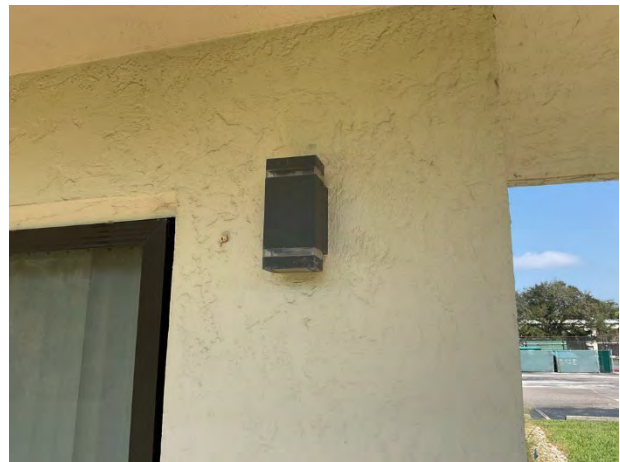
**Balcony exterior light fixture**

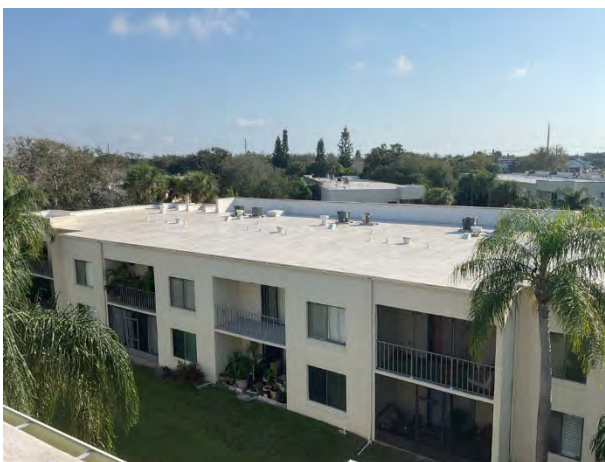
**Modified bitumen roof overview**

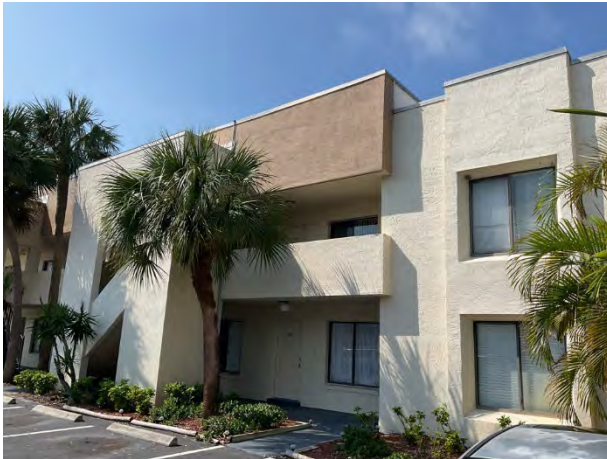
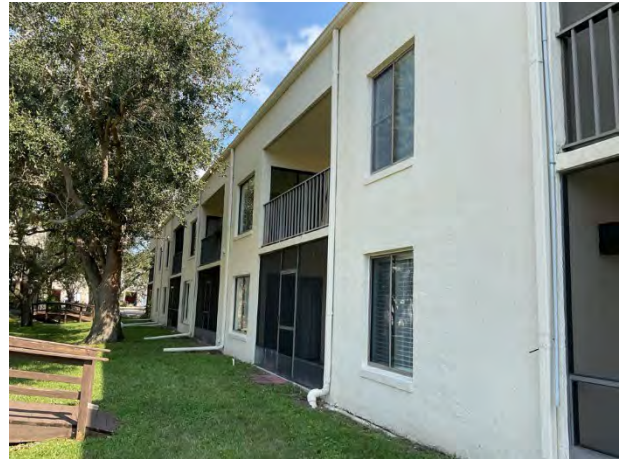
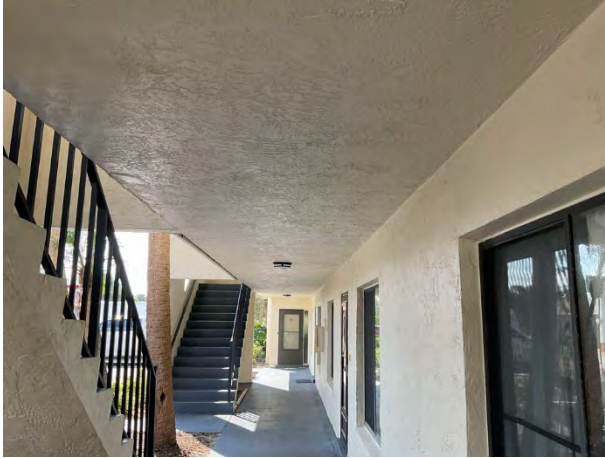
**Condition:** Good to fair overall with stains and finish fade evident. The Board informs us of an increased need for repairs at the breezeway walls which originally included openings for planters

**Stucco wall finishes**

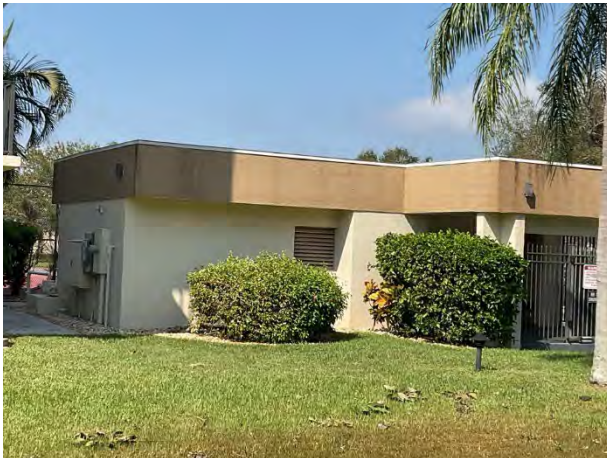
**Stucco wall finishes at pool house**

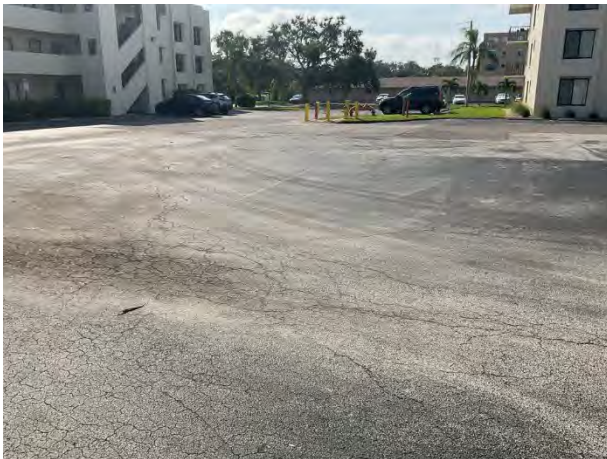
**Condition:** Building 1-6 pavement is good to fair overall and buildings 7-9 pavement is fair to poor overall with cracks, potholes, spalls, upheaval and vehicle stains evident

**Asphalt pavement overview**

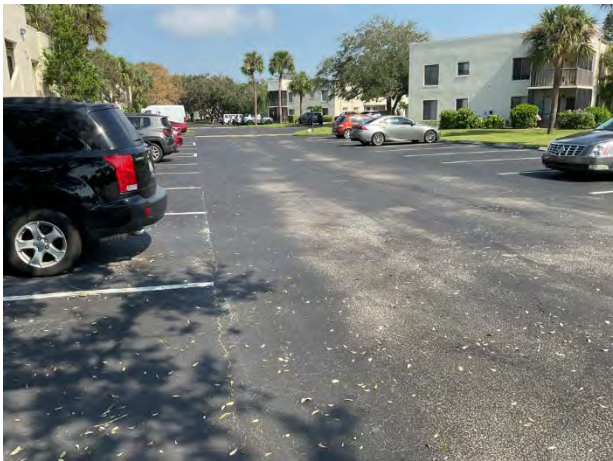
**Asphalt pavement overview**

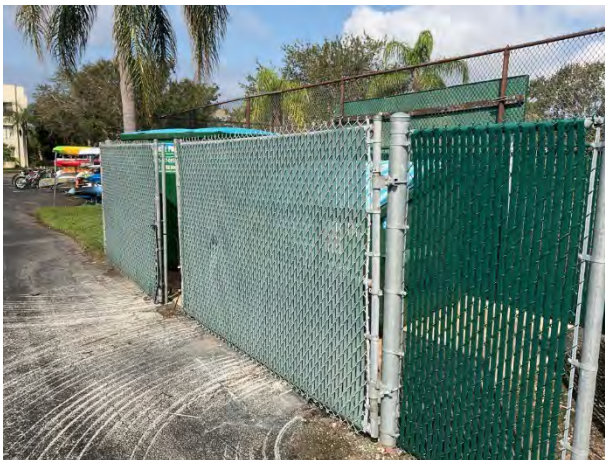
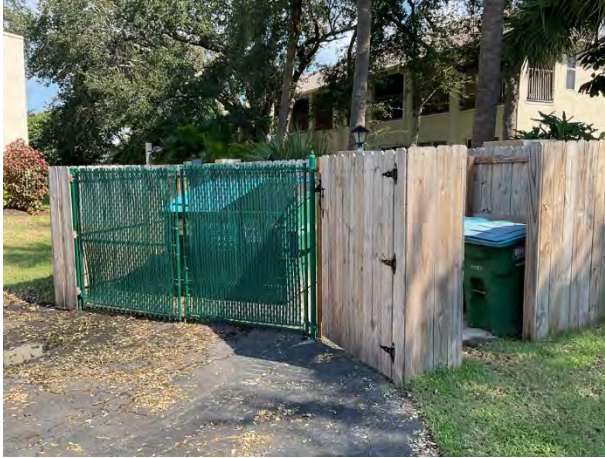
**Fences at trash corral overview**

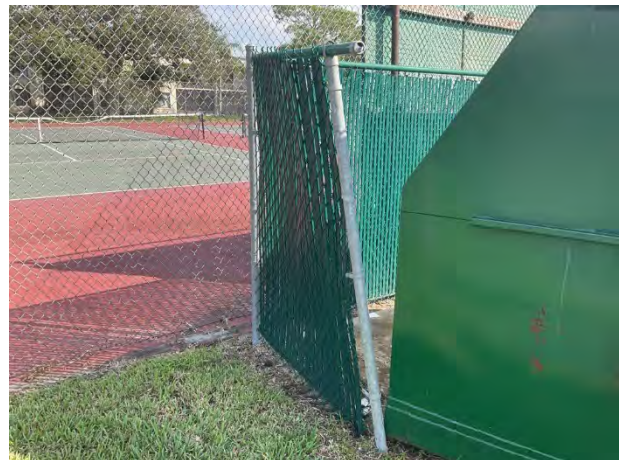
**Condition:** Good to fair overall with warped webbing and leaning sections evident

**Fence leaning section**

- Inspect and repair loose sections, and damage
- Repair leaning sections and clear vegetation from fence areas which could cause damage

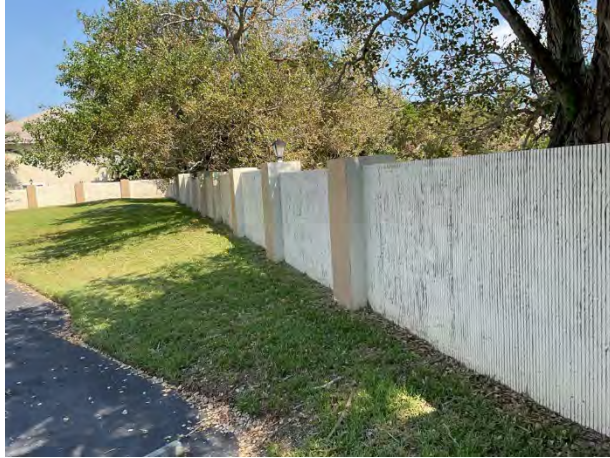
**Condition:** Good to fair overall with cracks evident

**Perimeter wall overview**

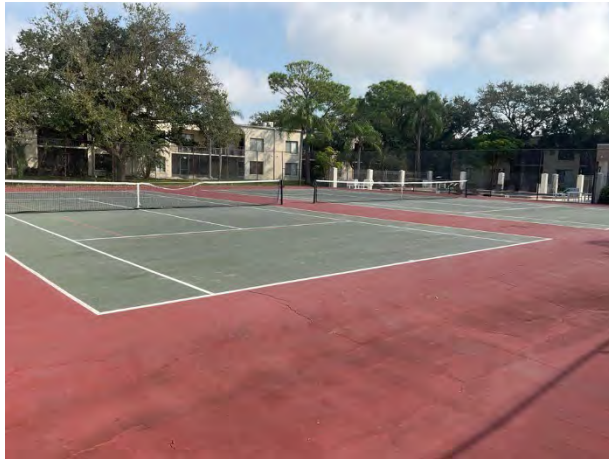
**Condition:** The color coat is in fair condition with finish fade evident. The playing surface is in fair condition with systematic cracks evident.

**Tennis court overview**

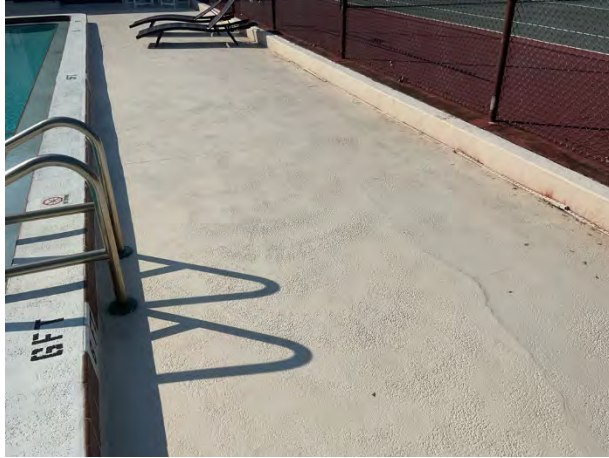
**Condition:** Fair overall with cracks evident

**Concrete deck overview**

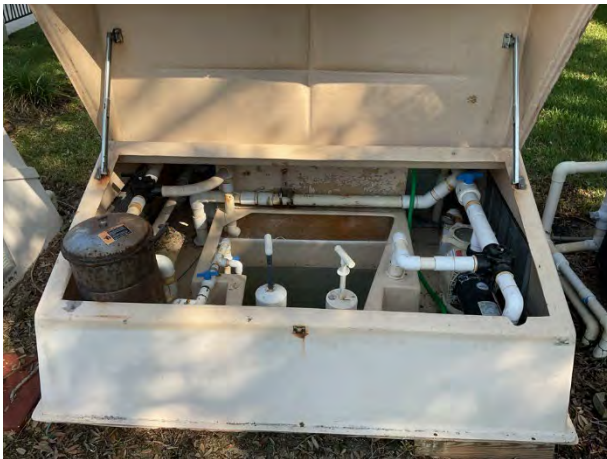
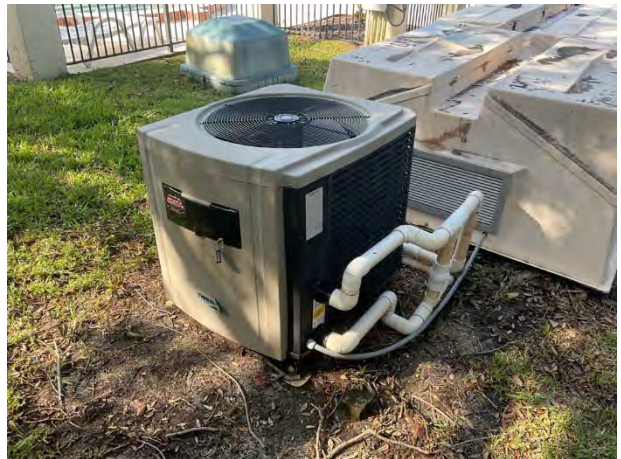
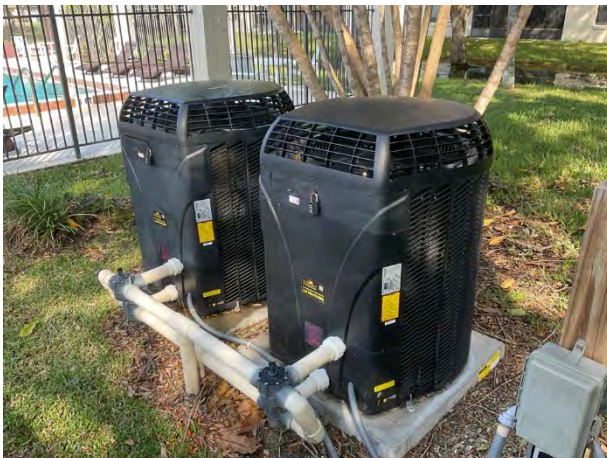
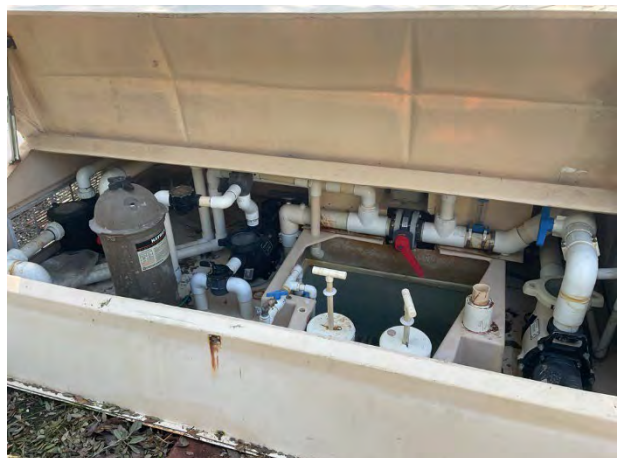
**Condition:** Reported satisfactory

Pool mechanical equipment

**Preventative Maintenance Notes:** We recommend the Association maintain a maintenance contract with a qualified professional and follow the manufacturer's specific recommended maintenance and local, state and/or federal inspection guidelines.

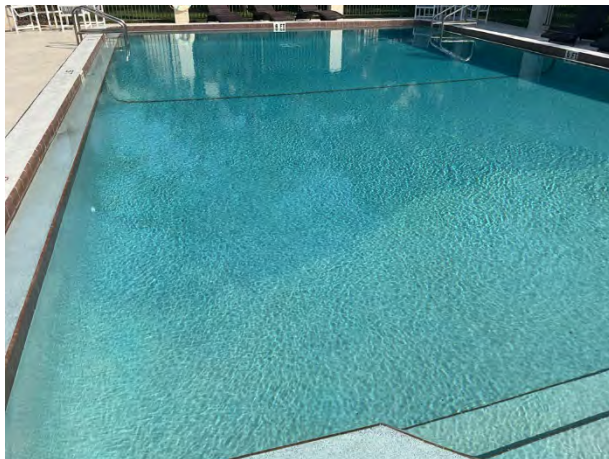
**Condition:** Fair overall with deterioration evident

Pool plaster overview

- Removal and replacement of the plaster finishes
- Partial replacements of the scuppers and coping as needed
- Replacement of tiles as needed
- Replacement of joint sealants as needed
- Concrete structure repairs as needed

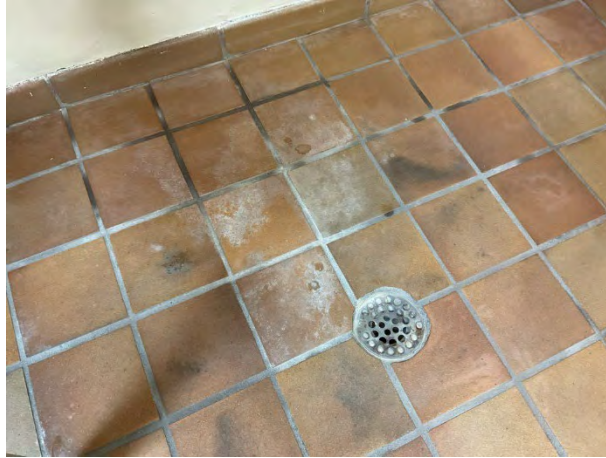
**Condition:** Fair overall with isolated damage, finish deterioration and rust evident

**Tile finish deterioration**
