# Surfside South Condominium Association, Inc.

March 2, 2023 • Madeira Beach, FL

FULL RESERVE STUDY

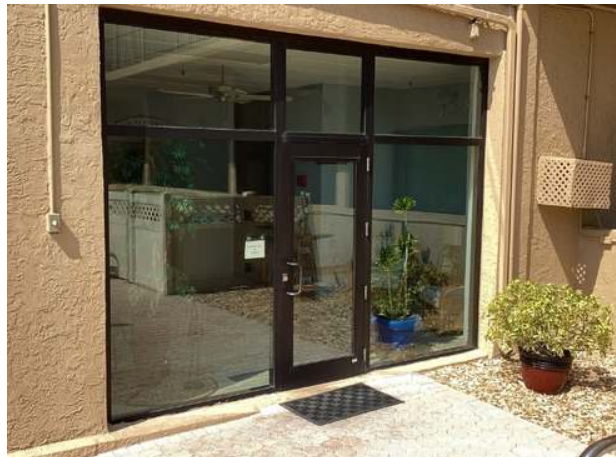
**Common windows and door at lobby**

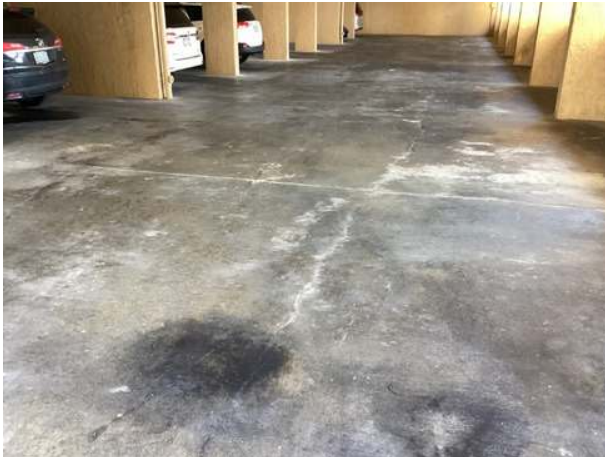
**On-grade concrete garage floor with cracks**

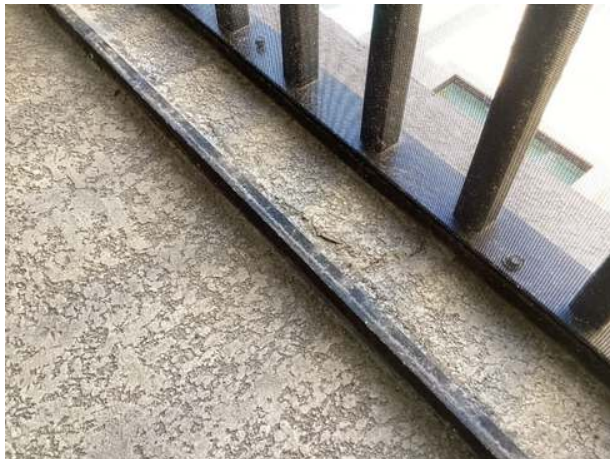
**Coating delamination at unit 204**

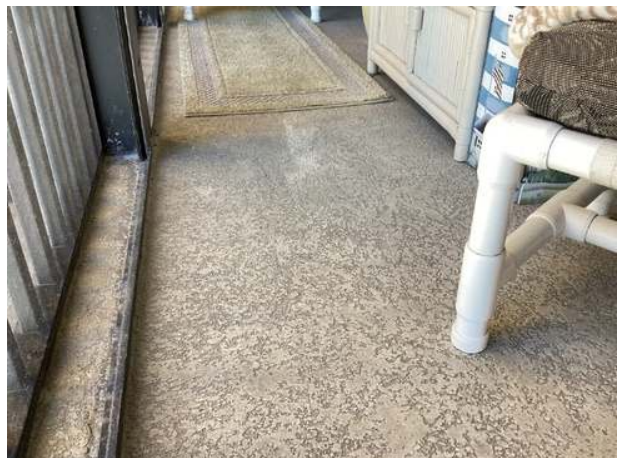
**Concrete balcony at unit 204**

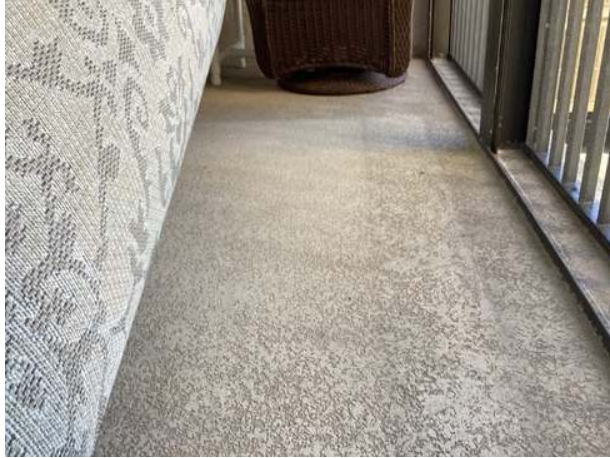
**Concrete balcony at unit 204**

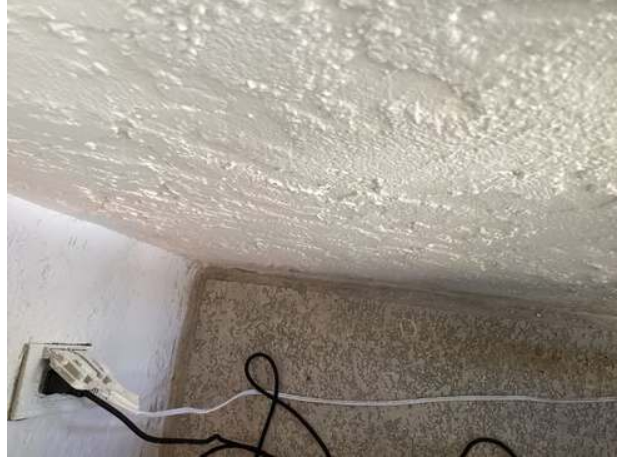
**Sealant at balcony perimeter**

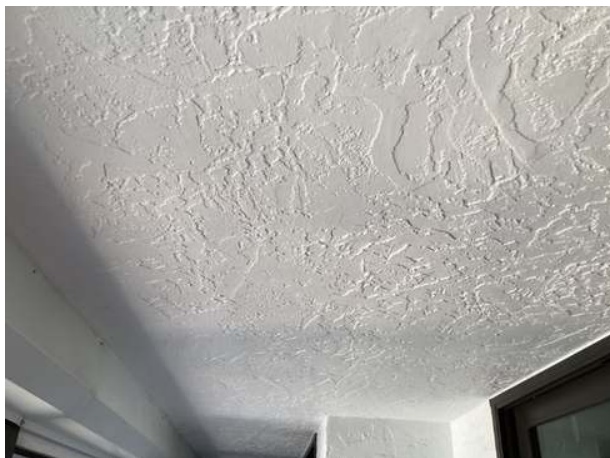
**Unit 304 balcony underside**

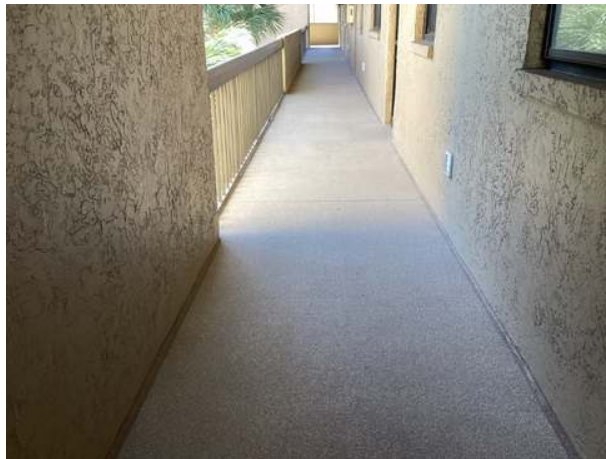
Third floor breezeway at center tower

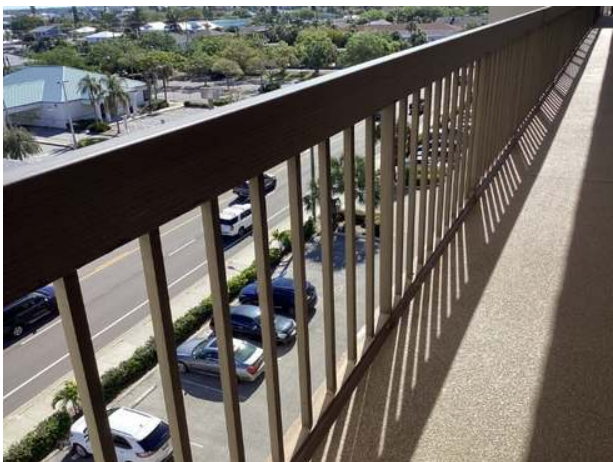
**Aluminum railings at north tower 5th floor breezeway**

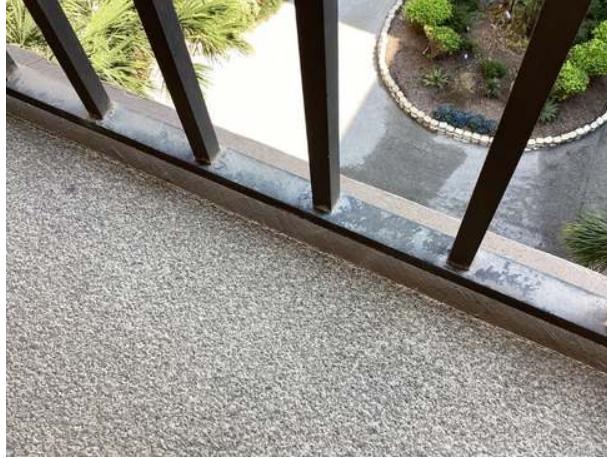
**Railing finish deterioration at fifth floor**

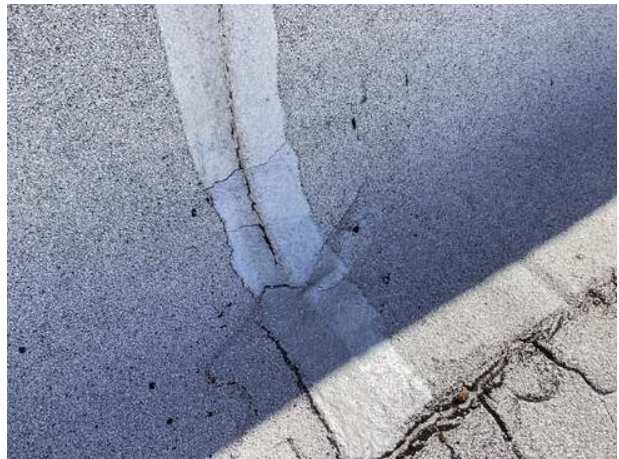
**Membrane tear at south tower west elevation  
parapet**

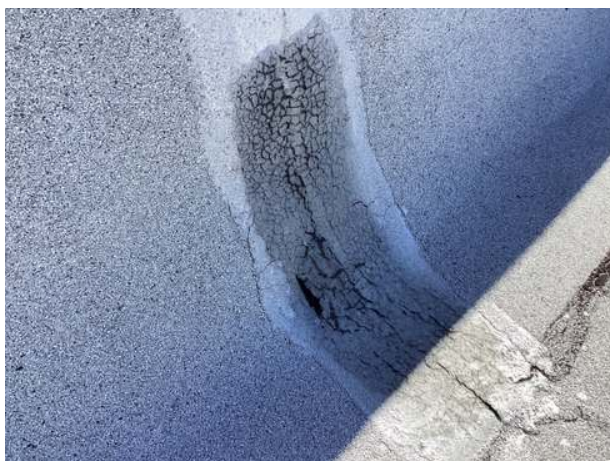
**Membrane tear at south tower west parapet wall**

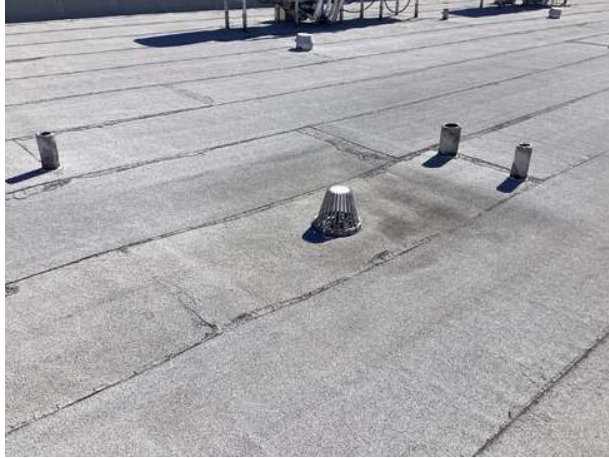
**South tower roof drain**

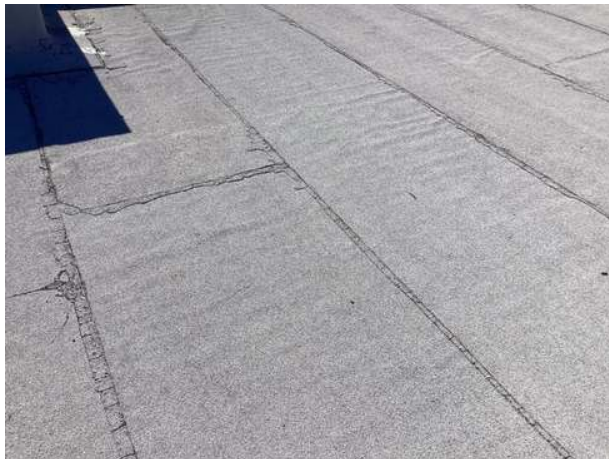
**Wrinkles evident at the south elevation of the south tower**

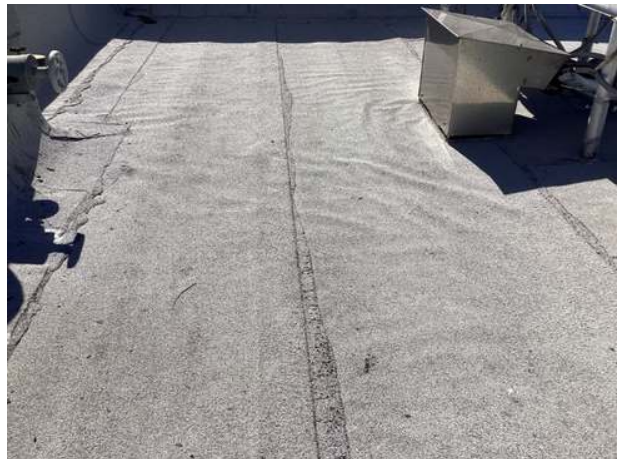
**Wrinkles evident at the south west corner of the south tower roof**

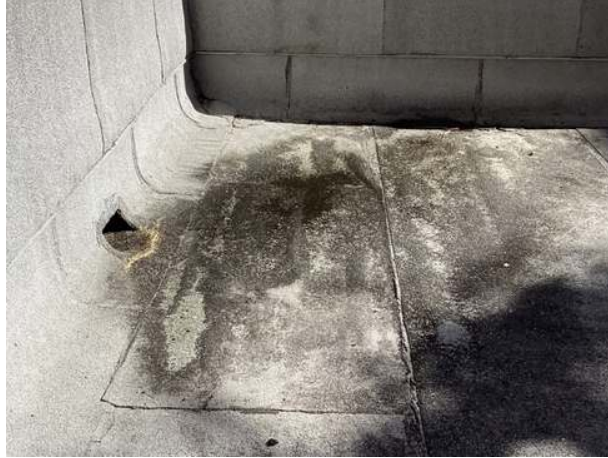
Standing water at the lobby roof

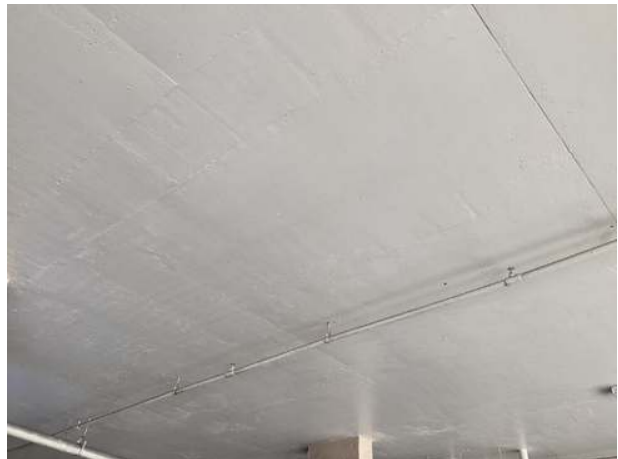
Underside of center tower first floor

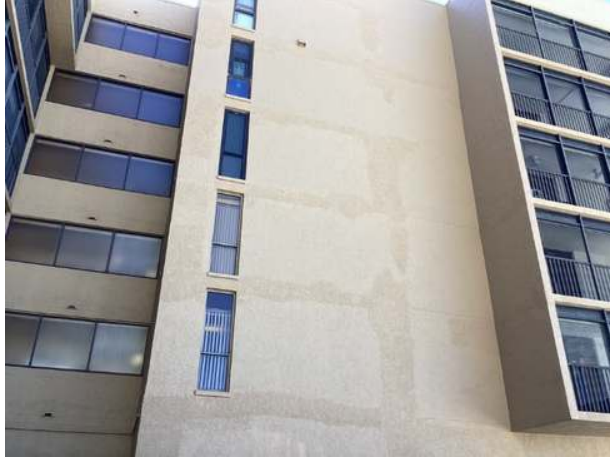
**Inconsistent finishes Evident at the north elevation of the center tower**

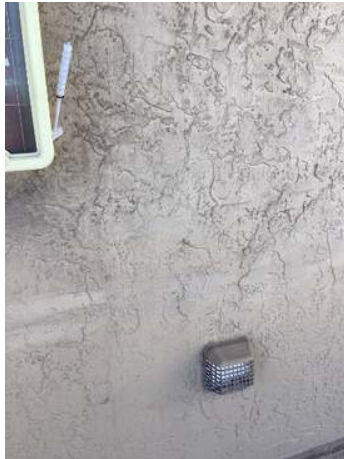
**Stucco cracks in between units 502 and 503**

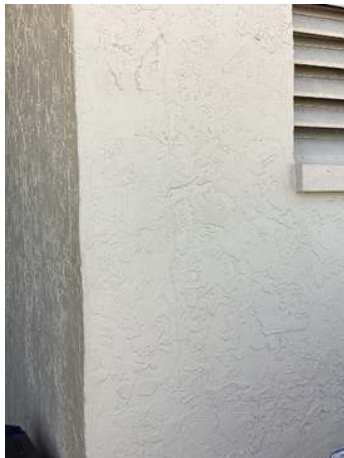
**Stucco cracks near generator room entrance**

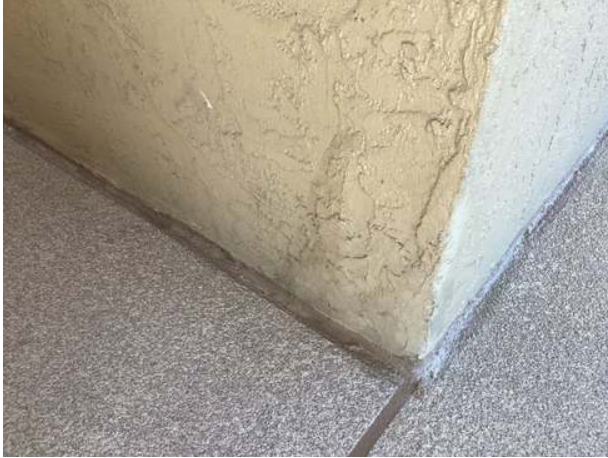
**Stucco deterioration outside fourth floor north tower trash room**

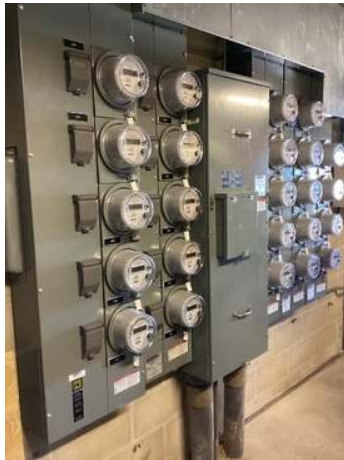
**History:** Primarily varies to construction. The meters in the mechanical room at the center of the building are exposed to coastal air. They were replaced in 2020 for \$30,500. The other meters and main panels are in satisfactory operational condition.

**Electrical meters for building b center building recent replacements**

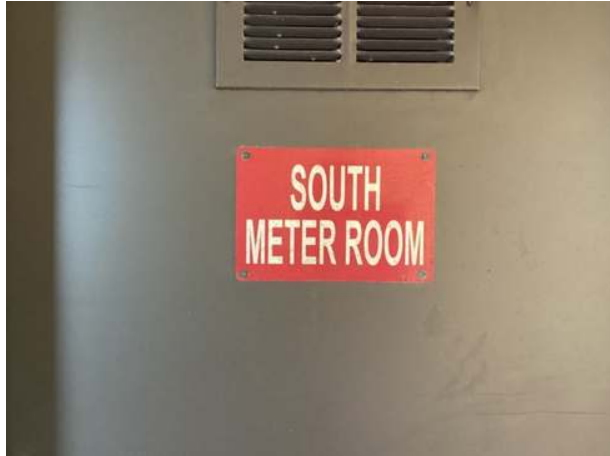
**Electrical room label**

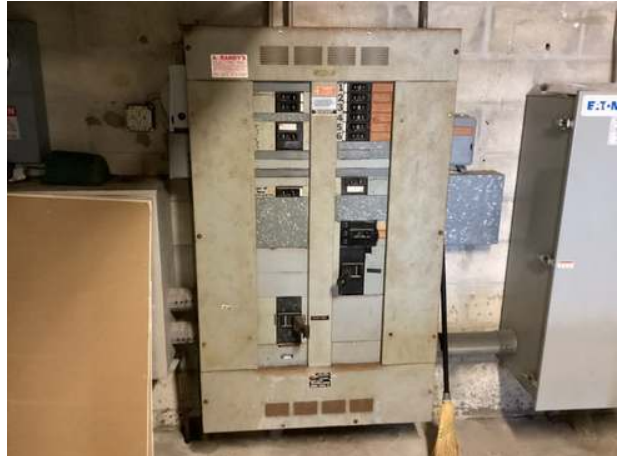
**Electrical system main panel**

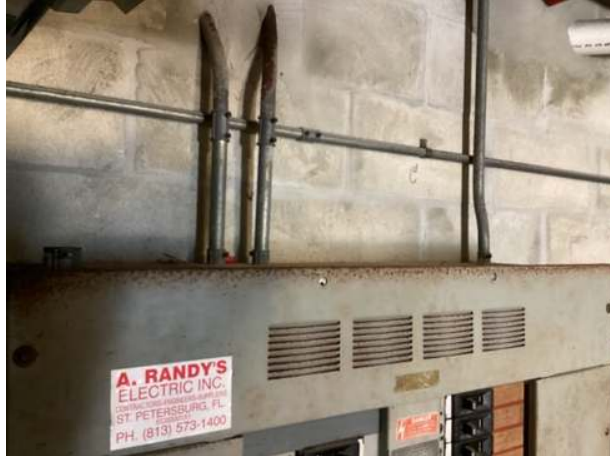
- Rust at electrical panels was present. This indicates a presence of moisture or water which can result in unsafe conditions. The Association should further explore the cause of the rust and repair or replace the rusted panels.
- No apparent water was observed in or near the electrical rooms.

**Minor rust evident at common area switchgear**

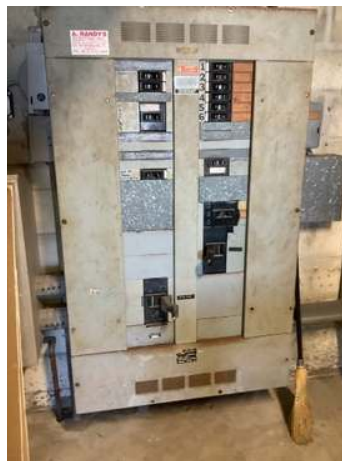
**Switchgear for common areas**

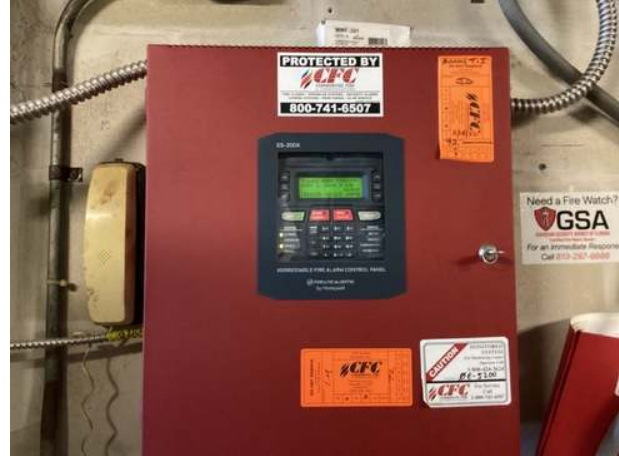
**Conditions:** Reported satisfactory without operational deficiencies. The life safety system was last inspected on February 18, 2022. The life safety system was yellow tagged during the most recent inspection, as deficiencies were noted that must be remedied.

**Control panel reports trouble in the system**

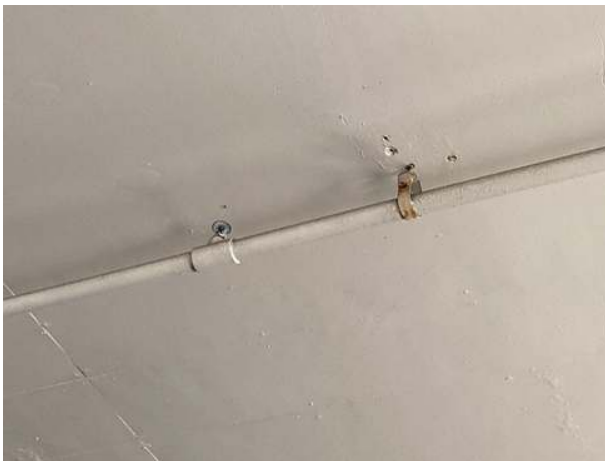
**Condition:** Fair overall with pipe rust evident.

**Rust at pipes**

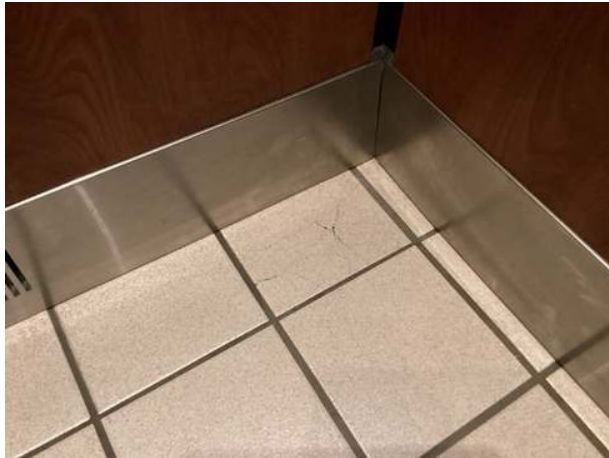
**Condition:** Good to fair overall with isolated tile damage

Cracked elevator cab tile

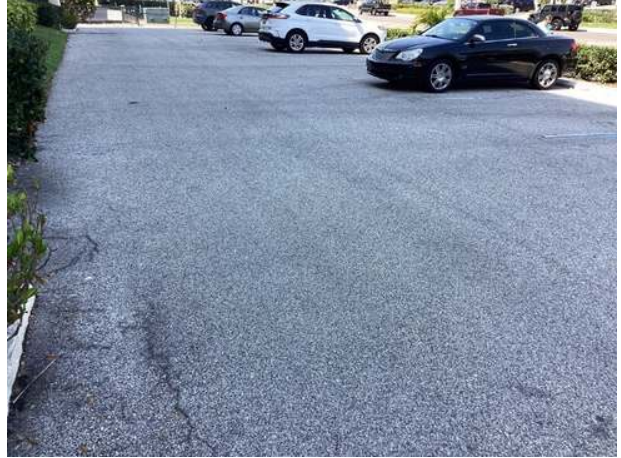
**Condition:** Fair overall with periodic cracks, settlement and patches evident.

**Asphalt pavement parking lot overview**

The manner of repaving is either a mill and overlay or total replacement. A mill and overlay is a method of repaving where cracked, worn and failed pavement is mechanically removed or milled until sound pavement is found. A new layer of asphalt is overlaid atop the remaining base course of pavement. Total replacement includes the removal of all existing asphalt down to the base course of aggregate and native soil followed by the application of two or more new lifts of asphalt. We recommend mill and overlayment on asphalt pavement that exhibits normal deterioration and wear. We recommend total replacement of asphalt pavement that exhibits severe deterioration, inadequate drainage, pavement that has been overlaid multiple times in the past or where the configuration makes overlayment not possible. Based on the apparent visual condition and configuration of the asphalt pavement, we recommend the total replacement method of repaving at Surfside South.

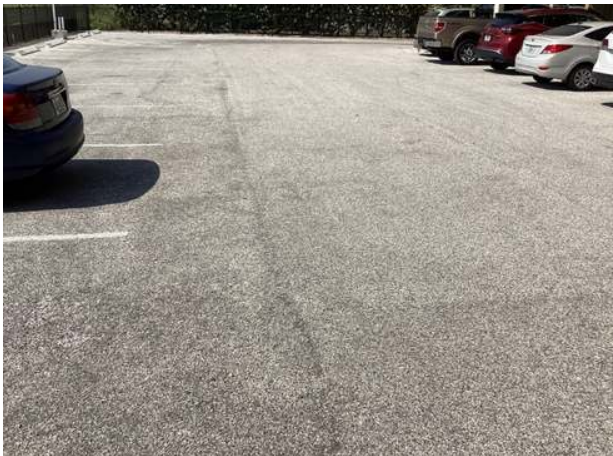
**Asphalt pavement parking lot overview**

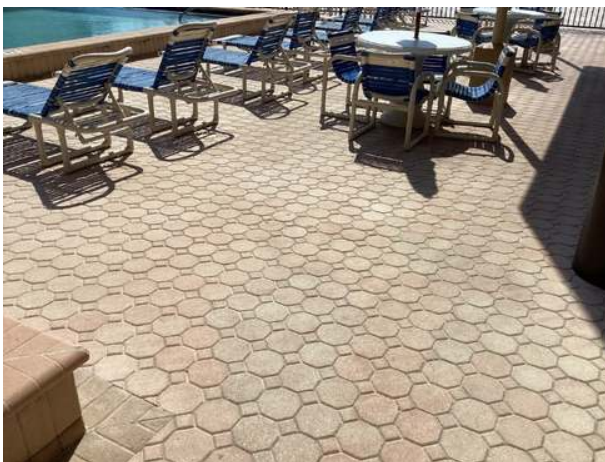
**Condition:** Good to fair overall with isolated settlement evident.

Paver pool deck overview

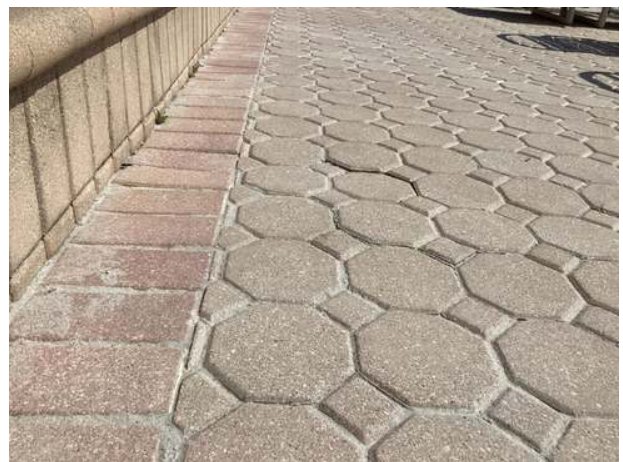
Minor paver settlement

- Annually:
  - o Inspect and repair settlement, trip hazards and significant paver spall
  - o Reset and/or reseal damaged pavers as necessary
  - o Periodically clean and remove overgrown vegetation as needed

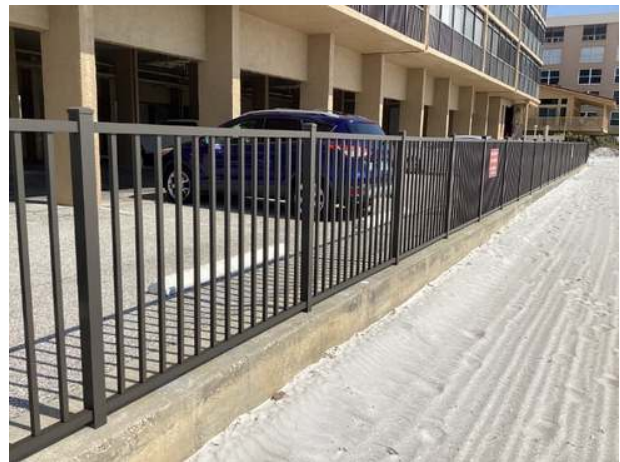
**Condition:** Good to fair overall

Aluminum fence at southwest perimeter

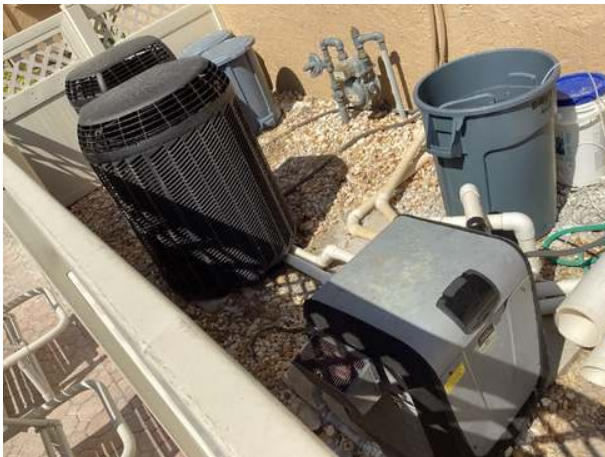
**Condition:** Reported satisfactory without operational deficiencies

Pool and spa heaters

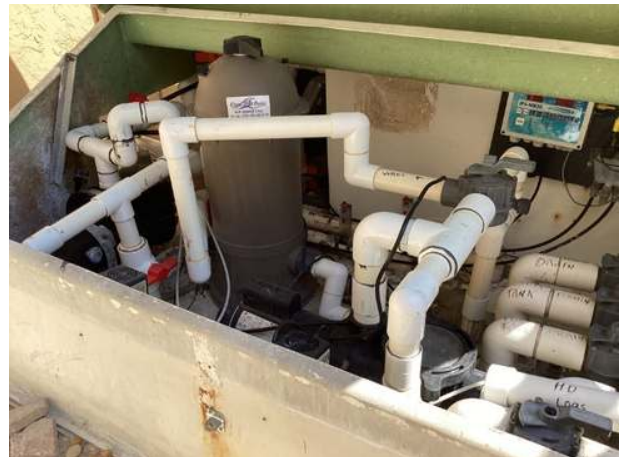
Pool mechanical equipment

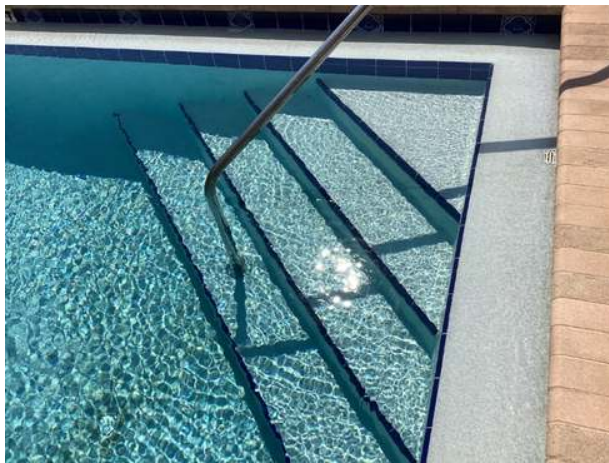
**Condition:** Good to fair overall with discoloration evident at the spa.

Pool plaster finish with tile perimeter

- Removal and replacement of the plaster finishes
- Partial replacements of the scuppers and coping as needed
- Replacement of tiles as needed
- Replacement of joint sealants as needed
- Concrete structure repairs as needed
