# Costa Del Sol

## Condominium Association, Inc.

Inspected: July 29, 2024 • Revised on: November 19, 2024  
Cape Canaveral, FL

**STRUCTURAL INTEGRITY  
RESERVE STUDY**

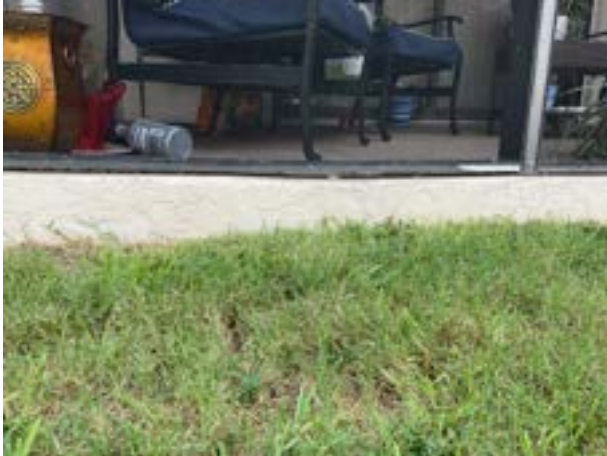
**Condition:** Fair overall with settled concrete, cracks, concrete deterioration, coating deterioration and rust stains evident. We note the following:

**Settled concrete**

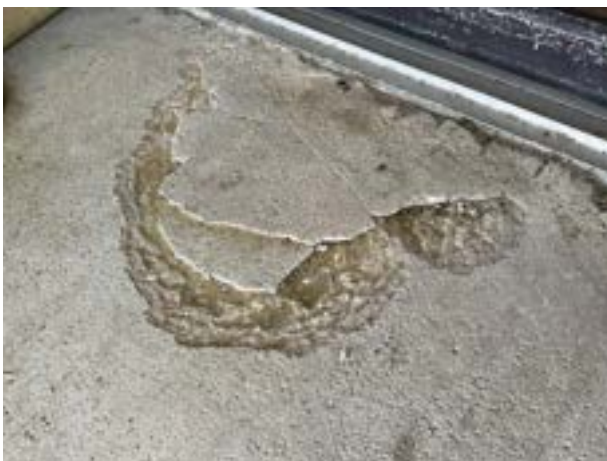
**Concrete deterioration**

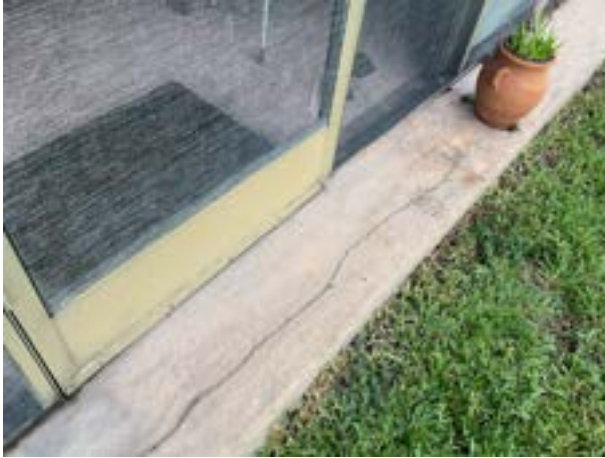
**Concrete crack**

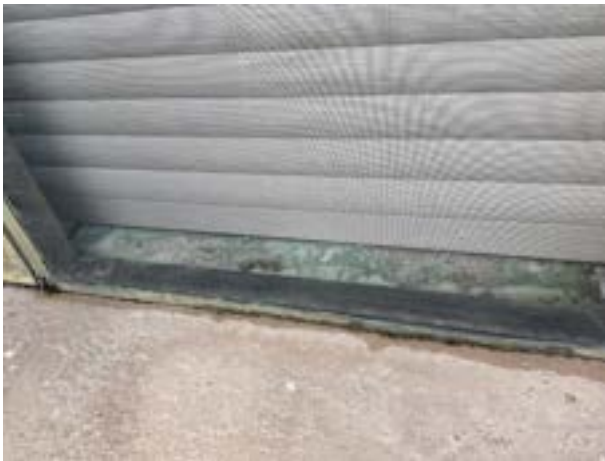
**Coating deterioration**

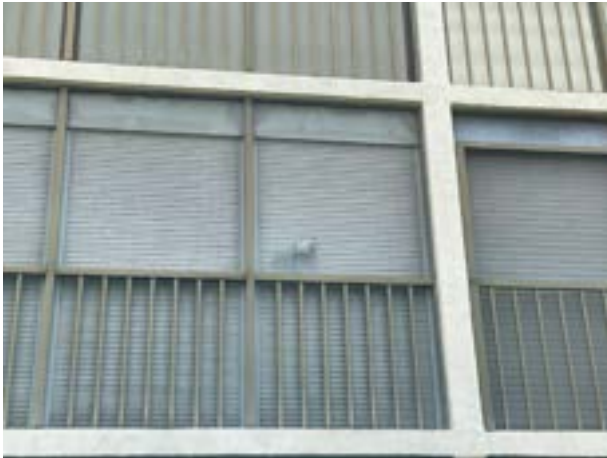
**Torn Screen**

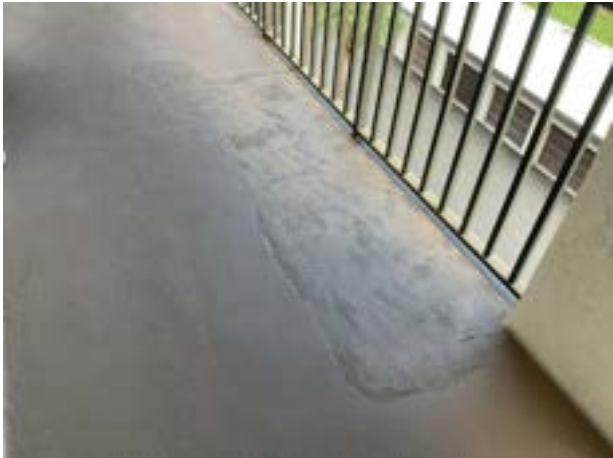
**Evidence of partial replacement**

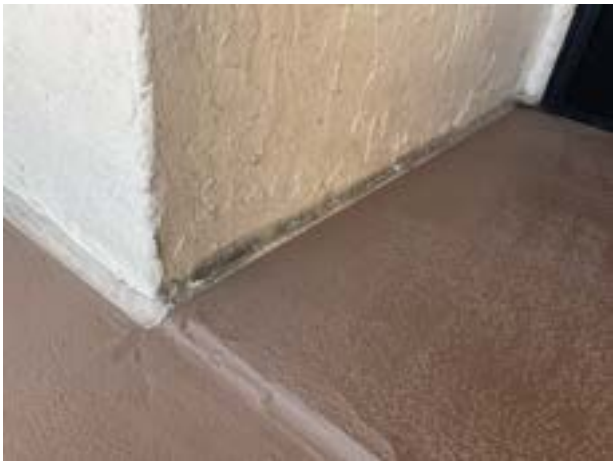
**Sealant deterioration**

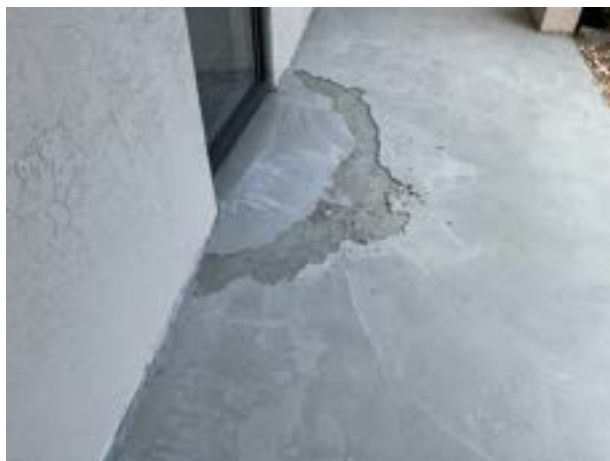
**Concrete deterioration**

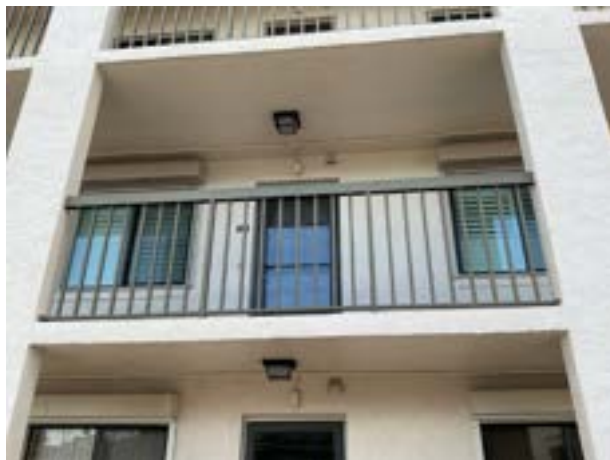
**Railing finish fade**

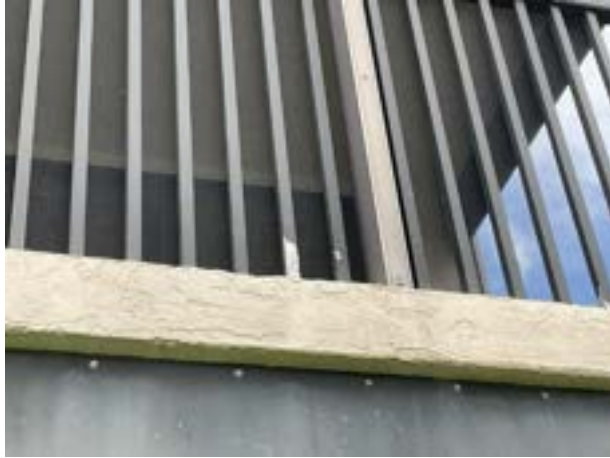
**Railing finish fade**

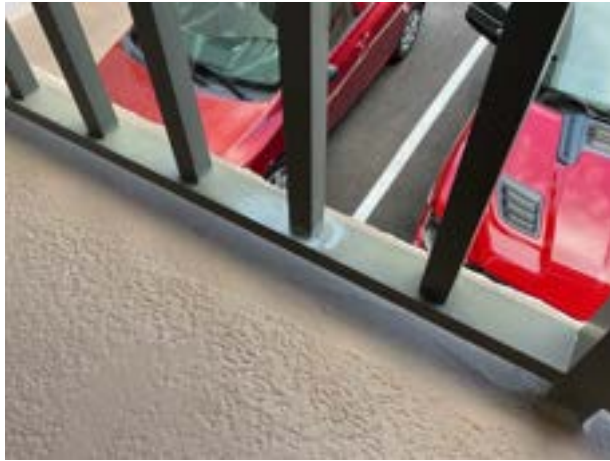
**Corrosion**

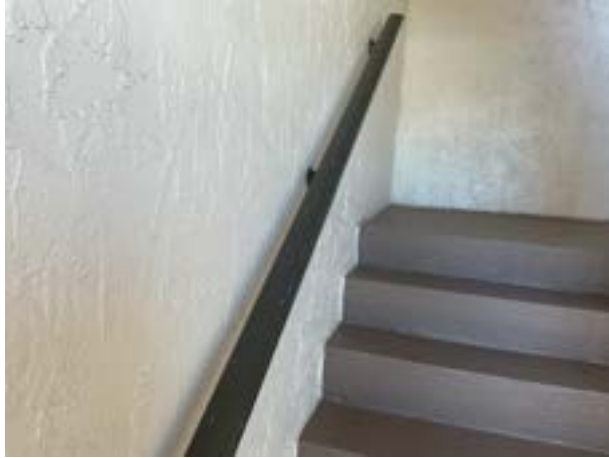
**Finish deterioration**

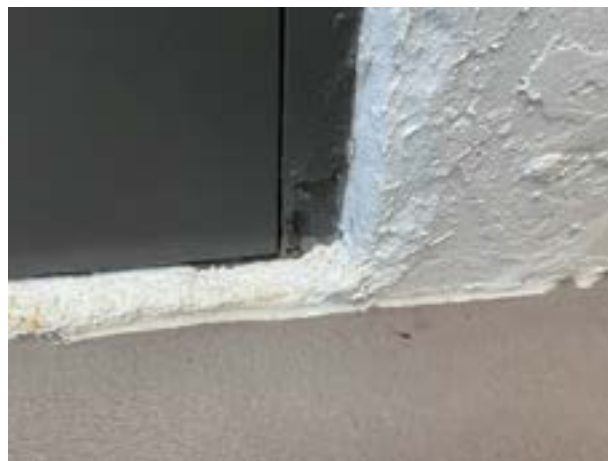
**Condition:** Fair overall with rusting and frame deterioration evident

Frame deterioration

- Inspect and repair any damage, base corrosion or alignment issues
- Replace deteriorated hardware and loose weather stripping
- Periodic touch-up paint finish applications as needed

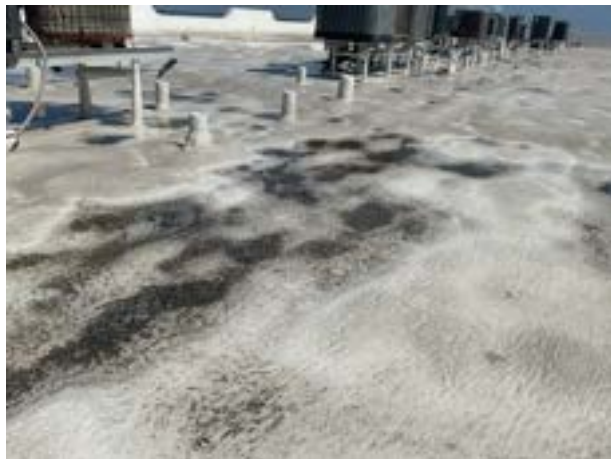
**Condition:** Fair overall with standing water, damage and deterioration evident. Management and the Board do not report a history of leaks.

**Standing water**

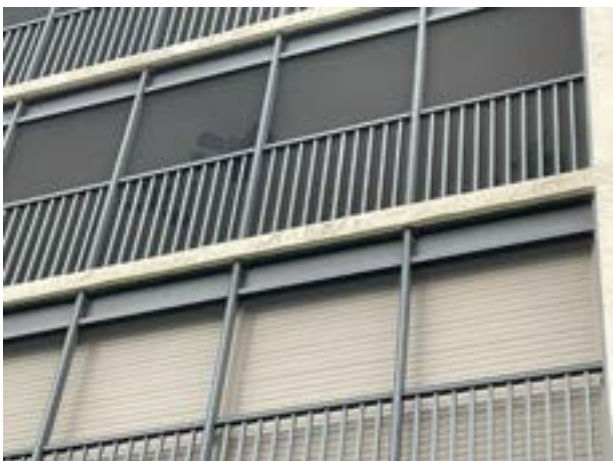
**Mildew build up**

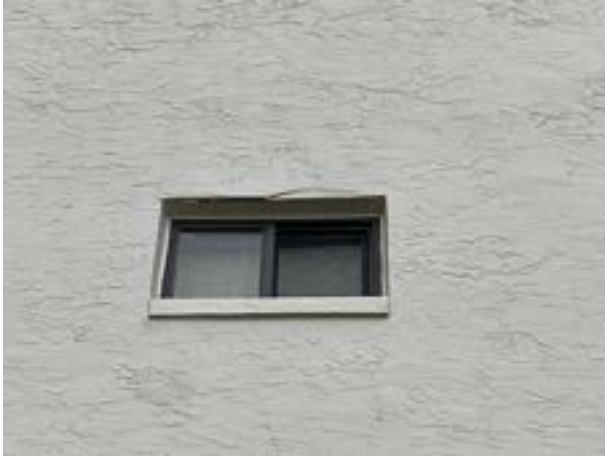
**Condition:** Fair overall with cracks, spalls, rust stains and deterioration evident. We note the following:

**Stucco cracks**

- Complete inspection of the stucco
- Crack repairs as needed (Each paint product has the limited ability to cover and seal cracks but we recommend repair of all cracks which exceed the ability of the paint product to bridge.)
- Replacement of up to one percent (1%), of the stucco walls (The exact amount of area in need of replacement will be discretionary based on the actual future conditions and the desired appearance.)
- Replacement of up to one percent (1%) of the sealants in coordination with each paint finish application.

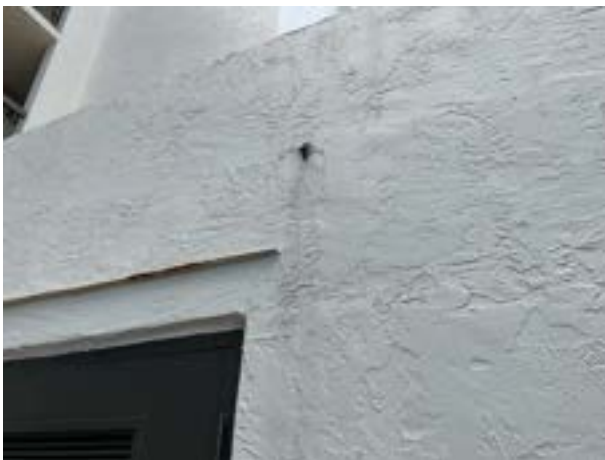
**Drainage stains**

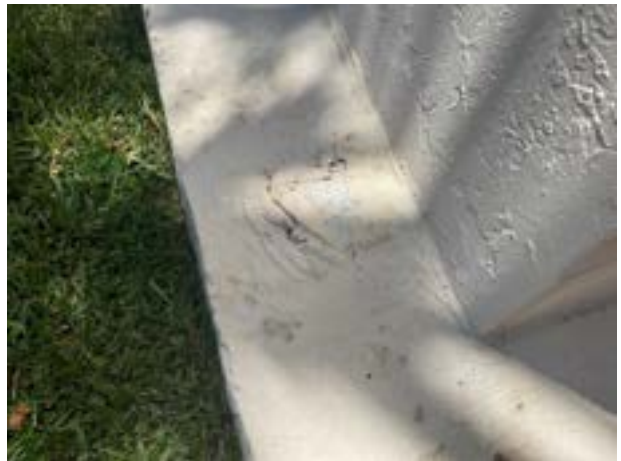
**Peeling finishes**

Correct and complete preparation of the surface before application of the paint finish maximizes the useful life of the paint finish and surface. The contractor should remove all loose, peeled or blistered paint before application of the new paint finish. The contractor should then power wash the surface to remove all dirt and biological growth. Water-soluble cleaners that will not attack Portland cement are acceptable for removing stains.

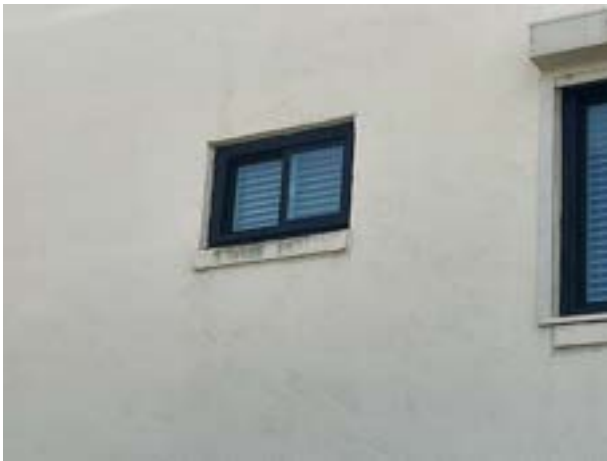
**Stains**

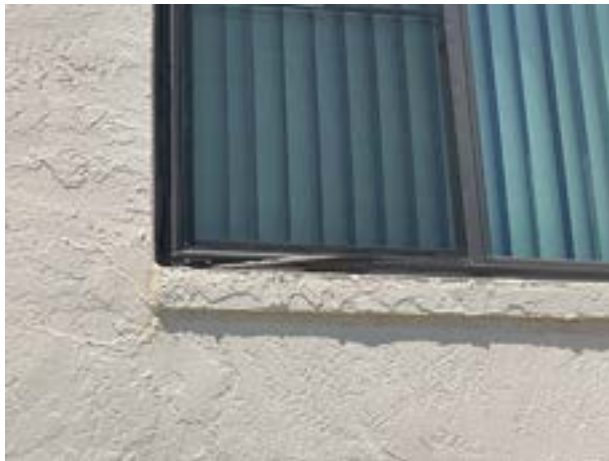
**Condition:** Good to fair overall with weather stripping and frame finish deterioration evident. We note the following:

**Weather stripping**

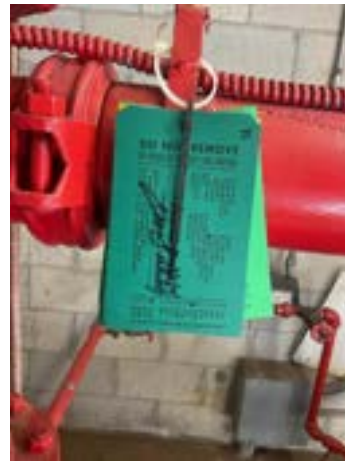
- July 2024 inspection date
- Faded tag coloring
- Water leaking

**Inspection tags**

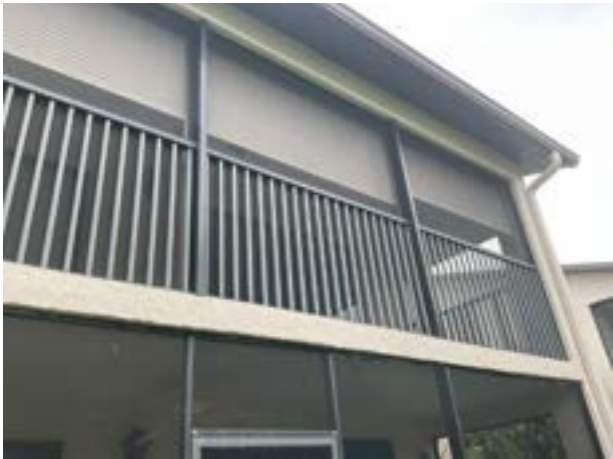
**Condition:** Good to fair overall with finish deterioration evident.

**Balcony railings with integrated screen frame**

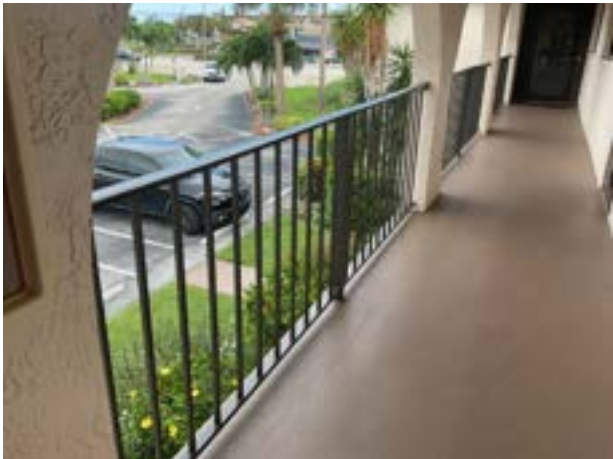
**Condition:** Good to fair overall with no significant deterioration evident.

**Railing finish fade**

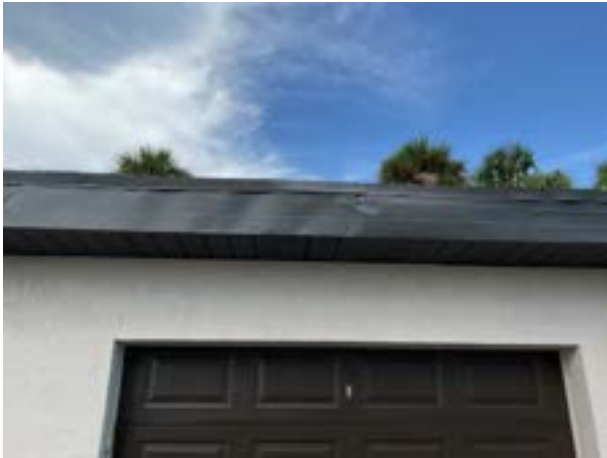
**Damaged fascia**

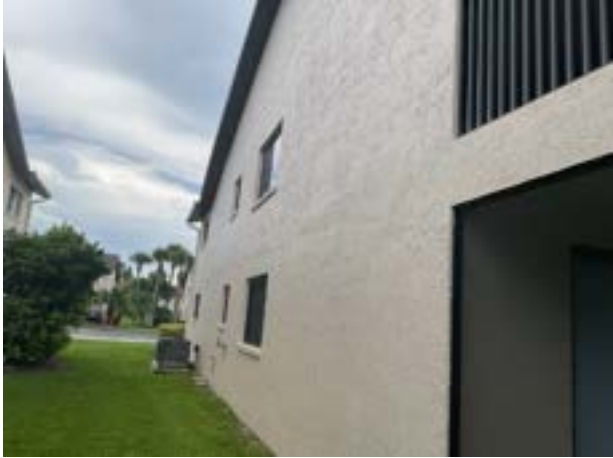
**Condition:** Good to fair overall with stucco cracks evident.

**Finish deterioration**

- Complete inspection of the stucco
- Crack repairs as needed (Each paint product has the limited ability to cover and seal cracks but we recommend repair of all cracks which exceed the ability of the paint product to bridge.)
- Replacement of up to one percent (1%), of the stucco walls (The exact amount of area in need of replacement will be discretionary based on the actual future conditions and the desired appearance.)
- Replacement of up to thirty-three percent (33%) of the sealants in coordination with each paint finish application.

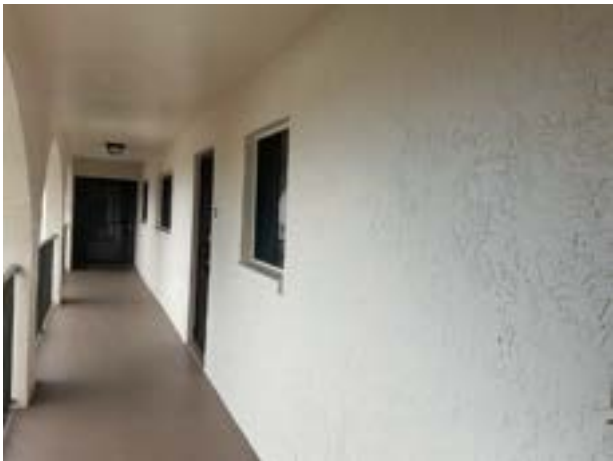
**Stains**

Correct and complete preparation of the surface before application of the paint finish maximizes the useful life of the paint finish and surface. The contractor should remove all loose, peeled or blistered paint before application of the new paint finish. The contractor should then power wash the surface to remove all dirt and biological growth. Water-soluble cleaners that will not attack Portland cement are acceptable for removing stains.

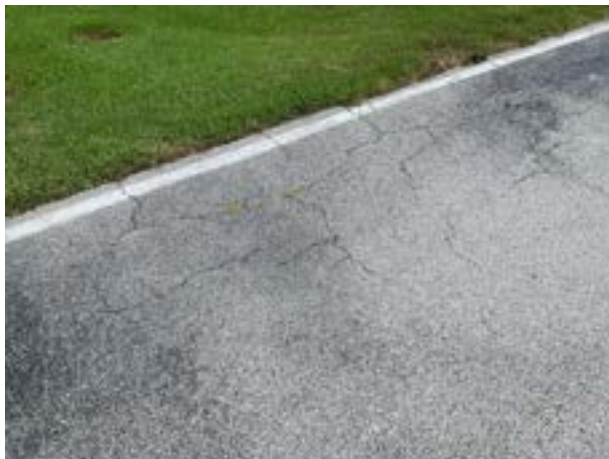
**Condition:** Good to fair overall with cracks, vehicle stains and deterioration evident

**Pavement cracks**

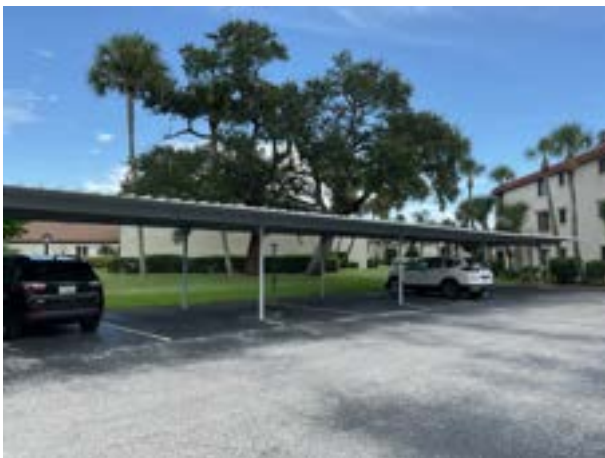
**Condition:** Fair overall with rusted metal frames evident

**Carport overview**

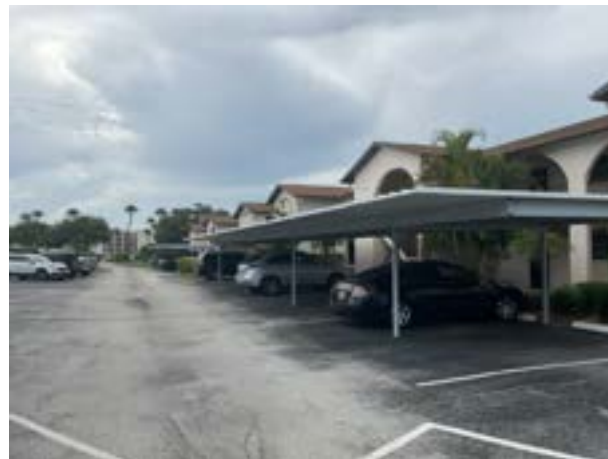
**Carport at 2 story buildings**

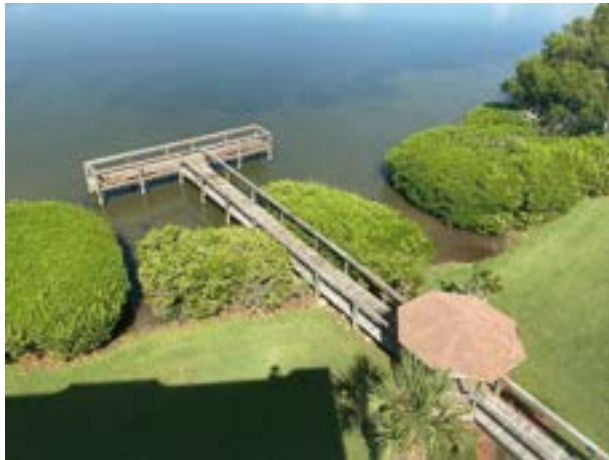
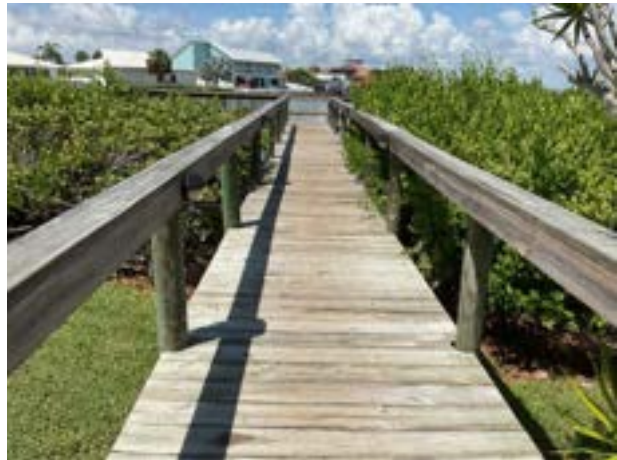
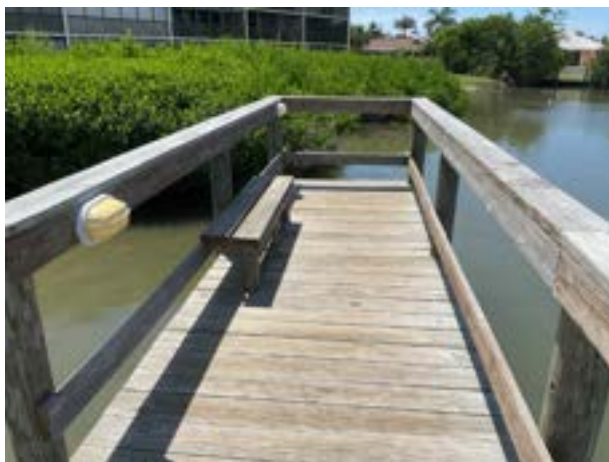
**Condition:** Good to fair overall with splintered wood, settled boards and missing boards evident

Dock overview

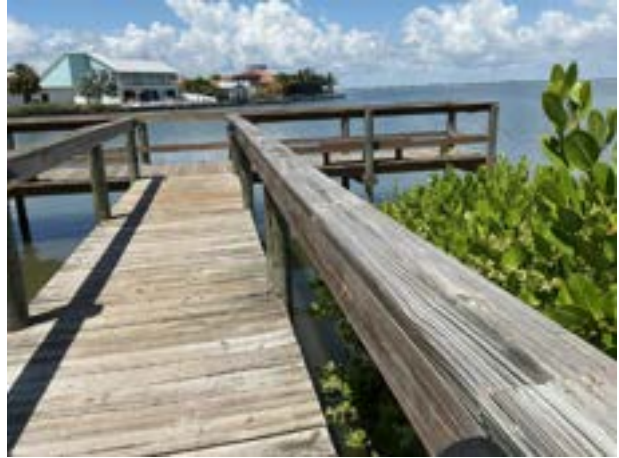
**Railing**

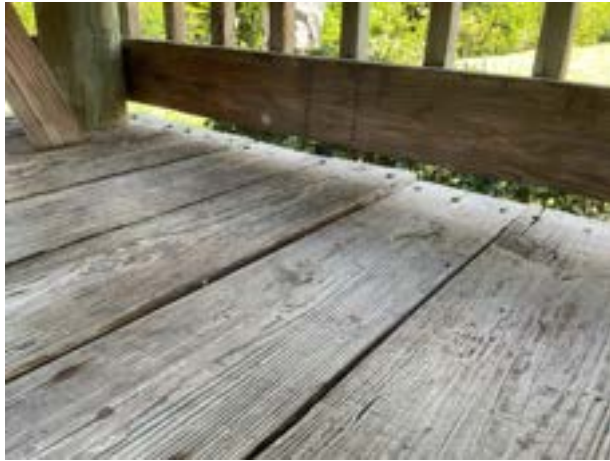
**Settled board**

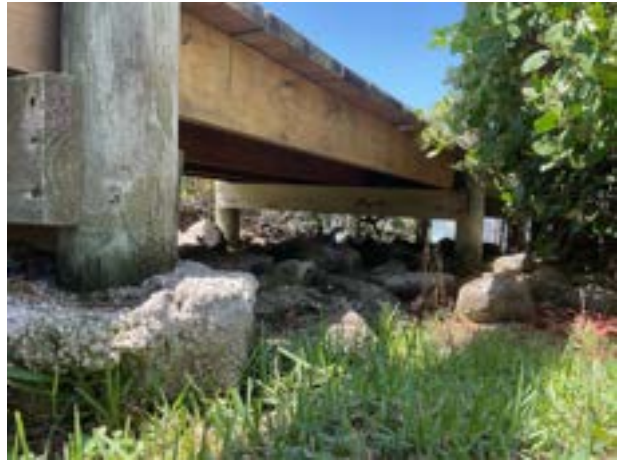
**Dock structure**

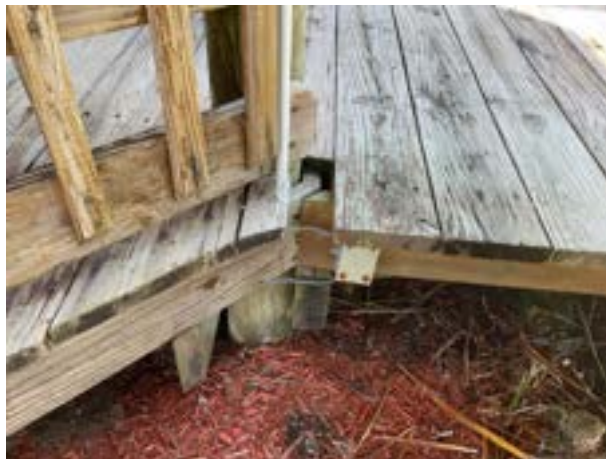
**Missing board**

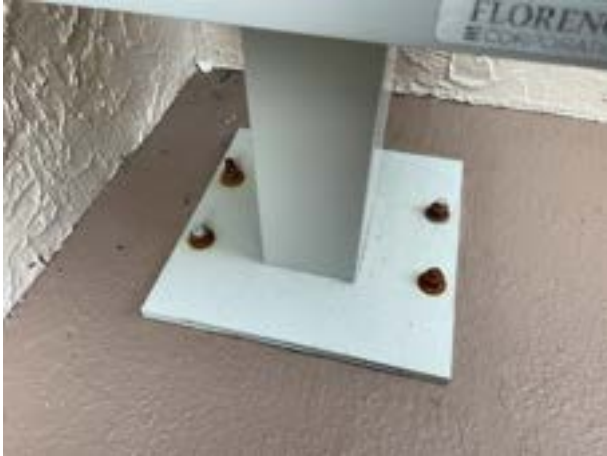
**Condition:** Good to fair overall with rusted fasteners evident

**Rusted fasteners**

- As-needed:
  - Inspect and repair damage, vandalism, and finish deterioration
  - Verify posts are anchored properly

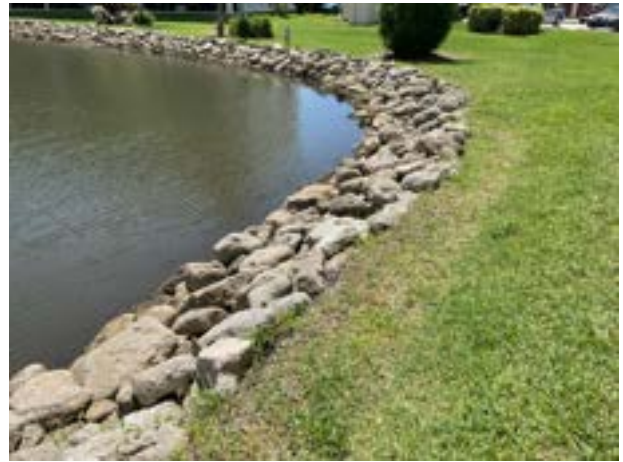
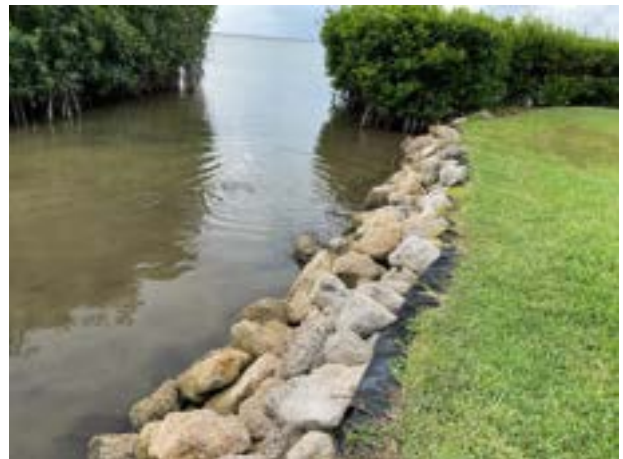
**Rip rap shoreline**

**Expenditure Detail Notes:** Expenditure timing and costs are depicted in the **Reserve Expenditures** table in Section 3. We recommend the Association plan to install a combination of plantings and rip rap around the pond along 165 linear feet, or approximately fifteen percent (15%), of the shoreline per event.

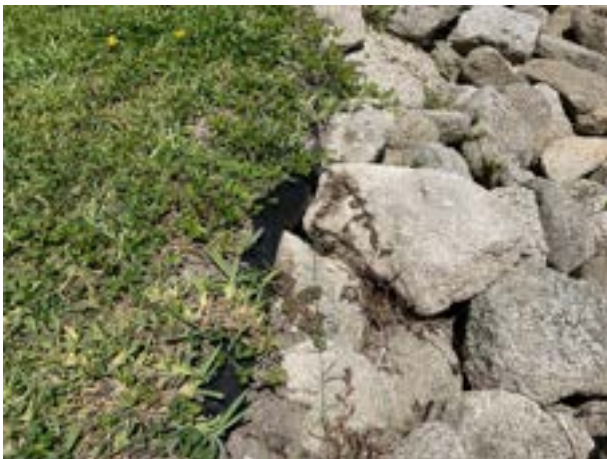
**Geotech fabric**

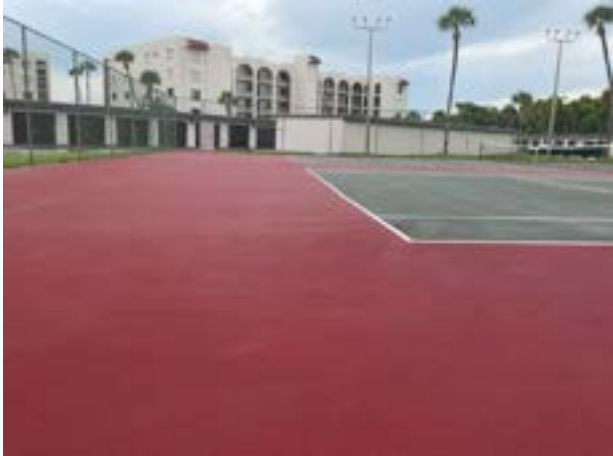
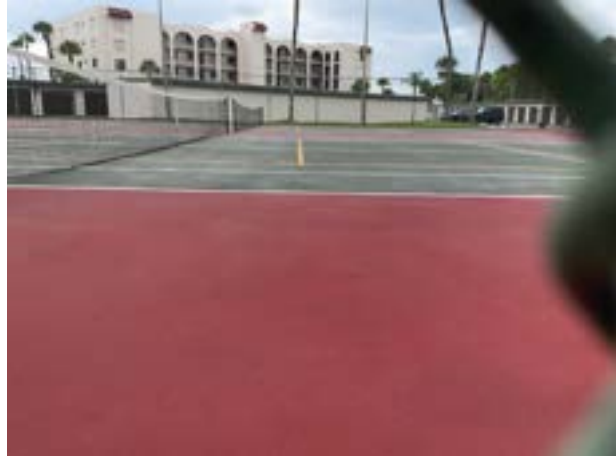
**Condition:** Good to fair overall with surface cracks and edge deterioration evident

**Surface cracks**

**Preventative Maintenance Notes:** Prior to the application of the color coat, the Association should require the contractor to rout and fill all cracks with hot emulsion. This deters water infiltration and further deterioration of the asphalt playing surface. We note the following select recommended preventative maintenance activities to maximize the remaining useful life:

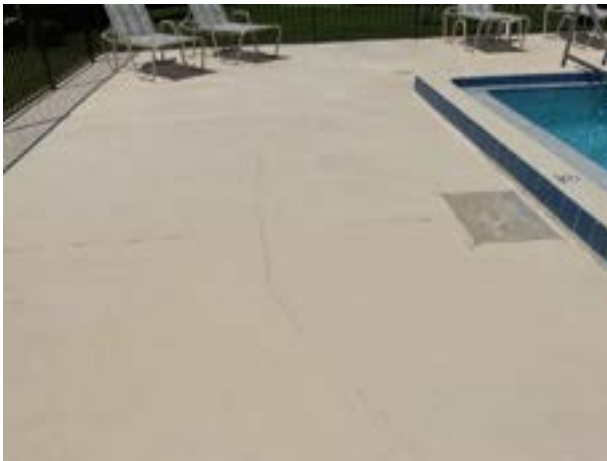
**Condition:** Fair overall with cracks and deterioration evident

**Concrete cracks**

- Selective cut out and replacements of up to ten percent (10%) of concrete
- Crack repairs as needed
- Mortar joint repairs
- Caulk replacement
- Coating replacement

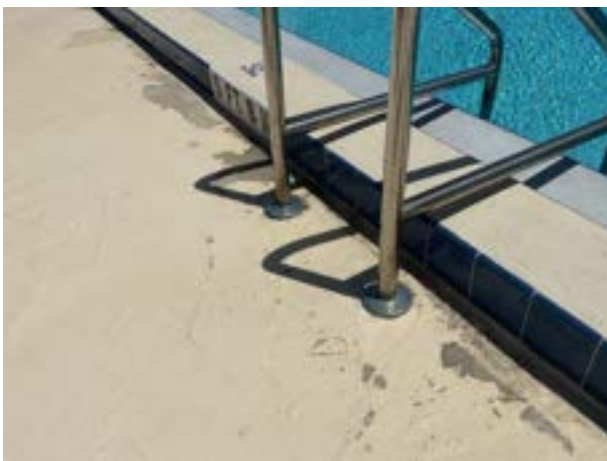
**Finish deterioration**

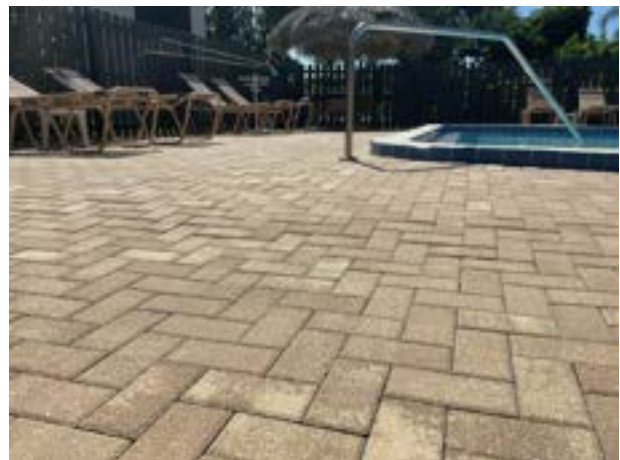
**Condition:** Good to fair overall with paver settlement evident

**Paver settlement**

- Annually:
  - Inspect and repair settlement, trip hazards and significant paver spall
  - Reset and/or reseal damaged pavers as necessary
  - Periodically clean and remove overgrown vegetation as needed

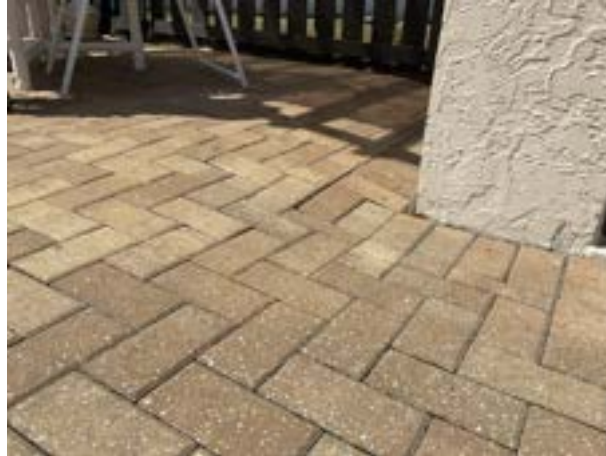
**Paver settlement**

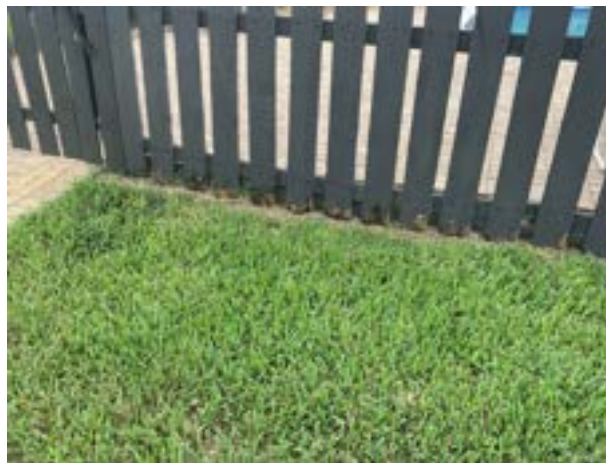
**Leaning section**

- Annually:
  - Inspect and repair loose sections, finish deterioration and damage
  - Repair leaning sections and clear vegetation from fence areas which could cause damage

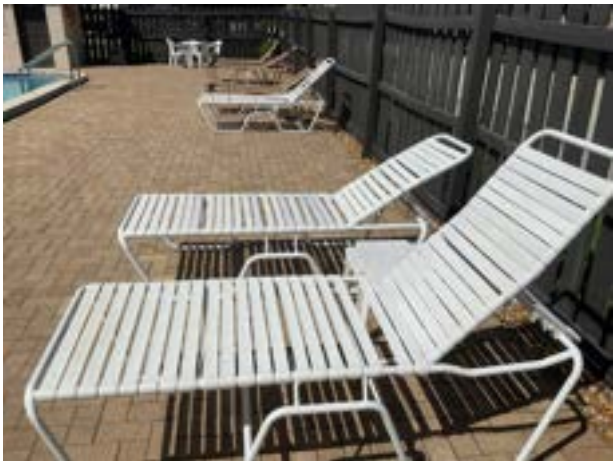
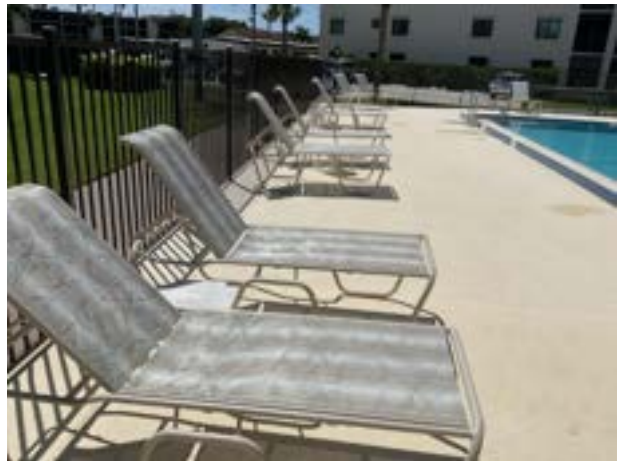
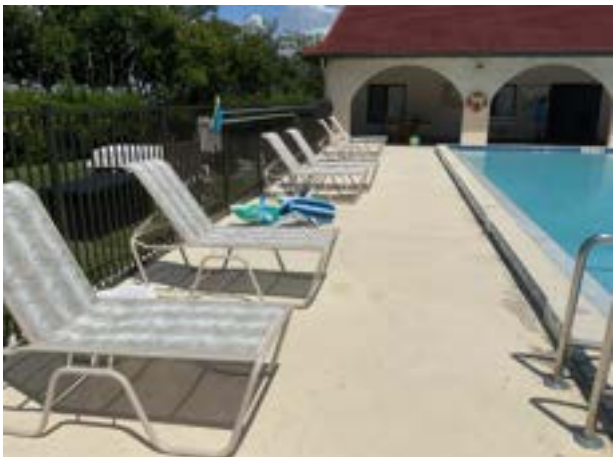
Pool furniture

**Condition:** Good to fair overall with no significant deterioration evident

**Expenditure Detail Notes:** Expenditure timing and costs are depicted in the **Reserve Expenditures** table in Section 3. We recommend interim re-strapping, refinishing, cushion replacements, reupholstering and other repairs to the furniture as normal maintenance to maximize its useful life.

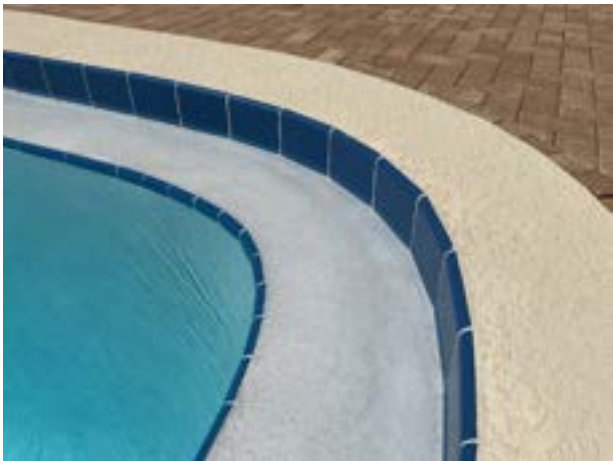
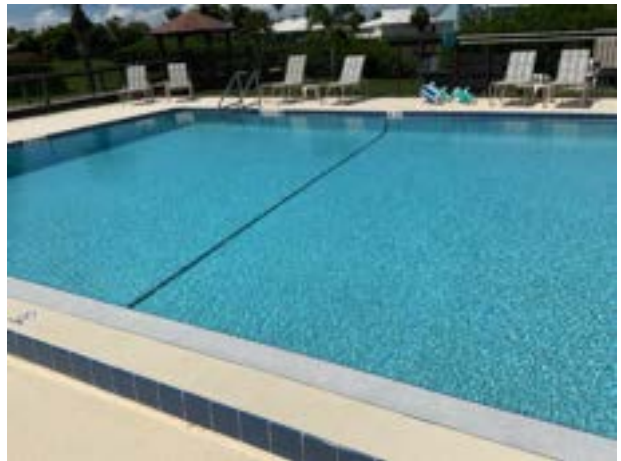
**Condition:** Good overall with no signs of significant deterioration

Plaster and tile finish at steps

Plaster finish at small pool

Tile finish

Plaster finish at clubhouse pool

- Removal and replacement of the plaster finishes
- Partial replacements of the scuppers and coping as needed
- Replacement of tiles as needed
- Replacement of joint sealants as needed
- Concrete structure repairs as needed
