# Canaveral Bay Condominium Association, Inc.

October 15, 2024 • Cape Canaveral, FL

STRUCTURAL INTEGRITY  
RESERVE STUDY

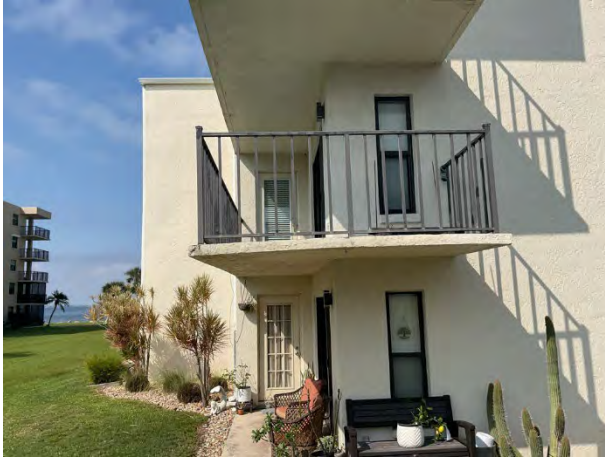
**Condition:** Due to the non-invasive nature of our inspection, we are unable to fully verify the condition of the balconies. However, we note isolated balconies with exposed reinforcement. In addition, we note isolated deflection, spalls, cracks, coating deterioration and the use of carpet floor coverings. Carpet conceals concrete deterioration, retains water and inhibits drainage. Water trapped by the carpet can result in accelerated concrete deterioration. Therefore, we do not recommend the use of carpet on balcony surfaces. We note the following:

**Sloped balcony**

**Useful Life:** As noted above, we recommend the Association conduct near term inspections and extensive repairs. Subsequent to these repairs, we recommend the Association anticipate the need for capital repairs including a close-up visual inspection, patching of delaminated concrete, routing and filling of cracked concrete, and waterproof coating applications every 10- to 15-years.

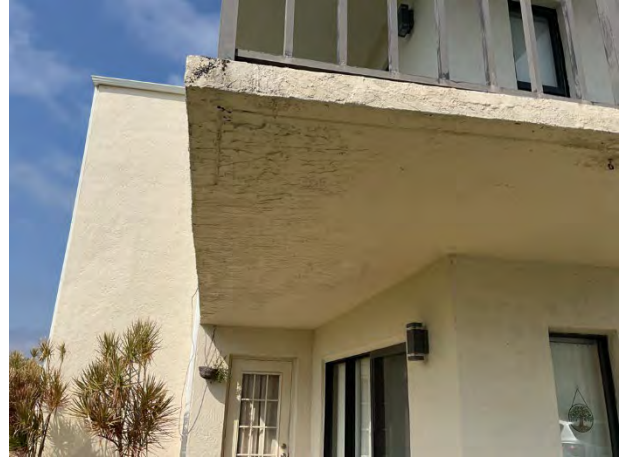
**Balcony underside**

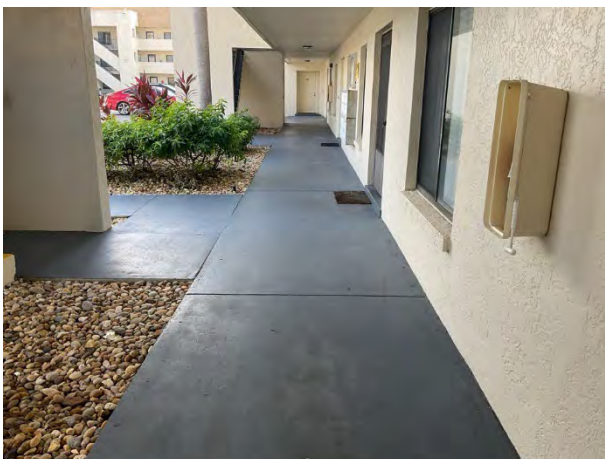
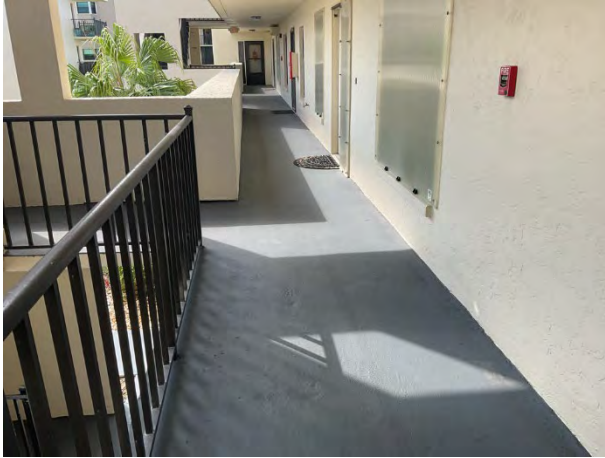
**Condition:** Good to fair overall with isolated cracks and trip hazards evident

Breezeway overview

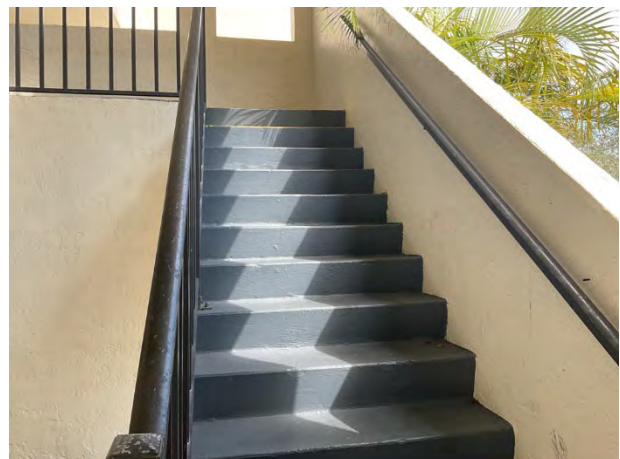
Stairs

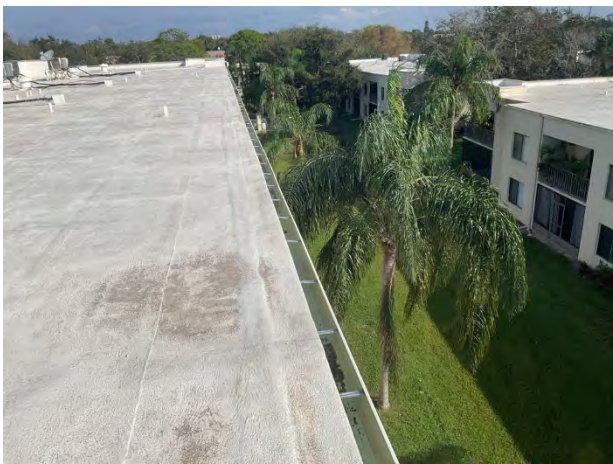
**Condition:** Good to fair overall with damage evident

**Metal gutter**

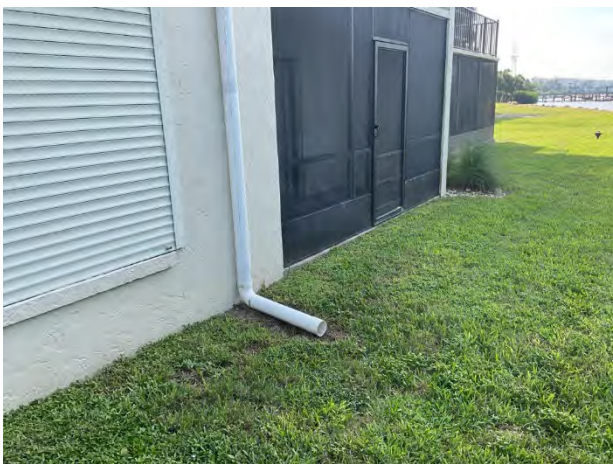
**Downspout**

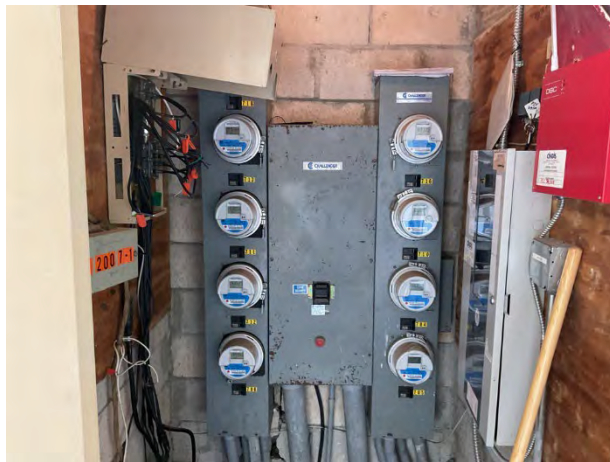
- No thermoscan inspection has been done
- No excessive buzzing/humming was present at the transformers we observed.
- No obvious combustible material storage was observed in electrical rooms. However, our inspection is not exhaustive and the Association should conduct periodic inspections of the electrical rooms to ensure compliance with 10.18.5 of NFPA 1.
- Some electrical rooms were not labeled. The Association should consider adding clear and proper signage to the electrical rooms.
- No obvious exposed wires were observed during our site inspection. However, our inspection is not exhaustive and the Association should conduct periodic inspections of the electrical rooms to ensure no unsafe conditions develop.
- Rust and peeling paint is noted at electrical panels.
- No apparent water was observed in or near the electrical rooms.

Electrical system

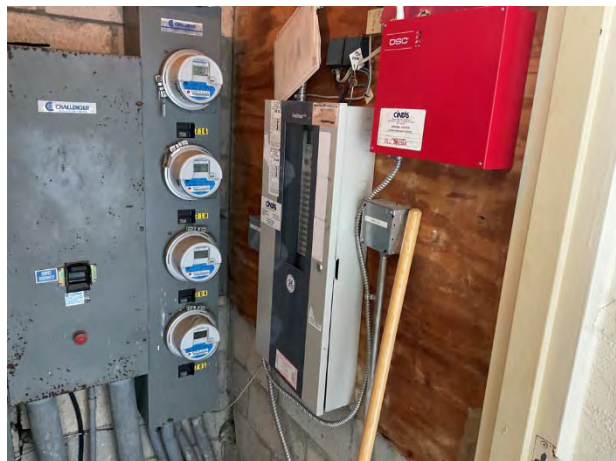
**History:** Installed in approximately 2018-2020 at Buildings 7, 8 and 9. One control panel was reportedly replaced.

**Control panel**

- Structural Integrity – Life safety system control panel replacements to ensure functionality
- Structural Integrity – Repairs and paint applications to exterior stucco to maintain desired condition and appearance

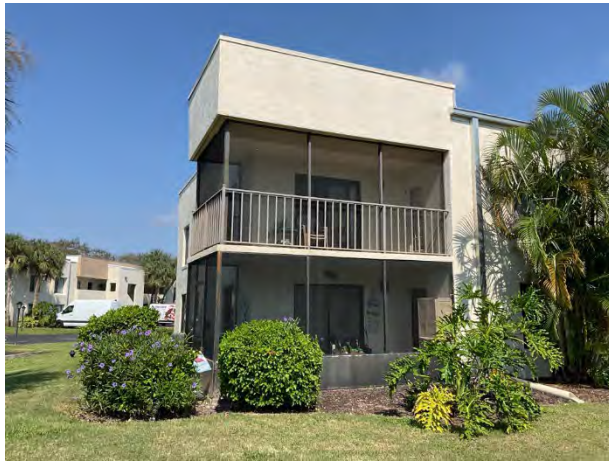
**Condition:** Due to the non-invasive nature of our inspection, we are unable to fully verify the condition of the balconies. However, we note isolated balconies with exposed reinforcement. In addition we note isolated deflection, spalls, cracks, coating deterioration and the use of carpet floor coverings. Carpet conceals concrete deterioration, retains water and inhibits drainage. Water trapped by the carpet can result in accelerated concrete deterioration. Therefore, we do not recommend the use of carpet on balcony surfaces.

**Balcony overview**

**Useful Life:** As noted above, we recommend the Association conduct near term inspections and extensive repairs. Subsequent to these repairs, we recommend the Association anticipate the need for capital repairs including a close-up visual inspection, patching of delaminated concrete, routing and filling of cracked concrete, and waterproof coating applications every 10- to 15-years.

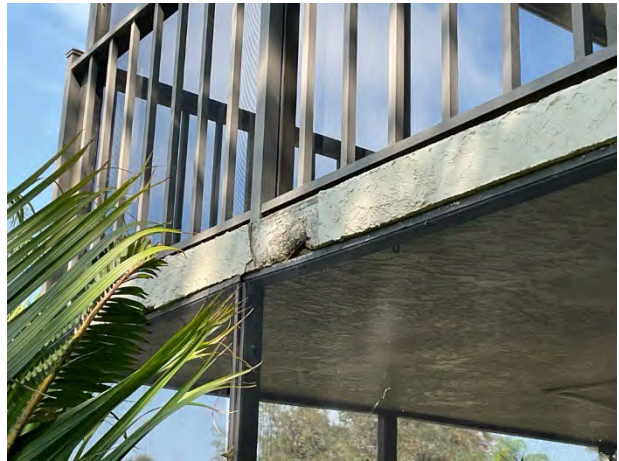
**Exposed reinforcement**

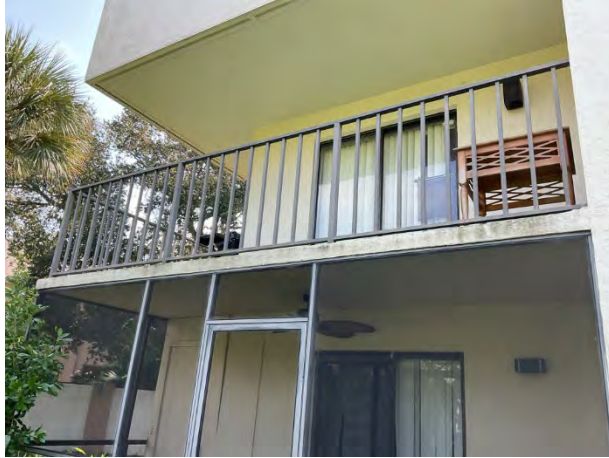
**Balcony overview**

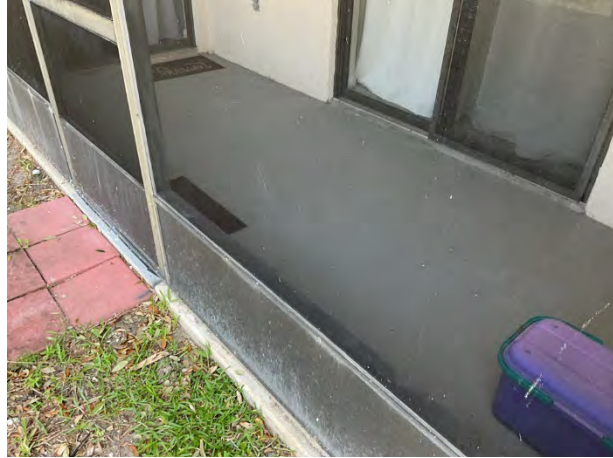
**Concrete Patio**

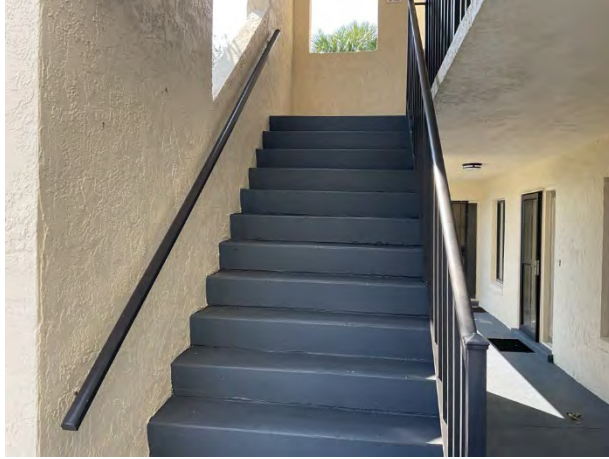
**Condition:** Good to fair overall with isolated cracks and spalls evident

**Staircase overview**

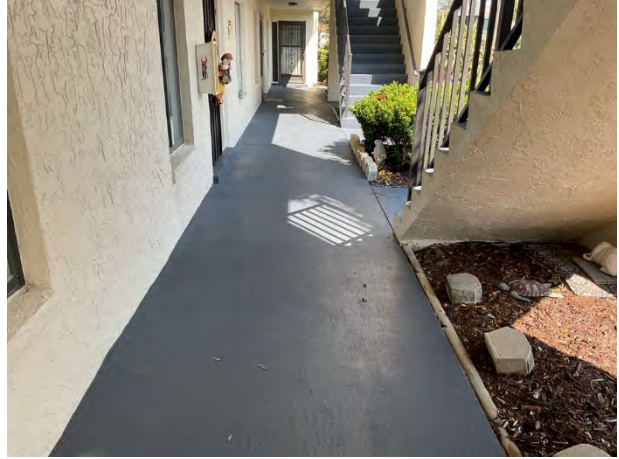
**Breezeway overview**

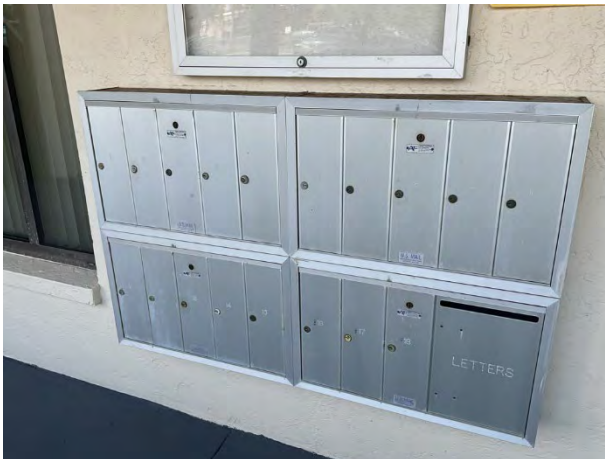
**Condition:** The condition of the mailboxes varies from fair to poor with rust evident

**Mailbox stations**

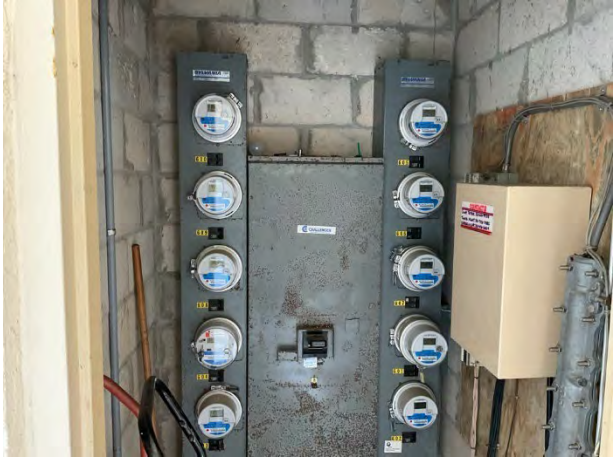
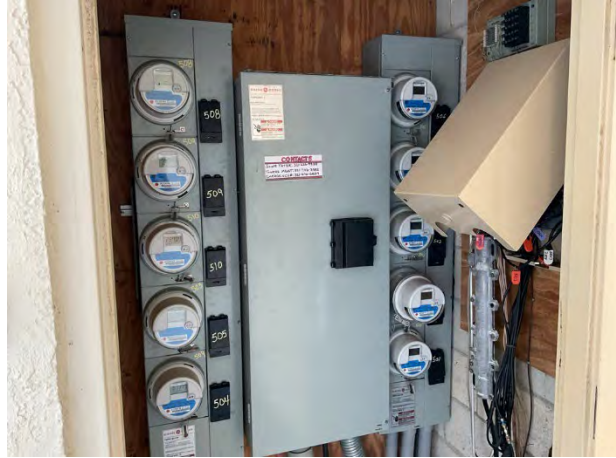
**Condition:** Reported satisfactory without operational deficiencies. We note finish deterioration to the outside of the panels evident

**Electrical system**

**Expenditure Detail Notes:** Expenditure timing and costs are depicted in the **Reserve Expenditures** table in Section 3. We recommend the Association budget to replace the main switchgear, distribution and circuit protection panels. Updates of this Reserve Study will consider possible changes in the scope and times of component replacements based on the conditions, including the need for replacement of the wires.

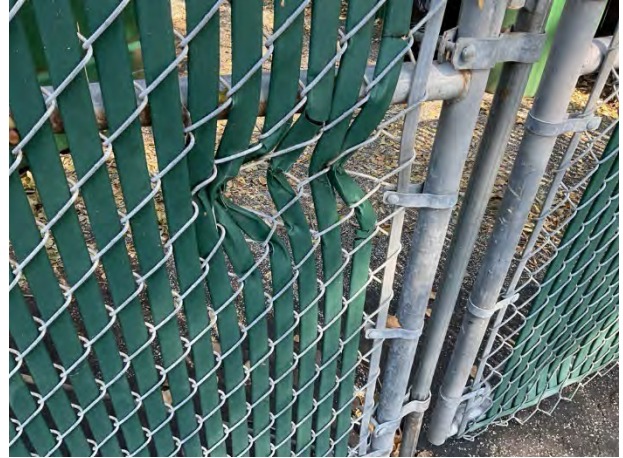
**Condition:** Good to fair overall with warped webbing and leaning sections evident

**Fence warped webbing**

- Inspect and repair loose sections, and damage
- Repair leaning sections and clear vegetation from fence areas which could cause damage

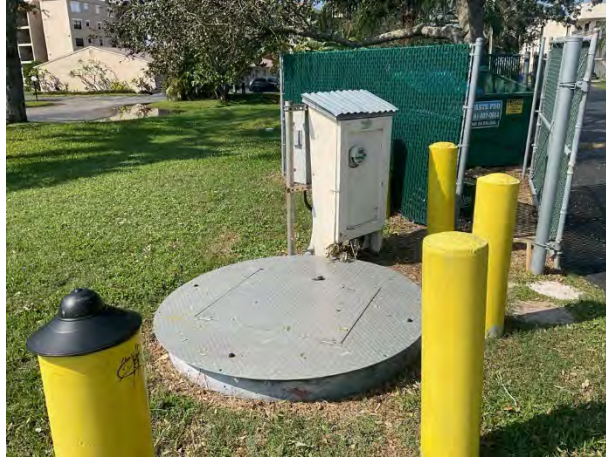
**Condition:** Reported satisfactory with the need for minor piping repairs

**Lift station**

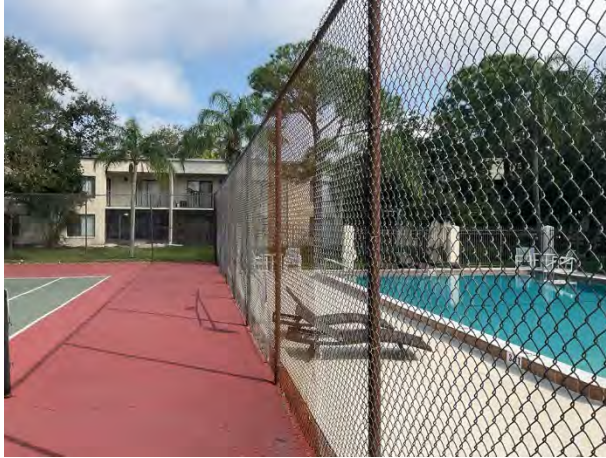
**Condition:** Fair overall with isolated deterioration, rust and damage evident

**Chain link fence**

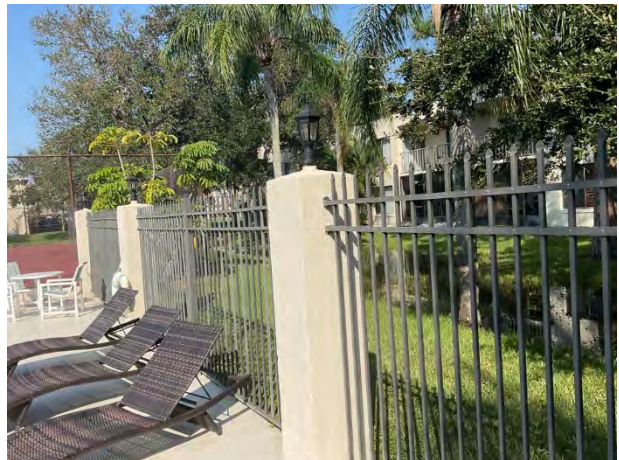
**Condition:** Good to fair overall with isolated bent pickets and finish deterioration evident

**Aluminum pool fence**

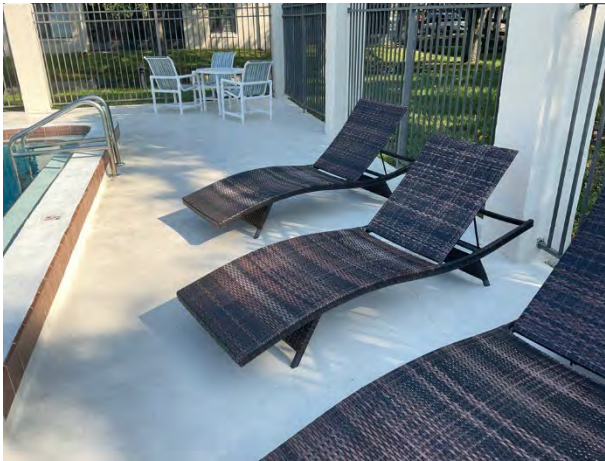
**Condition:** Fair overall with finish deterioration and damage evident.

**Pool furniture overview**

replacements, reupholstering and other repairs to the furniture as normal maintenance to maximize its useful life.

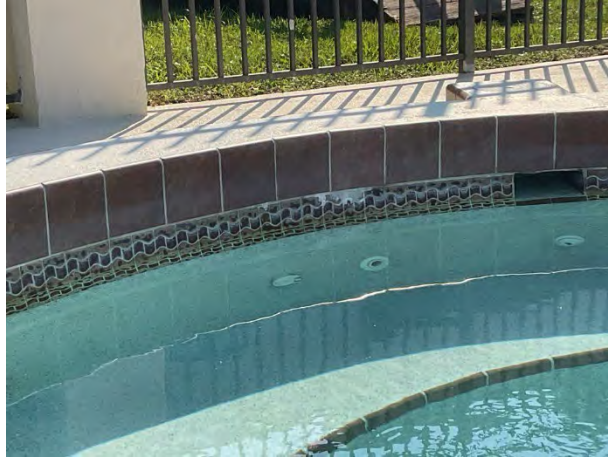
**Condition:** Fair overall with deterioration evident

**Tile deterioration**

**Expenditure Detail Notes:** Expenditure timing and costs are depicted in the **Reserve Expenditures** table in Section 3. We recommend the Association budget for full tile replacement every other plaster replacement event. Removal and replacement of the finish provides the opportunity to inspect the pool structures and to allow for partial repairs of the underlying concrete surfaces as needed. To maintain the integrity of the pool structures, we recommend the Association budget for the following:

- Removal and replacement of the plaster finishes
- Partial replacements of the scuppers and coping as needed
- Replacement of tiles as needed
- Replacement of joint sealants as needed
- Concrete structure repairs as needed

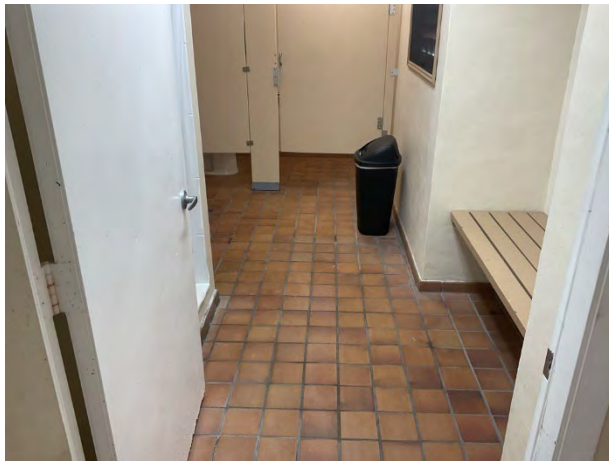
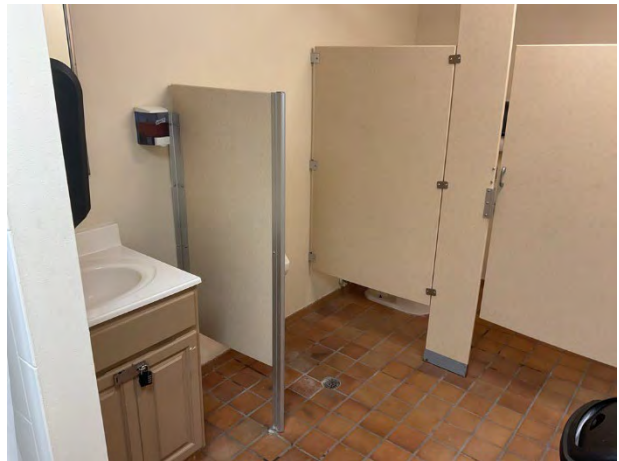
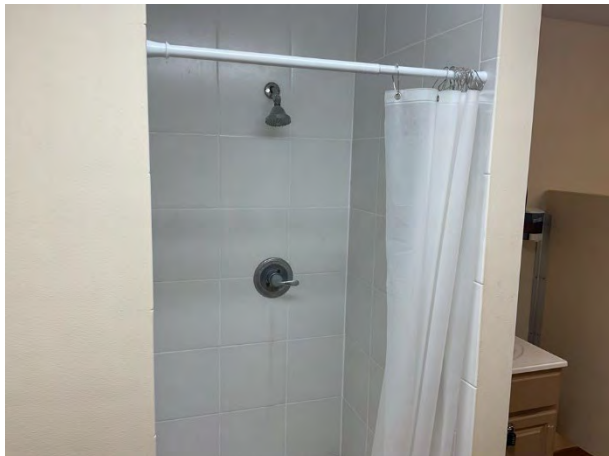
**Condition:** Fair overall with isolated damage, finish deterioration and rust evident

Rest room overview
