# Surfside South Condominium Association, Inc.

March 2, 2023 • Madeira Beach, FL

FULL RESERVE STUDY

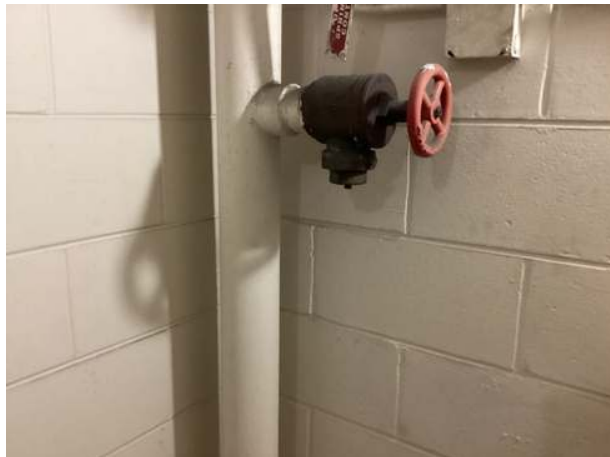
**Fire standpipe**

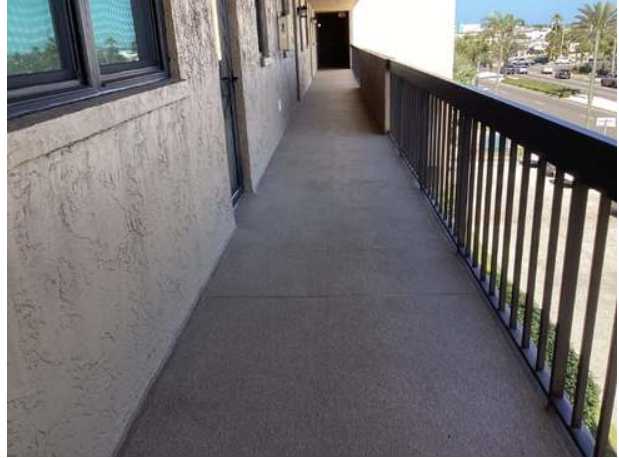
Second floor north tower breezeway

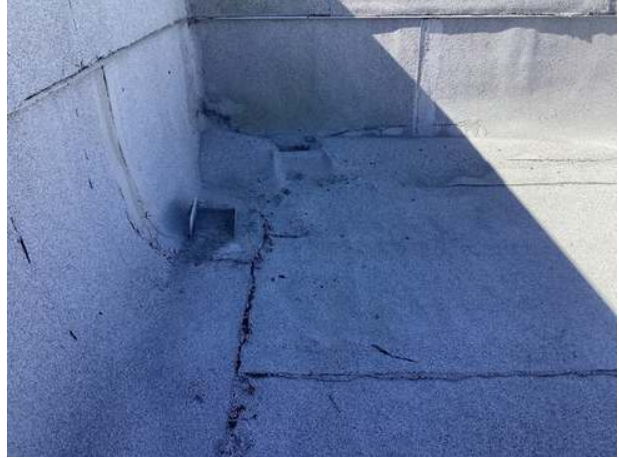
**Granular loss**

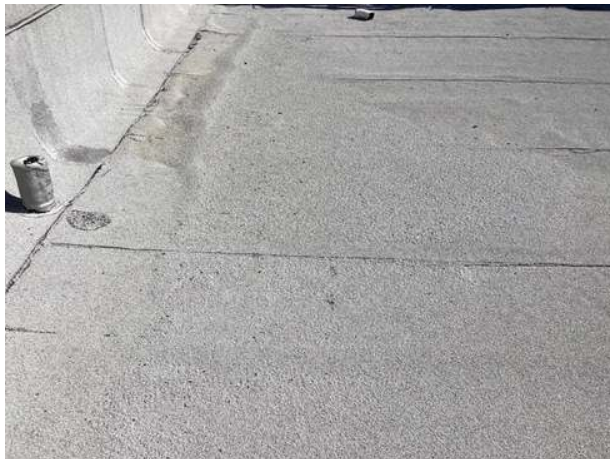
**Granular loss**

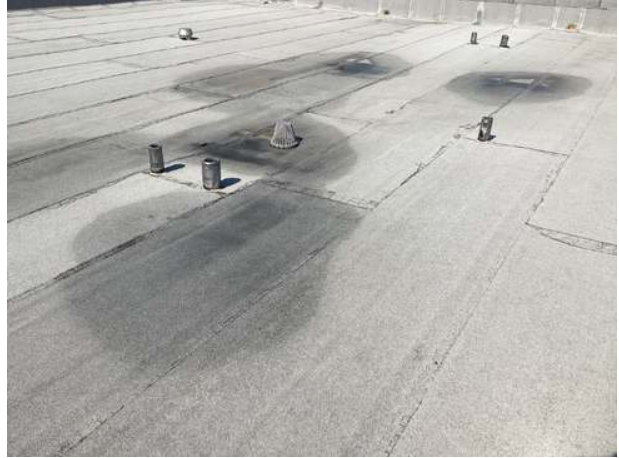
**Standing water**

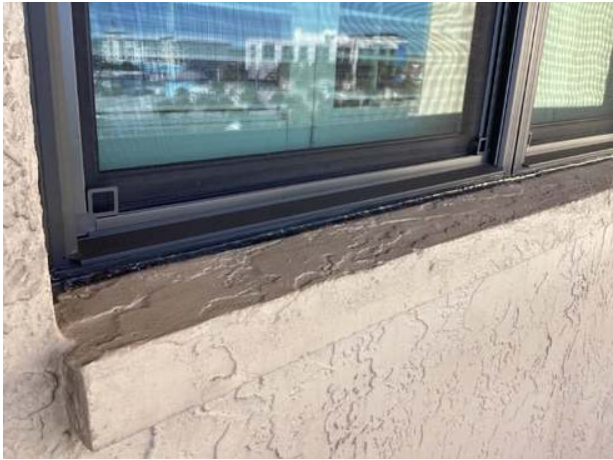
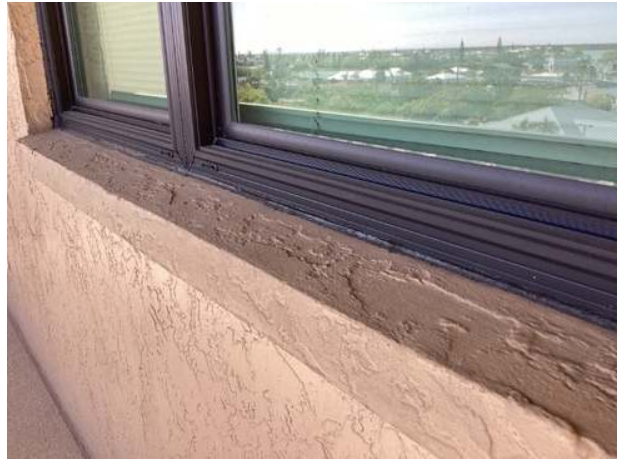
Sealant in good condition at unit 412 front window Sealant in good condition at unit 509 front window

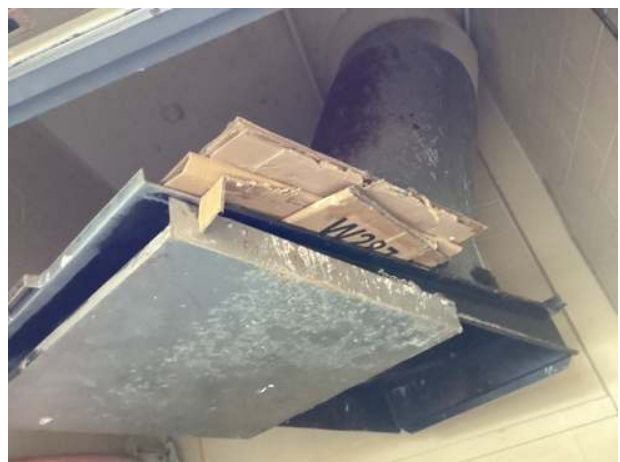
Trash chute door

Trash chute

**Component Detail Notes:** Damaged doors or poor door operation will result in a decreased useful life. The Association should fund interim repairs and partial replacements of the doors through the operating budget.
